March 18, 2016

02945 Version 1

MIL Comes On with DTC P0335 and/or P0339

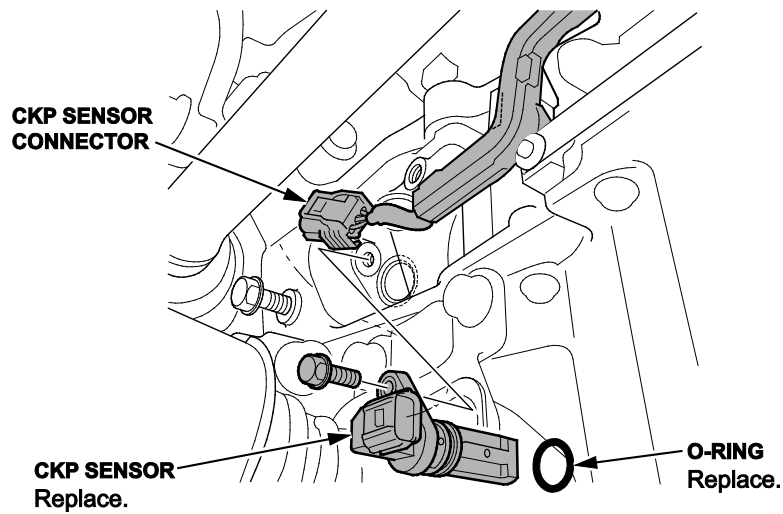
There is corrosion between the engine wire harness and the CKP sensor connector.

2. Disconnect the CKP sensor connector.
