T-SB-0083-16 July 27, 2016

MIL "ON" DTC P2610

YEAR(S)	MODEL(S)	ADDITIONAL INFORMATION
2014 - 2016	Sequoia

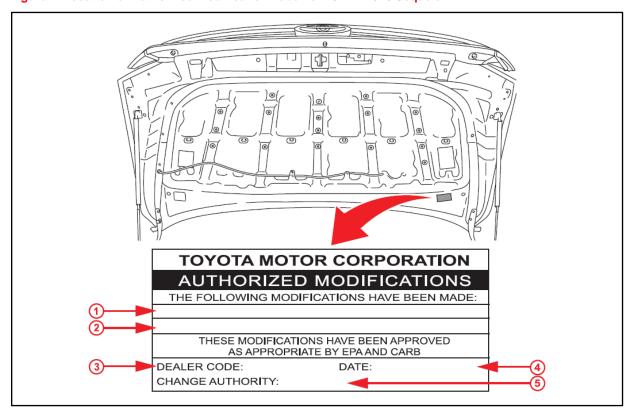
Figure 1. Location of Authorized Modification Label for 2014 - 2016 Sequoia

2. Check for the Authorized Modifications Label affixed to the vehicles in the location shown below. Confirm if the ECM (PCM) calibration has been updated.

- 4. Install the Authorized Modifications Label.
 - A. Using a permanent marker, enter the following information on the label:
 - ECM part number [Refer to the Parts Information section for the NEW PART NUMBER]
 - Calibration ID(s) [Refer to the Calibration Information section for the NEW CALIBRATION ID]
 - Dealer Code
 - Repair Date
 - Change Authority [This bulletin number]
- 5. Affix the Authorized Modifications Label to the vehicle at the location shown in Figure 1. The Authorized Modifications Label is available through the MDC, P/N 00451-00001-LBL.
- 6. Test drive vehicle to confirm proper vehicle operation.
