TSB140120

Fault Codes Caused by Insulation Buildup on the Aftertreatment Diesel Particulate Filter (DPF) Inlet Face.

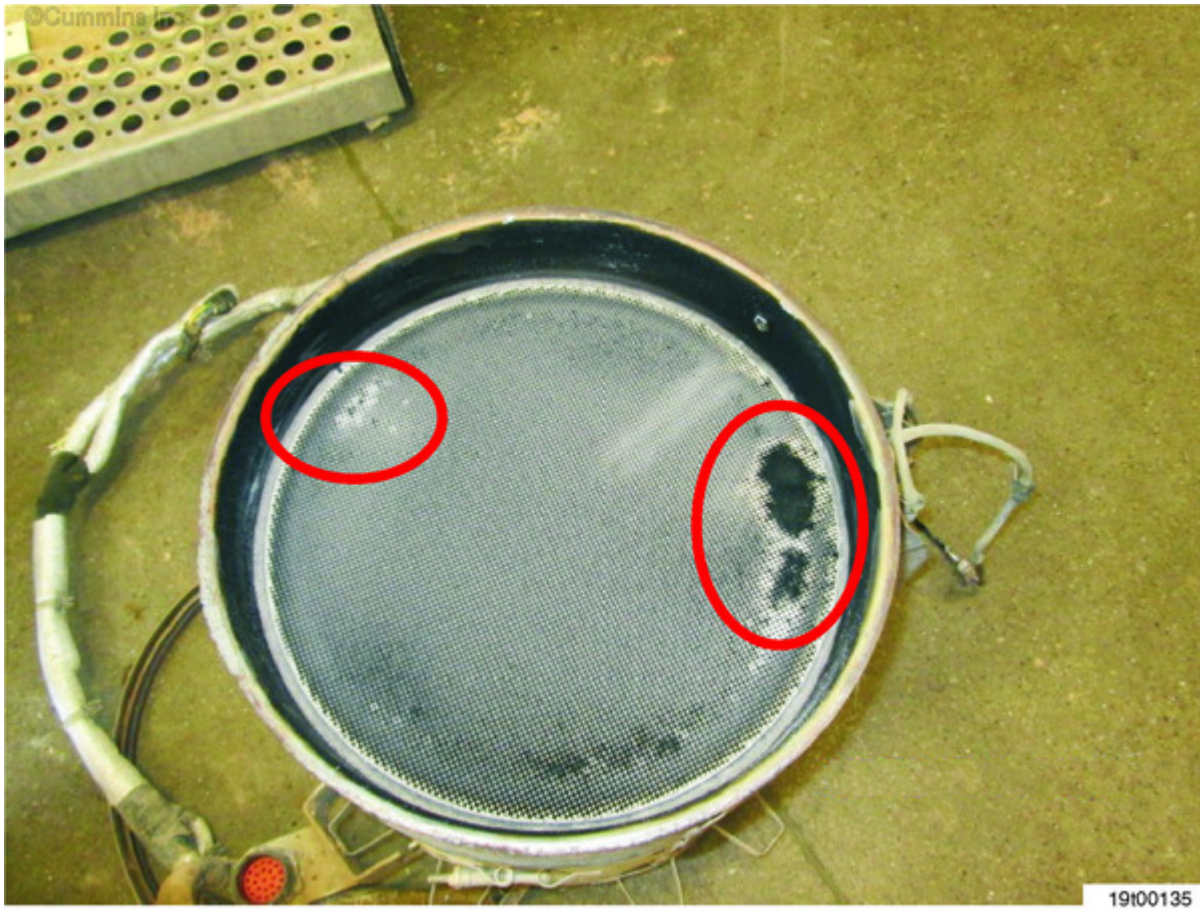
Figure 1

The insulation collects near the aftertreatment DPF intake temperature sensor port, plugging the aftertreatment DPF inlet face. See Figures 1 and 2 below.

1. If insulation buildup is present on the aftertreatment DPF inlet face and the aftertreatment system is equipped with one of the aftertreatment DOC part numbers listed in Table 1, perform the following:

- Clean the aftertreatment DPF.
- Use the following procedure in the ISX12 CM2350 X102 Service Manual, Bulletin 4310646. [Refer to Procedure 011-041 in Section 11](#)
- Use the following procedure in the ISX15 CM2350 X101 Service Manual, Bulletin 4310641. [Refer to Procedure 011-041 in Section 11.](#)
- Remove and replace the aftertreatment DOC.
- Use the following procedure in the ISX12 CM2350 X102 Service Manual, Bulletin 4310646. [Refer to Procedure 011-049 in Section 11.](#)
- Use the following procedure in the ISX15 CM2350 X101 Service Manual, Bulletin 4310641. [Refer to Procedure 011-049 in Section 11.](#)
- Clean the aftertreatment DPF intake temperature sensor probe.
