Improper Exhaust Gas Recirculation (EGR) Cooler Replacement with No Failure Found

ISX15 CM2250, QSX15 CM2250 ECF, ISX12 CM2250, and QSX11.9 CM2250 ECF Fuel Pump - Ceramic Plunger and Tappet Roller Inspection and Repair

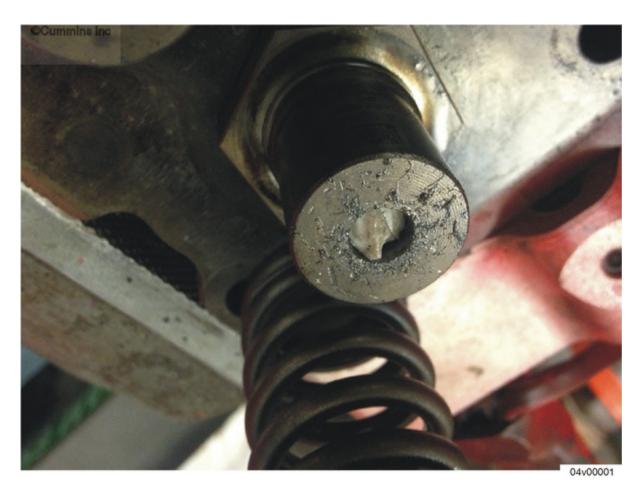
04v00002

This document, in conjunction with the information provided within the manuals listed in the table above, provides the inspection and repair practice when ceramic plungers are found to be fractured (see Figure 1) and/or tappet roller damage is found on fuel pumps with ceramic plungers (see Figure 2). Ceramic plungers can be identified by their white color. See Procedure 005-227 in the Associated Procedures Table for removal of the fuel pump head.

Figure 1: Fractured Fuel Pump Ceramic Pumping Plunger

If the ceramic plungers are fractured (see Figure 1), but no damage is found on the fuel pump tappet rollers (see Figure 2), no further inspection is needed. Perform the following steps for the appropriate engine (ISX15 CM2250, QSX15 CM2250 ECF, ISX12/ISX11.9 CM2250, or QSX11.9 CM2250 ECF):

- 1. Replace the fuel pump. See Procedure 005-016 in the Associated Procedures Table.
  - a. For ISX15 CM2250 or QSX15 CM2250 ECF: Refer to TSB110064 (New Two-Cylinder High-Pressure Fuel Pump Assembly) if replacing a three-cylinder twopiston pump with a two-cylinder pump.
  - b. For ISX15 CM2250 or QSX15 CM2250 ECF: New fuel lines are required if replacing a fuel pump gear pump with bottom mount fuel lines. See Technical Service Bulletin, New Fuel Pump Gear Pump with Revised Fuel Line Locations, TSB130044.
- 2. Change the engine lubricating oil and lubricating oil filter. See Procedure 007-013 in the Associated Procedures Table.
