MODEL  
2014~2015MY  
Soul (PS)

NUMBER  
093

## TECHNICAL SERVICE BULLETIN

**SUBJECT:** HEADLAMP BULB CONNECTOR REPLACEMENT

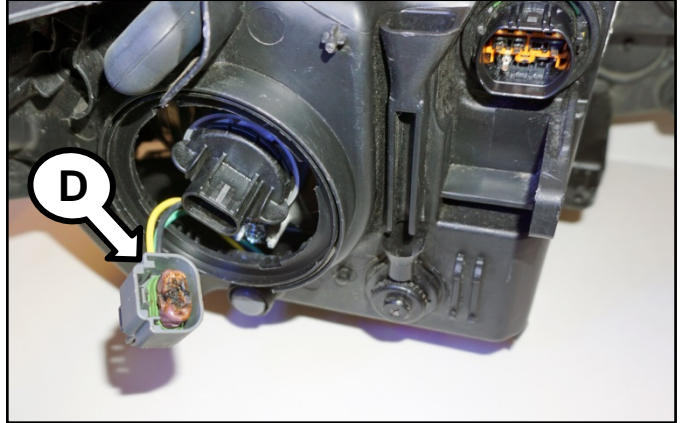
5. Disconnect the headlamp connector (D) from the bulb and confirm heat deformation. If heat deformation is confirmed on either headlamp connector, replace the connectors on BOTH the RH and LH headlamp assemblies.

*Headlamp removed from vehicle for illustration purposes*

This bulletin provides information about replacing the bulb connector in the headlamp assembly on some Soul (PS) vehicles, equipped with non-projector style headlamps and produced from August 26, 2013 through April 20, 2015, which may exhibit a heat-deformed headlamp bulb connector. To correct this concern, replace the affected headlamp bulb connector by following the procedure outlined in this TSB. **NOTE: vehicles equipped with projector-style headlamps are NOT affected.**
