| TSB140137 |

ISX 12/15 CM2250/CM2350 Variable Geometry Turbocharger (VGT) Turbocharger Bearing Housing Coolant Leak Test - Service Tool Leaks

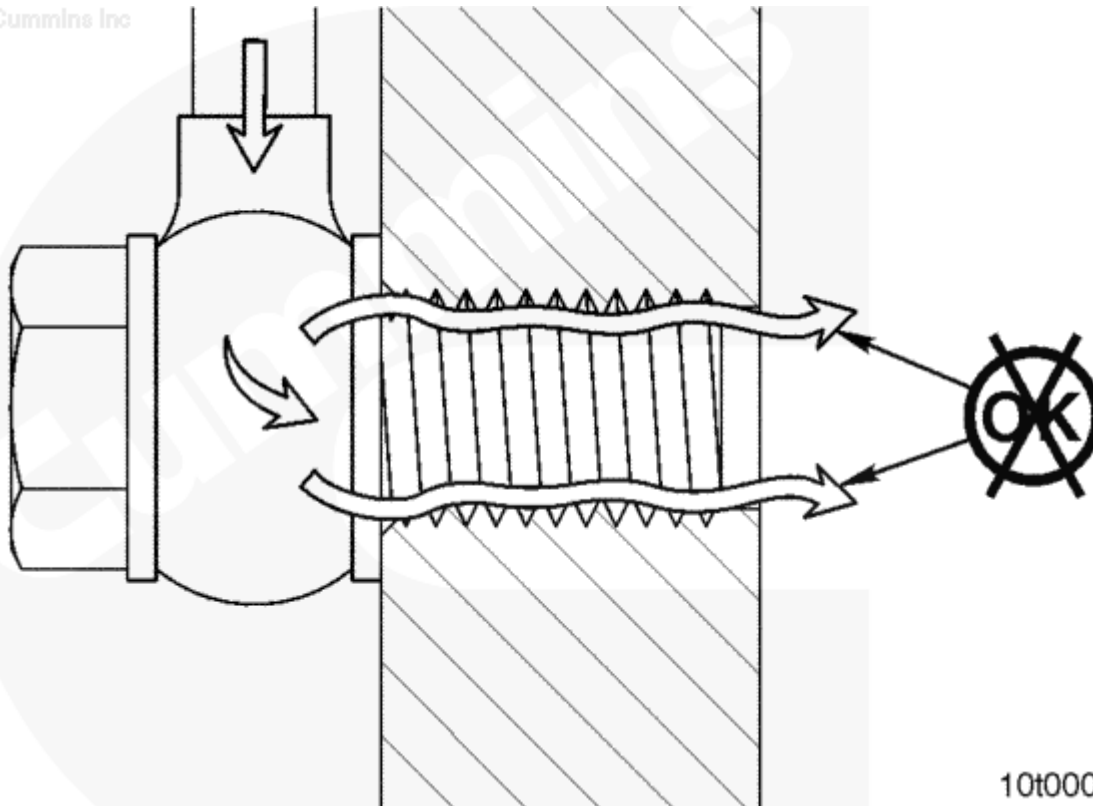
Figure 1

Turbochargers are being returned due to failing the bearing housing leak test when using Service Tool Kit, Part Number 2892101, as described in Procedure 010-033 (Turbocharger) in the service manual. It was found that the actual leak was caused by the service tool. The block off fittings do **not** provide enough shoulder for the inner seal of the banjo washer to seal properly, allowing air to leak down past the bolt and mating component threads. See Figure 1.

Pack the threads of the block off fittings with an all-purpose or bearing grease to seal off air leaks caused by the service tool. After the test, wipe off the grease from mating components. Use new sealing washers, since the grease may **not** be compatible with seals in the cooling system.
