Service Bulletin

Bulletin No.: 15-08-44-001H

Date: June, 2016

Subject: GM of Canada OnStar® Cellular Communication Upgrade

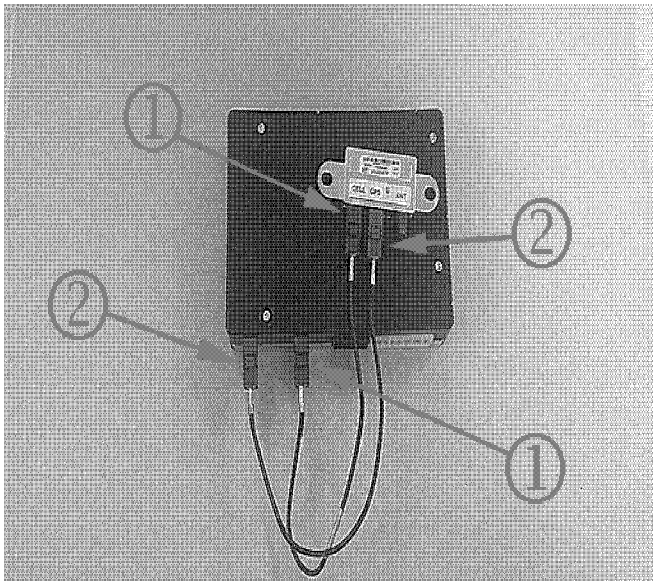
4013102

Note: During installation of the antenna cable and the cellular cable to the splitter, if the cables inadvertently become incorrectly installed, the technician may notice a red LED with DTCs B101D-3C and B101D-F0 set as current in the OnStar VCIM.

4. Connect the male to male cable (P/N 23310710) to the cellular connector (1) to the splitter as shown above.
5. Connect the male to male cable (P/N 23242477) to the GPS connector (2) to the splitter as shown above.
