# Service Bulletin

**Subject:** Inspection and Repair Guidelines for Dust Intrusion into Passenger Compartment

**Models:** 2010-2017 Chevrolet Equinox  
2010-2017 GMC Terrain

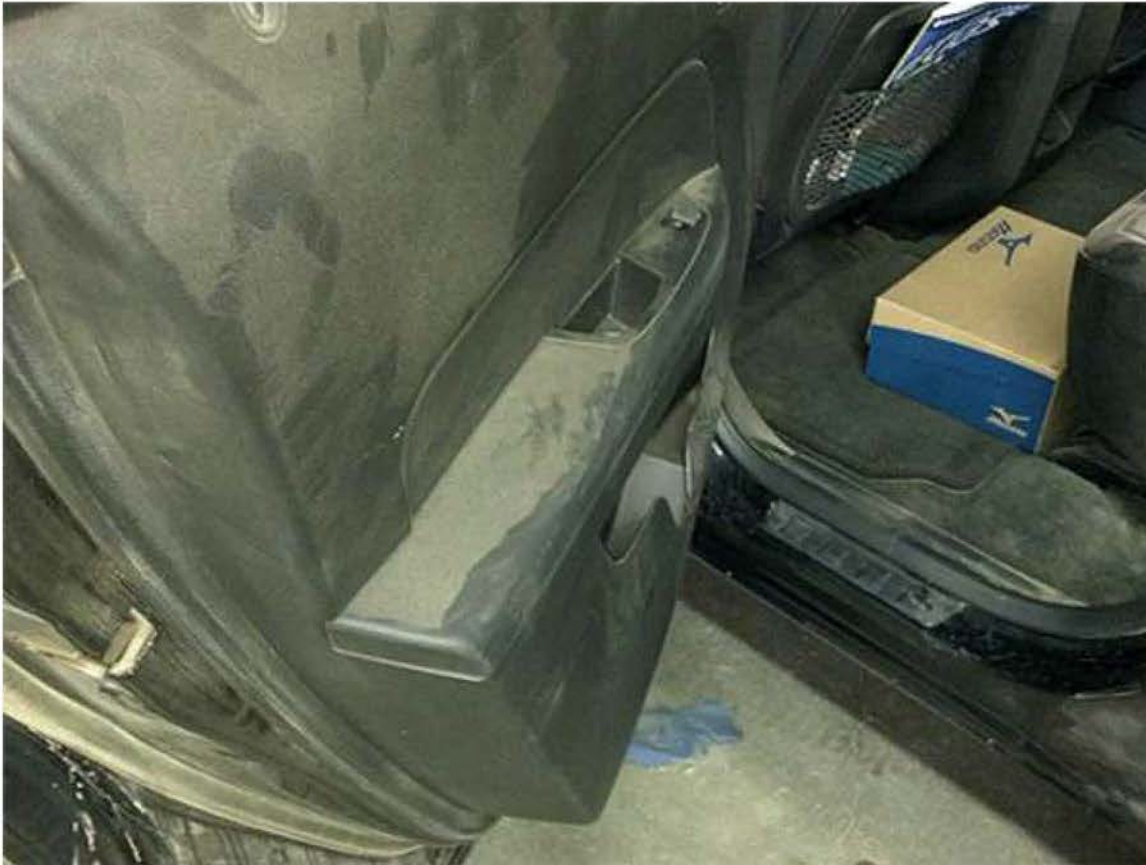
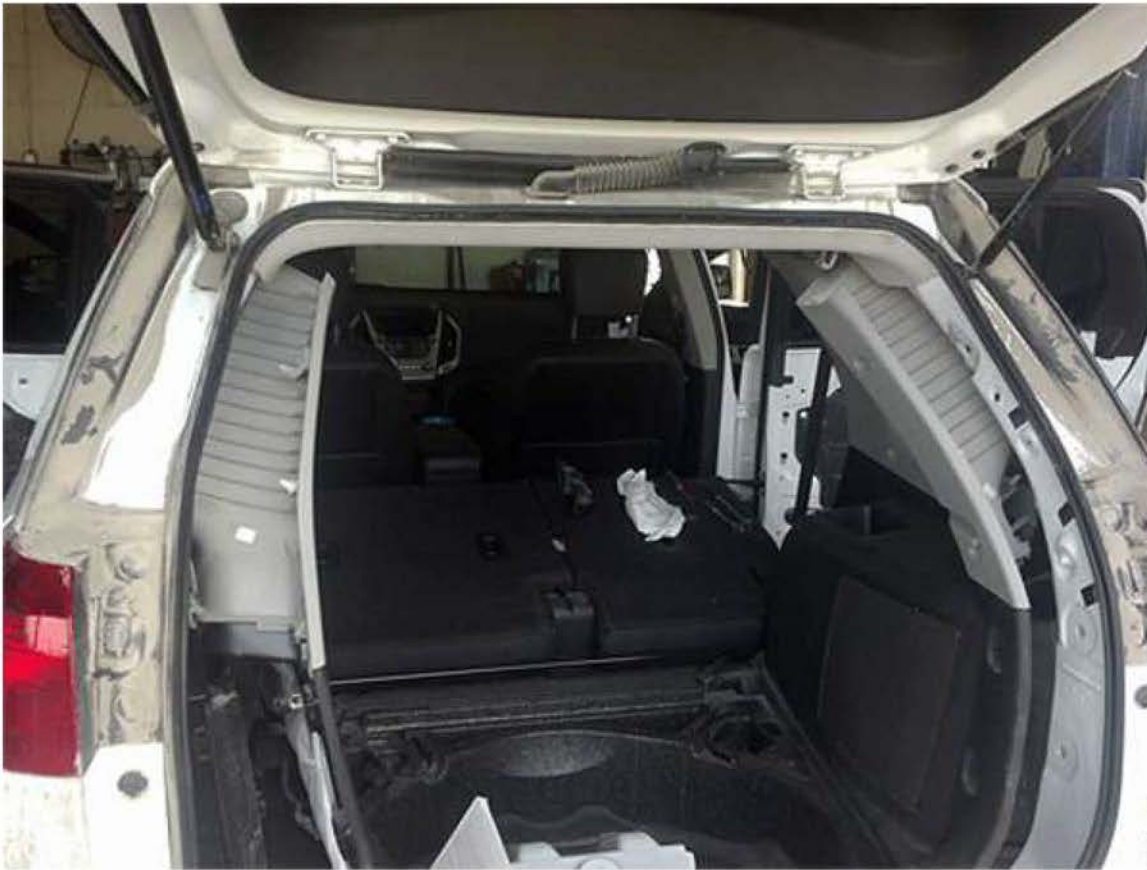
Some customers may comment that excessive dust is entering into the passenger compartment through the side doors or rear liftgate areas. This is usually found to occur when the vehicle is driven in high dust areas. Examples of this condition are shown in the graphics below.

The cause of this condition may be that the dust/debris is working past the side door or liftgate sealing surfaces.

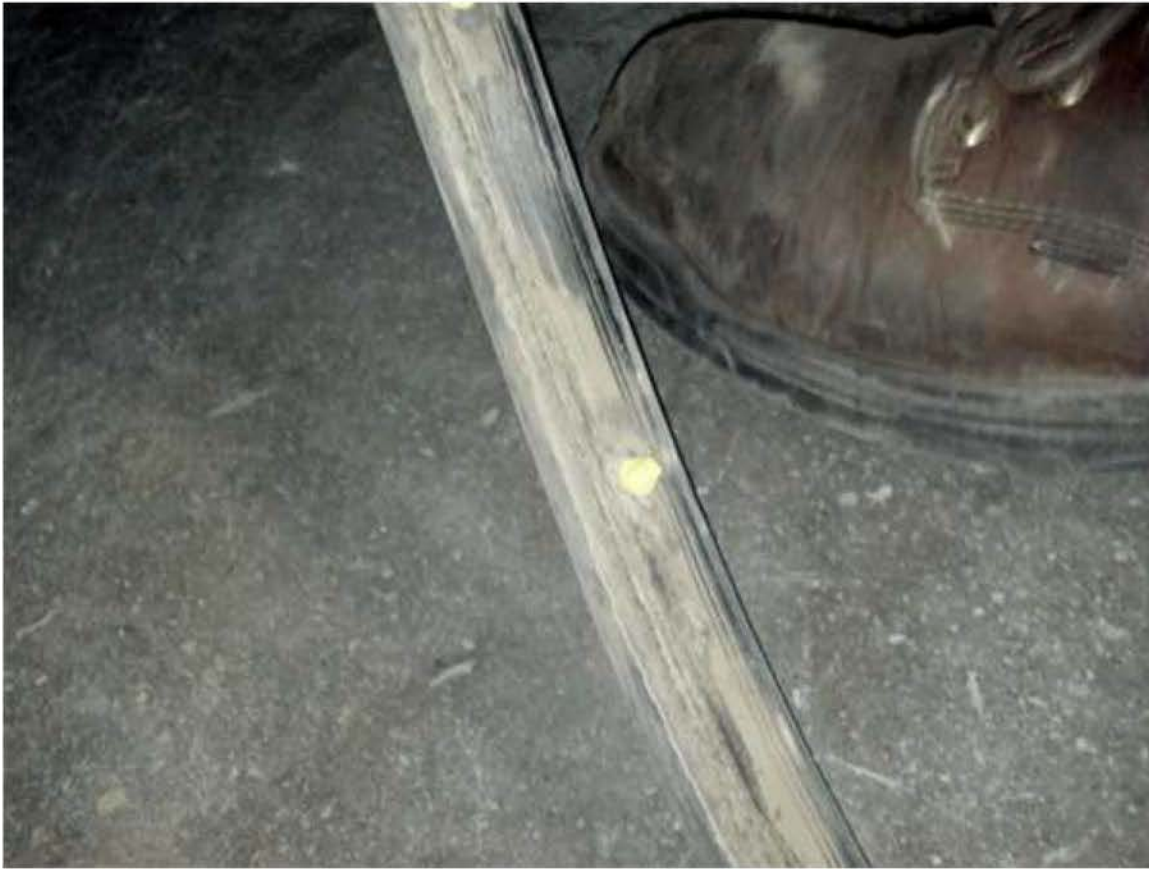
**Note:** A vehicle will sometimes show evidence of dirt/dust being pulled past the backside of the rocker moldings as shown above. A double sided tape is added to the moldings to help eliminate this condition.

**2.1.** Remove the left and right rocker panel moldings (seals). Refer to Rocker Panel Molding Replacement in SI. Inspect the seals for any deformations or damage and replace as appropriate.
