TSB140136

Oil Leaks at the Non-Hydraulic Drive Front Cover

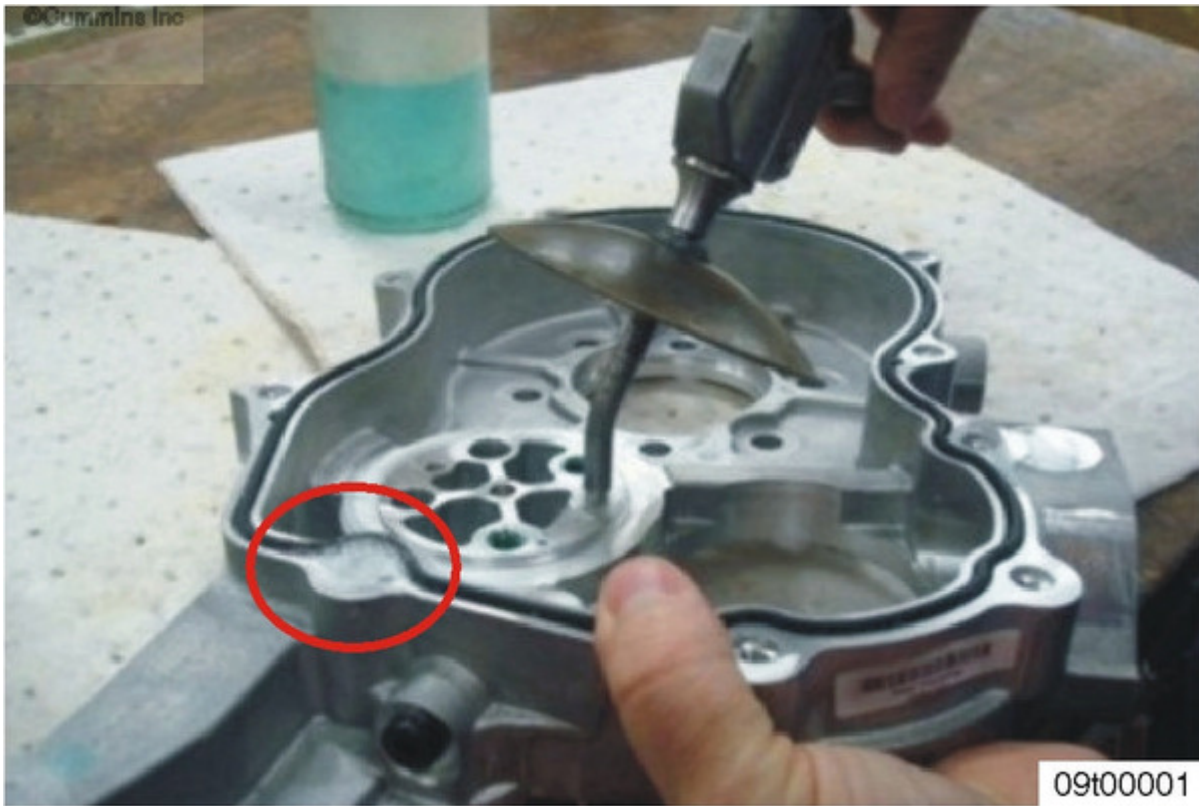
Figure A

Oil leaks are being detected on the gear housing and front cover of ISX 12 CM2250, ISX 12 CM2350 X102, and ISX12G engines by black light inspection. This leakage is attributed to the porosity in the cast aluminum gear housing wall that separates an oil galley from an adjacent bolt hole that retains the gear housing cover. See Figures A and B below.

Thoroughly clean the area around the leaking bolt hole to remove all oil. Apply a wicking thread sealant as deep in the bolt hole as possible. Cummins® recommends Part Number 3823689 (50ml. bottle), Part Number 3824039 (10ml. bottle), or Loctite™ 290. These actions are taken for the sole purpose of sealing the bolt hole to prevent oil leakage, and are **not** required for retaining the bolt or making sure of proper engine operation.
