MODEL
2011~2014MY
Optima (QF/TF)
2011~2013MY
Sorento (XMa)

NUMBER
026

TECHNICAL SERVICE BULLETIN

SUBJECT: A/C EVAPORATOR FREEZE-UP DURING EXTENDED DRIVE

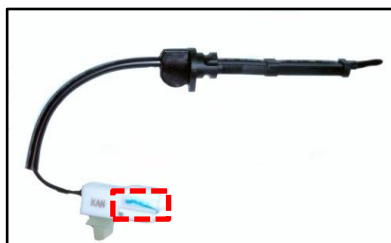
Sorento (XMa)
P/N 97614 3K000FFF

Replacement parts will have a small blue line on the connector, as shown below.

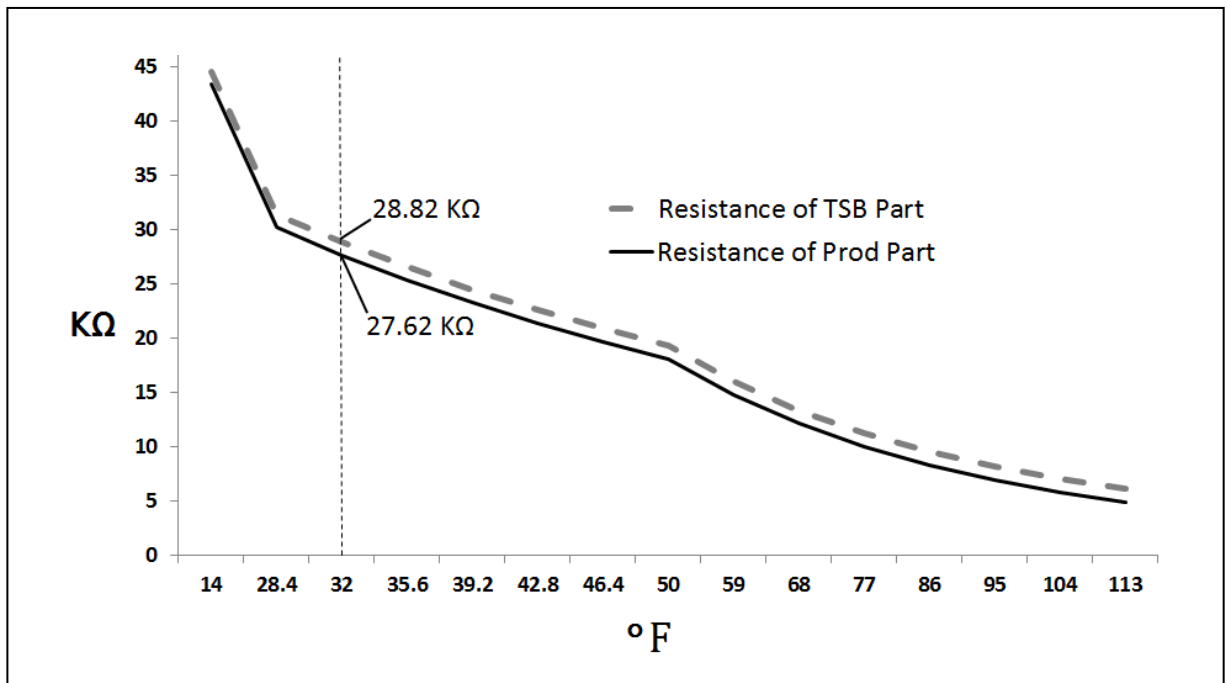
Temp.	Resistance (Original Part)	Resistance (Replacement Part)
(°F)	(KΩ)	(KΩ)
113	4.90	6.1
104	5.81	7.01
95.0	6.93	8.13
86.0	8.30	9.5
77.0	10.00	11.2
68.0	12.11	13.31
59.0	14.75	15.95
50.0	18.07	19.27
46.4	19.63	20.83
42.8	21.35	22.55
39.2	23.24	24.44
35.6	25.32	26.52
32.0	27.62	28.82
28.4	30.16	31.36
14.0	43.35	44.55

1. Replace the affected evaporator temperature sensor with a new one by referring to the applicable workshop manual on KGIS (Specific section section shown below).

Heating, Ventilation, Air Conditioning > Air Conditioning System > Evaporator Temperature Sensor > Repair procedures” chapter in the applicable Workshop Manual on KGIS.
