MODEL
2011~2016MY
Sportage (SL)
2011~2015MY
Sorento (XMa)

NUMBER
047

TECHNICAL SERVICE BULLETIN

SUBJECT: AWD SYSTEM HYDRAULIC ACTUATOR REPLACEMENT

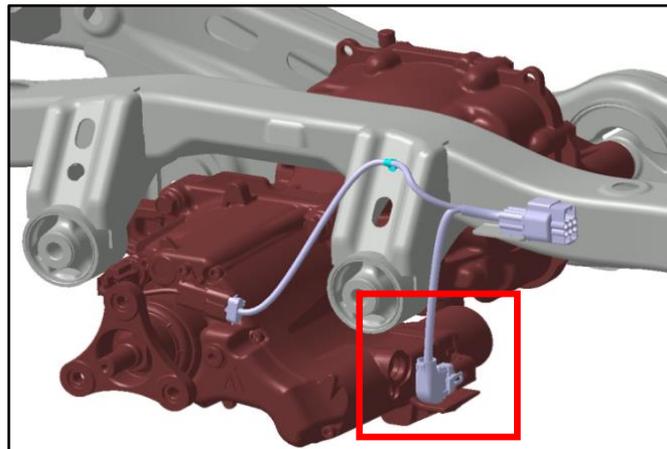
This bulletin provides the procedure for replacement of the hydraulic actuator of some All-Wheel Drive (AWD) equipped 2011~2016MY Sportage (SL) vehicles, produced from May 6, 2010 through February 19, 2013 and some AWD equipped 2011~2015MY Sorento (XMa) vehicles, produced from October 24, 2009 through December 11, 2014, which may exhibit an inoperative AWD system with the Malfunction Indicator Lamp (MIL) on and DTCs P1820/1821/1822/1823/1824 (Active or in History). To correct this concern, replace the affected hydraulic actuator by referring to the applicable service procedure on KGIS. **NOTE: Do NOT replace the coupling assembly for these concerns. Unnecessary assembly replacement may result in chargebacks.**

- P1820 Pump for 4WD Motor High overcurrent detected
- P1821 Pump for 4WD Motor Wire Short to Battery
- P1822 Pump for 4WD Motor Wire Open Load
- P1823 Pump for 4WD Motor Wire Short to Ground
- P1824 Pump for 4WD Slow Thermal Overload
