Technical Service Bulletin Number	Revision Level	Date	Group Number
TSB140071

Fault Code 2198 Caused by Original Equipment Manufacturer (OEM) Keyswitch Wiring

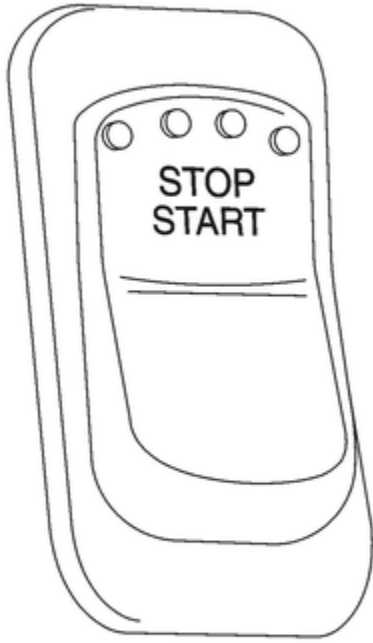
Previous

Certain Emergency One keyswitch configurations cause the ECM to power back ON while the turbocharger actuator is still powering down, when the engine start/stop switch is pressed and released to stop the engine. The actuator does **not** correctly process the communication from the ECM, causing it to log an error code. This condition is **not** present at the next key ON, and Fault Code 2198 should be inactive.

To prevent repeat occurrences of Fault Code 2198 and unnecessary replacement of parts, Emergency One has revised the keyswitch wiring on certain vehicles with specific optional equipment.

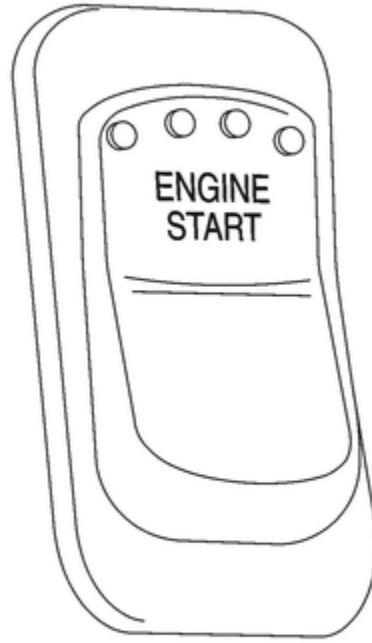
Revised

If a customer experiences Fault Code 2198 on an Emergency One fire apparatus, check the unit's keyswitch configuration. If the previous configuration is used, this can be the cause of Fault Code 2198. If the revised configuration is used, the keyswitch configuration is likely **not** the cause of Fault Code 2198. Follow the published troubleshooting for Fault Code 2198.

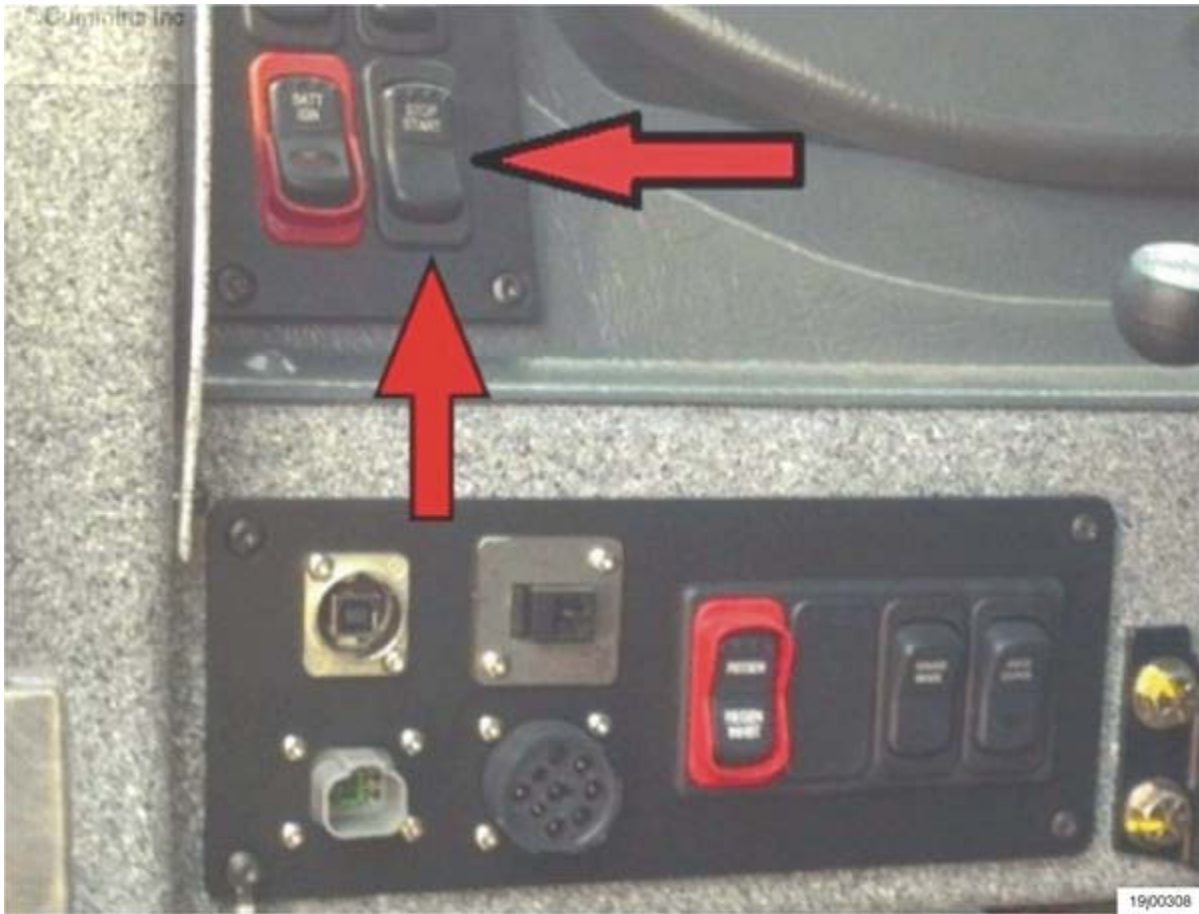
Pictured below are the previous and revised switches for reference. Also pictured below is the location of the switch configuration on the dash of Emergency One vehicles.

Contact a local Emergency One dealer to determine applicability of the wiring update. Emergency One dealer contact information can be found at www.e-one.com or by calling (352) 237-1122.
