Service Bulletin

SPECIAL COVERAGE

SUBJECT: Special Coverage Adjustment – Inadequate Clearance of Fuel Fill Pipe Clamp to Brake Lines

MODELS: 2011-2014 Chevrolet Express
2011-2014 GMC Savana
Equipped with Hinged Left Side Rear Door (RPO E26)

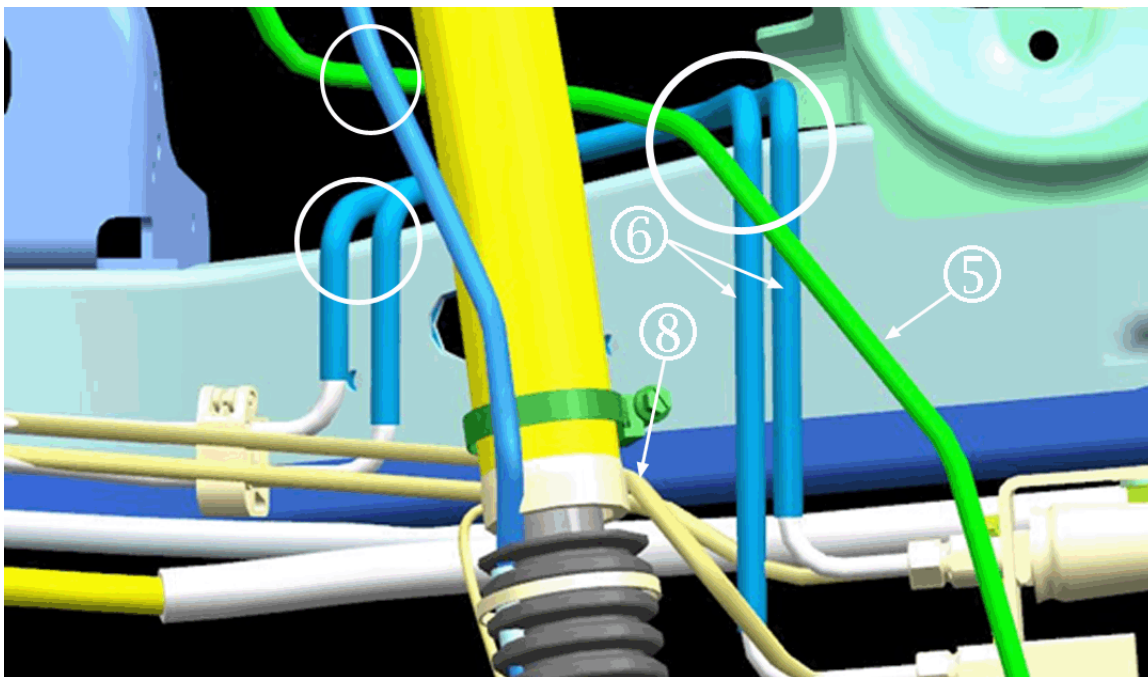
The illustration shows the brake line routing on the inboard side of the frame near the left wheel opening. Inspect the new brake lines (6) for frame contact in the areas that are circled in the illustration. Also ensure the right rear brake line (5) is NOT contacting the new brake line (5) in the circled areas of the illustration as well. The old brake line routing (8) is shown to display the differences between the two brake line designs.

- 10.5 Inspect the brake line routing on the inboard side of the frame near the rear left wheel opening. The brake lines should NOT contact the frame and should NOT have a stressed or tight fitment over the frame.
- 10.6 Install the brake line mounting clips in the production positions.
- 10.7 Ensure the brake lines are secured by the mounting clips in the production routing positions.
- 10.8 Tighten the rear jounce hose and crossover pipe mounting bracket bolt.
