Service Bulletin

SUBJECT: Special Coverage Adjustment – Transmission Clutch Wave Plate

MODELS: 2007-2009 Buick Enclave
2008-2009 Chevrolet Equinox, Malibu
2009 Chevrolet Traverse
2007-2009 GMC Acadia
2007-2009 Pontiac G6
2008-2009 Pontiac Torrent
2007-2009 Saturn AURA, OUTLOOK
2008-2009 Saturn VUE
Equipped with FWD or AWD and 6-Spd Automatic Transmission
(RPO MH2, MH4, MH6, or MY9)

Subject: 14404A – Special Coverage Adjustment
Transmission Clutch Wave Plate
Revised Models, RPO Codes and Warranty Information

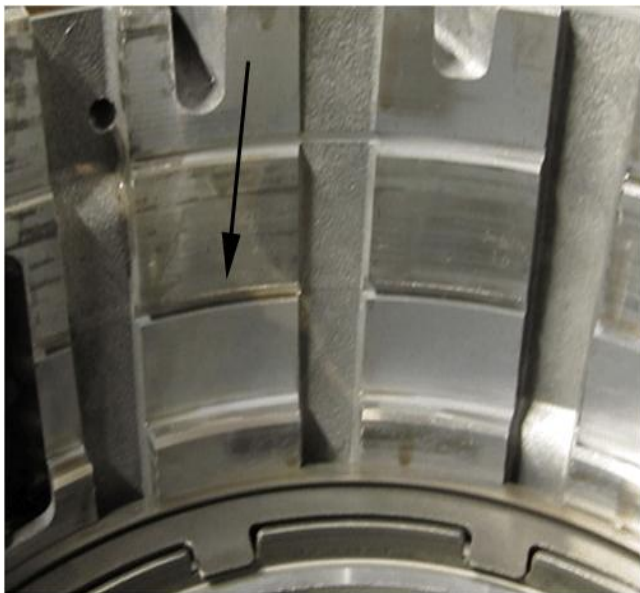
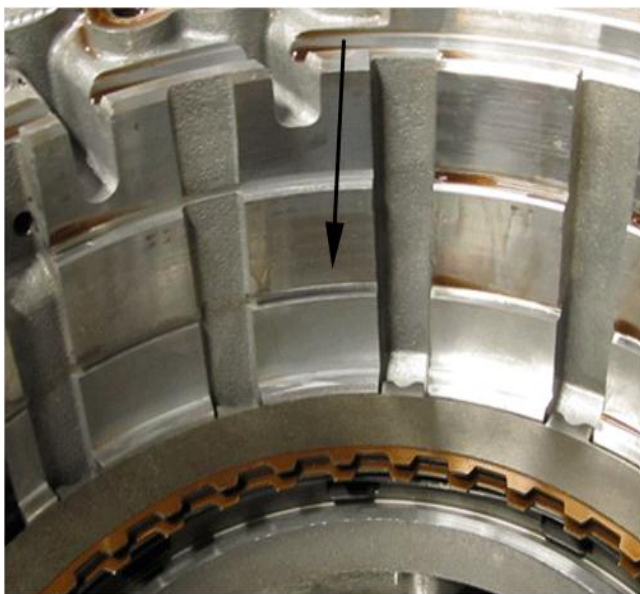
1. Remove the case cover assembly (35). Inspect the case cover for damage. This part is serviced and can be replaced if it is damaged.
2. Remove the 35R/456 clutch housing assembly (422) and inspect it for a broken 35R wave plate (423).
3. Inspect the case (21) for damage caused by a broken wave plate as shown below.

- The snap ring groove, which is well below the 3-5-R wave plate area, is unlikely to be damaged. It should still be checked to verify the snap ring is fully seated and to be securely retained.

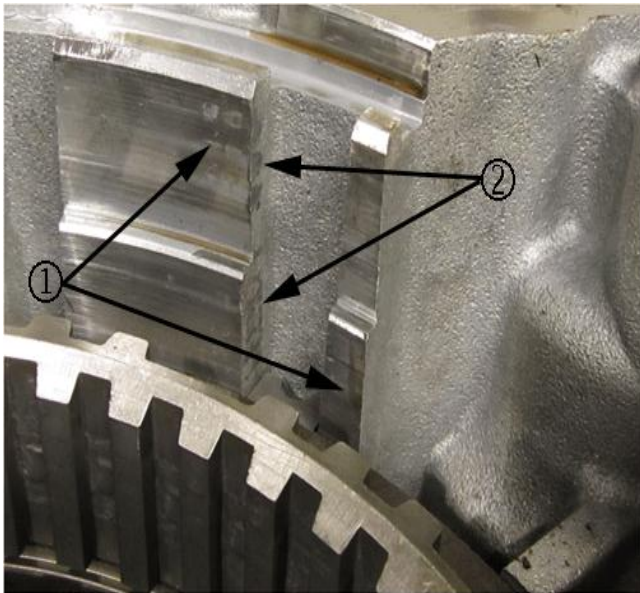
2753503

- Peening or wear of the face or edge of the case lugs that engage the steel clutch plates is normal and not cause for transmission replacement.

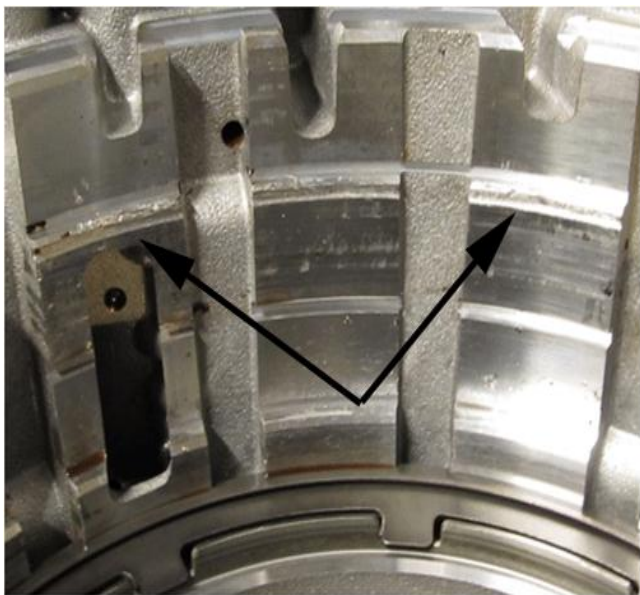
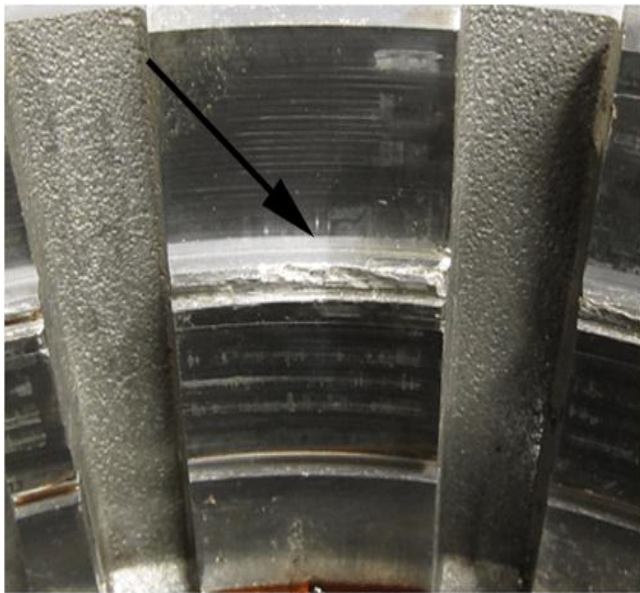
- Some degradation of the shelf for the 2-6 backing plate is acceptable as long as the plate can lie flat. A raised burr that prevents this can be removed using a de-burring tool, file or some other abrasive.

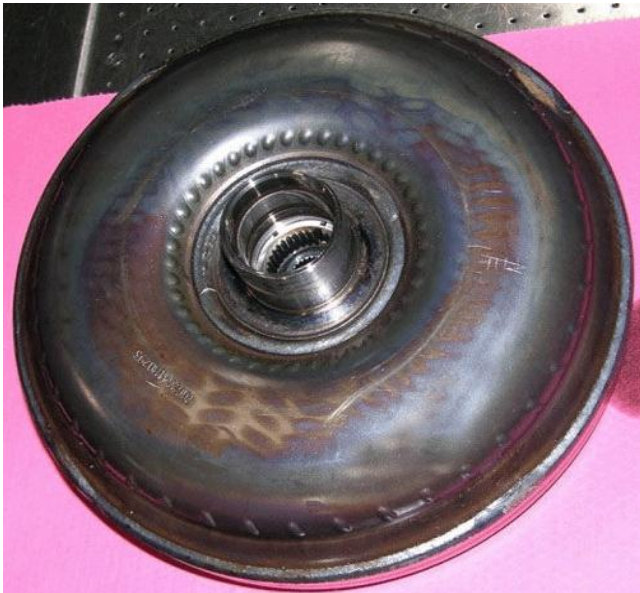
2739303

Note: The manufacturing process of the torque converter can cause the hub side to appear blue or darker in color while the lug side is a natural metal color. If the torque converter appearance is like this and no other reason is observed per the SI procedure for torque converter diagnosis, then the torque converter does not need to be replaced.

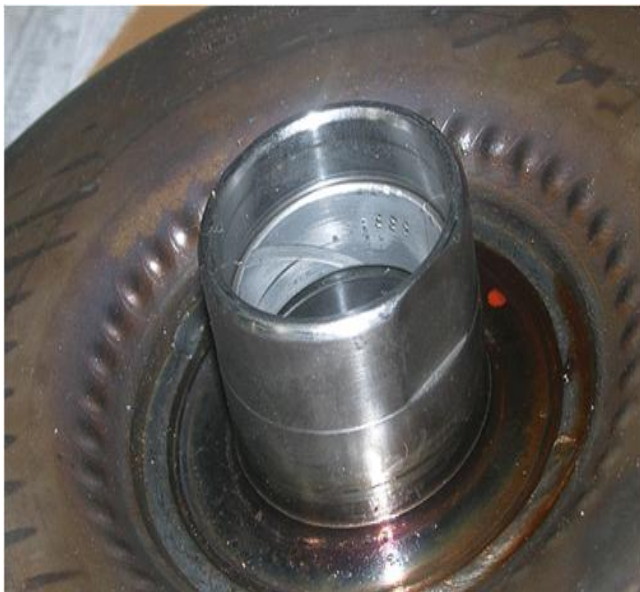
2753510

Marks such as these on the torque converter bushing are not a reason to replace the torque converter. They usually occur during removal of the transmission from the vehicle or removal/installation of the torque converter on the transmission and are caused by the bushing contacting the front differential transfer drive gear support (208) or the 3-5-R housing (422).

Also the marks are below the surface of the bushing and will not interfere with proper operation, however if there is a raised burr it can be removed with a de-burring tool or other abrasive.

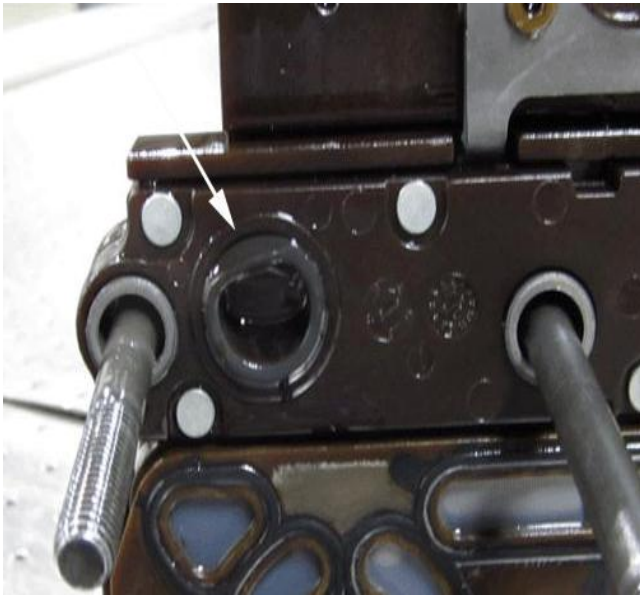
2850322

6. Inspect the control solenoid (w/body and TCM) valve assembly (TEHCM) (15) pressure switches. The O-ring seals may be deformed but if they are attached, as shown above, the TEHCM should not be replaced; it should be reused. Deformed seals do not affect switch performance.

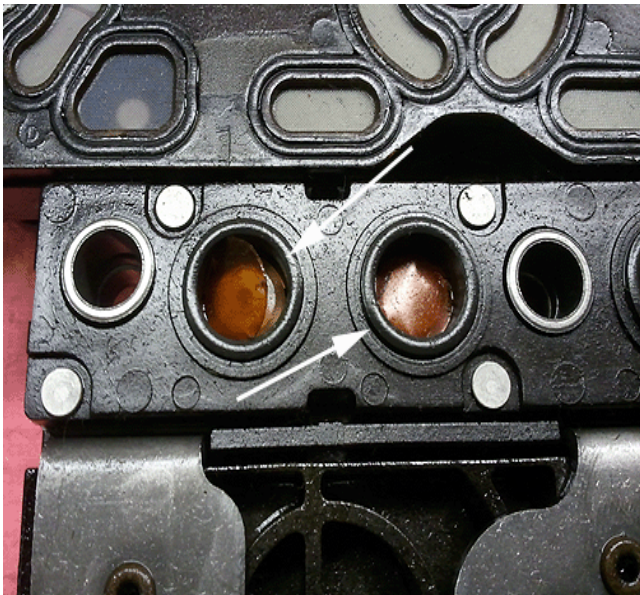
2630114

If any of the switch membranes are damaged, as shown above, the TEHCM must be replaced.

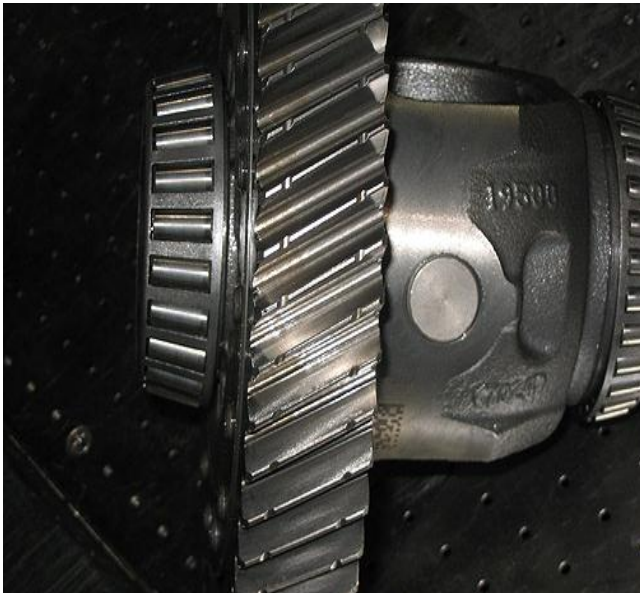
2584822

Note: The front differential carrier assembly (31) teeth are marked with notches to identify gear ratio (see picture above). Do not confuse these marks with tooth damage. Do not replace the gear for this condition.
