Service Bulletin

SUBJECT: Special Coverage Adjustment – Unable to Remove Ignition Key

MODELS: 2005-2010 Chevrolet Cobalt
2006-2011 Chevrolet HHR
2006-2010 Pontiac Solstice
2007-2010 Pontiac G5
2005-2006 Pontiac G4/Pursuit
2007-2010 Saturn Sky
2003-2007 Saturn Ion
Equipped with Automatic Transmission

Subject: 14632B – Special Coverage Adjustment
Unable to Remove Ignition Key
Part Information Revised

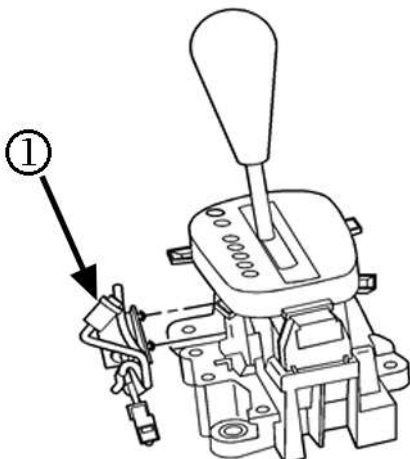
Important: For Ion models only, refer to *Diagnostic Starting Point - Automatic Transmission Shift Lock Control* and as necessary, *Shift Lock Control Solenoid (1) Replacement* in SI.
