TSB150116

New Service Tool for Diesel Exhaust Fluid (DEF) System Troubleshooting

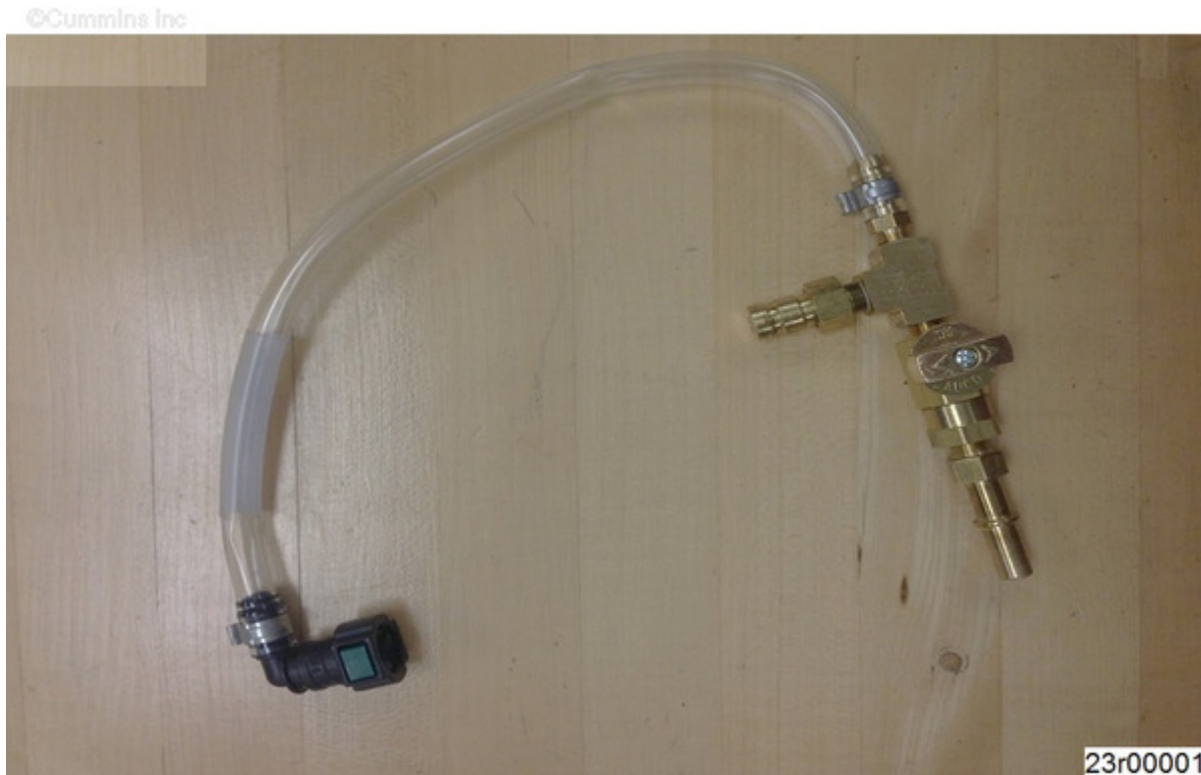
Figure 1, DEF System Diagnostic Tool, Part Number 5299833

A new diagnostic tool, Part Number 5299833, has been created to improve DEF system troubleshooting capability. This tool is being automatically shipped to authorized Cummins® repair locations in the United States and Canada. The auto-ship process is expected to be complete October 2015. After that the tool will be available for purchase through the regular process.
