Technical Information Bulletin**The Intake Throttle Valve Is Causing Regeneration Issues on Certain On-Highway Truck Engines {1000, 1087, 7000}**

Media Number -M0069062-00

Publication Date -2016/03/04

CT660S (S/N: TGA1-UP; TGD1-UP; TRK1-UP; TKL1-UP; TGR1-UP; TGS1-UP; TJS1-UP; TGT1-UP; TGW1-UP; TSW1-UP; TSY1-UP; TGZ1-UP)

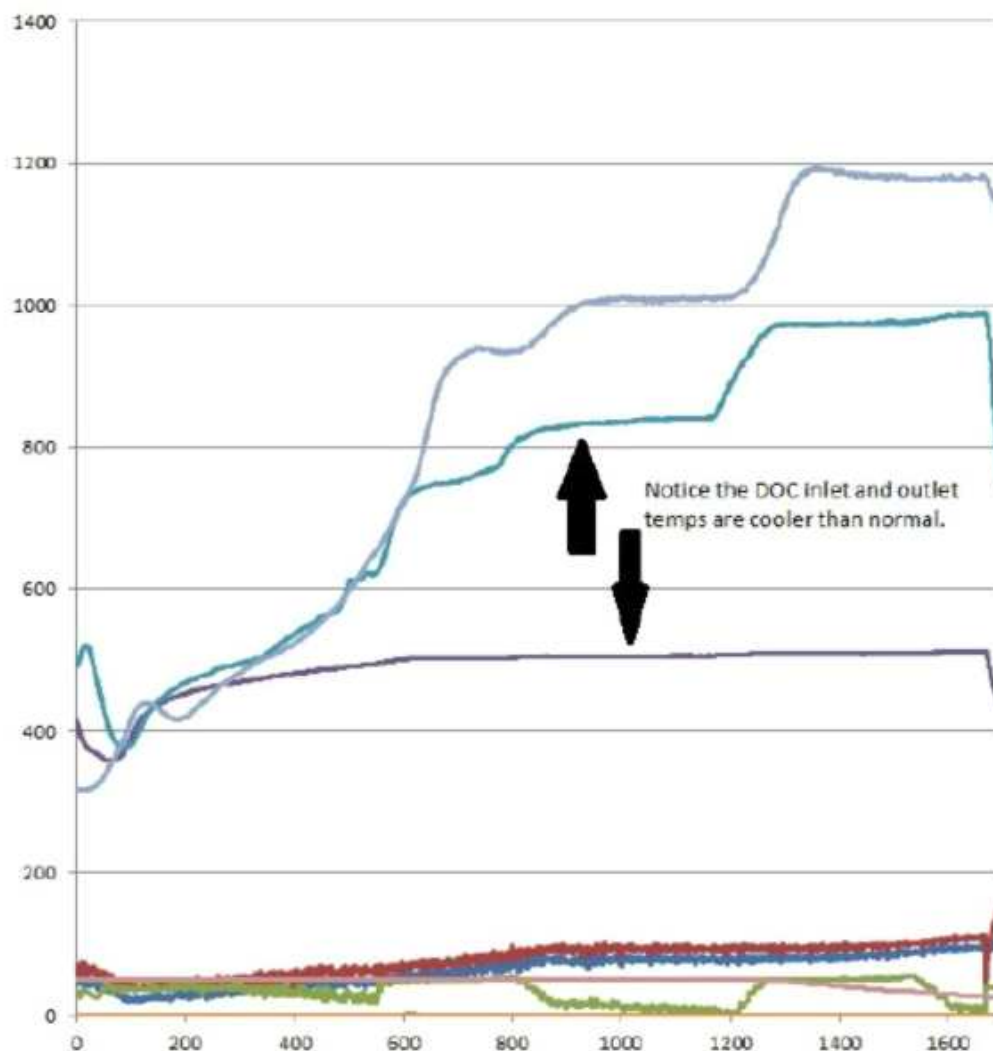
OBFCT with a Bad ETV

Item 1: Notice that the DOC inlet and outlet temperatures are cooler than normal regeneration should be. The DOC inlet should be in the 288° C (550° F) to 371° (700° F) range. This is due to the ITV not working properly to produce enough heat in the exhaust system.

Item 2: Notice the length of time it takes for the temps to start rising.

2. Review the OBFCT and compare to the graph as shown in Illustration 1. As stated in items 1 and 2 of Illustration 1 look for a slow to build temp and a DOC inlet temperature that stays too cold. You generally should see DOC IT around 288° C (550° F) to 371° (700° F) as shown in Illustration 2.
3. If your OBFCT looks similar to Illustration 1 and all aftertreatment components are testing good, then replace the ETV and retest. If it does not exhibit a similar failure, refer to the UENR5801Aftertreatment System Diagnostics and Service Manual for further diagnostics of any regeneration concerns.

1. Replace the ITV and rerun the OBFCT to verify the repair.

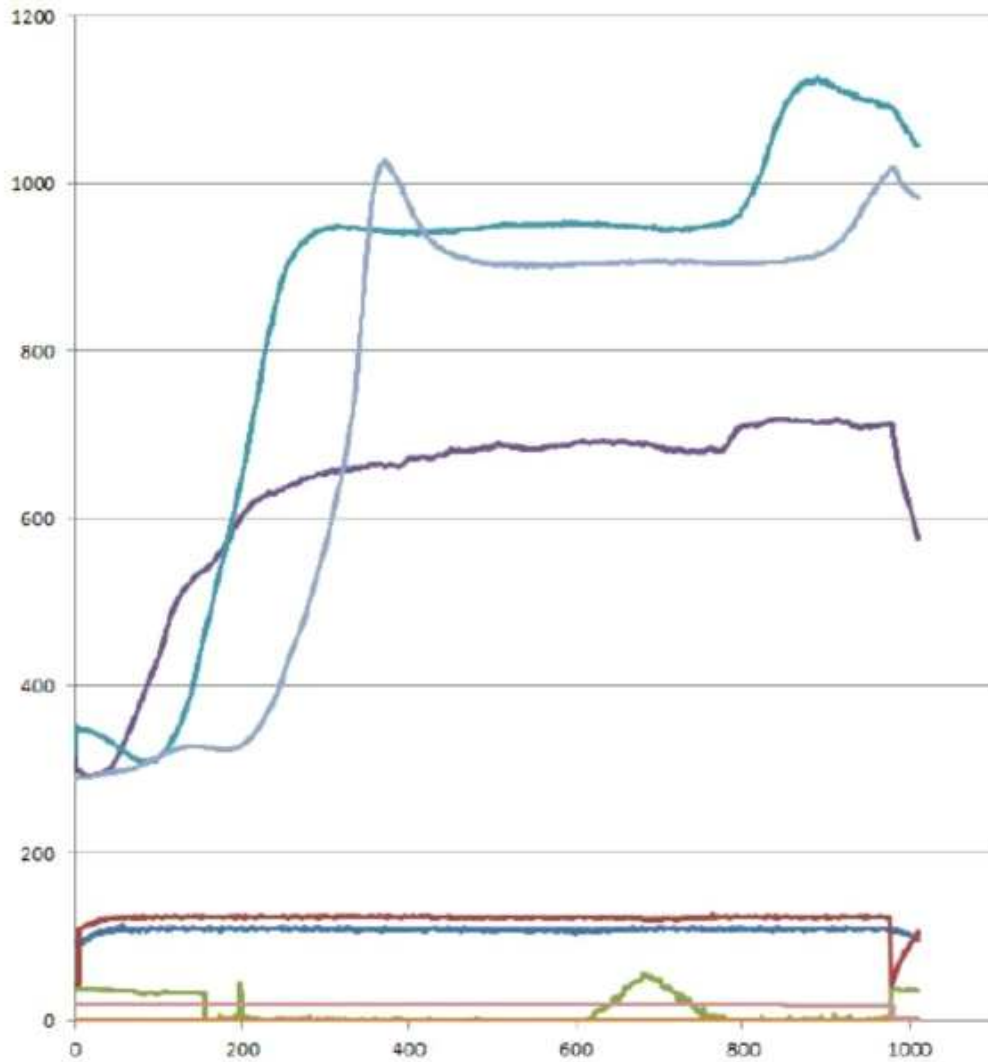
Illustration 2

Good Regeneration Chart

Item 1: Notice the temperatures rise much quicker than the bad regeneration shows.

Item 2: DOC inlet temperature is in a good range.
