NUMBER: 02-143-13R

SERVICE BULLETIN

APPLICABILITY: 2013 Legacy & Outback Models with 2.5L

SUBJECT: Surface Treatment Change To Oil Control

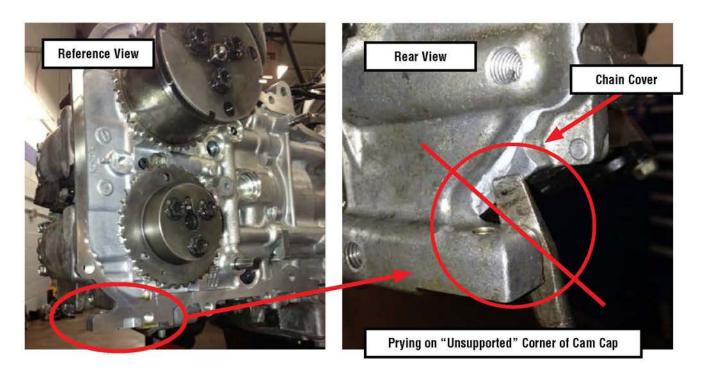
• IMPORTANT: After all 32 bolts securing the chain cover are removed, be VERY careful where you pry and what you pry on to break the silicone sealant bond. The photos below show an example of where NOT to pry. In this case, the cam cap became cracked requiring a complete cam carrier replacement. Patience is the key!

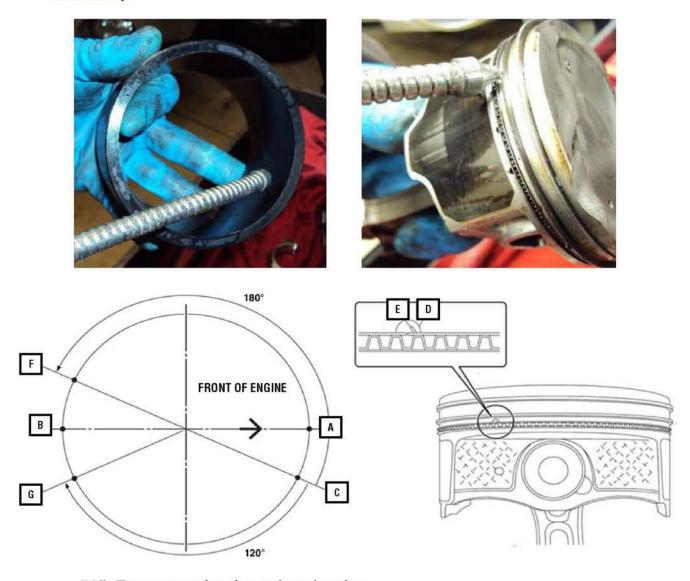
- "A"- Top compression ring end gap location
- "B"- Second compression ring end gap location (180 degrees away from "A")
- "C"- Top oil control scraper ring end gap
- "D"- Recess in top of ring land to accept the "tang" of the upper oil control scraper ring "E"
- "F" Expander gap (180 degrees away from "C")
- "G" Bottom oil control scraper ring end gap (120 degrees away from "C")

• When cleaning the pistons prior to installing the new rings, take care not to damage the antifriction coating applied to the skirts. A mild parts cleaner may also be used with the Scotch-Brite Ultra-Fine #7448 (gray in color) to loosen and remove carbon deposits from the piston crown and from between the ring lands. Do not use Scotch-Brite to clean the piston skirts as it can damage the anti-friction coating. The ends of a removed compression ring may be used to carefully clean deposits from inside the ring lands. Rinse the piston / rod assemblies thoroughly and dry before installing the new rings onto the pistons. Refer to the Service Manual and the illustrations below for ring direction (marks facing upward) and end gap placements before placing the piston/rod assembly into the ring compressor.
