SERVICE BULLETIN

APPLICABILITY: 2012 (AFTER VIN C*411693)- 14 MY
 Forester Models with 2.5L FB Engines

NUMBER: 02-144-13R

SUBJECT: Surface Treatment Change To Oil Control
 Piston Rings

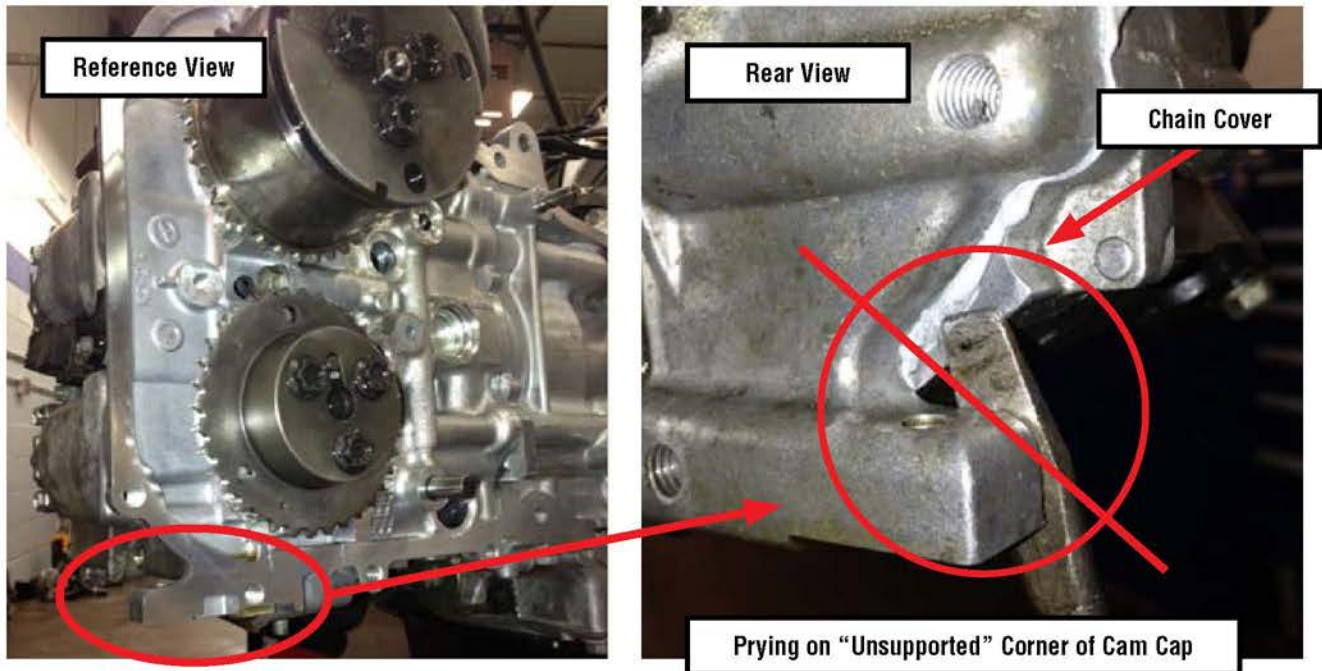
- **IMPORTANT:** After all 32 bolts securing the chain cover are removed, be **VERY** careful where you pry and what you pry on to break the silicone sealant bond. The photos below show an example of where **NOT** to pry. In this case, the cam cap became cracked requiring a complete cam carrier replacement. Patience is the key!
