SERVICE BULLETIN

APPLICABILITY: 2010-14MY Legacy and Outback Models
SUBJECT: Design Change to Retaining Clip for Front ABS Wheel Speed Sensor

NUMBER: 06-49-15
DATE: 05/29/15

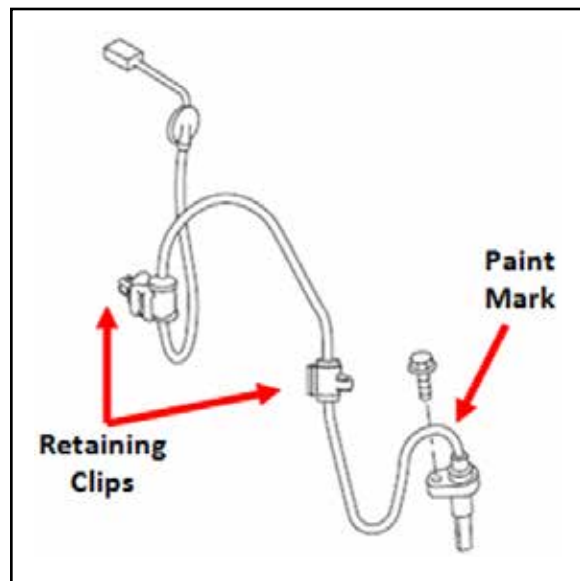
NOTE: The paint markings are located on the harness near the sensor mounting flange end. Old parts may be recognized on the car by their Pink (Legacy) or Blue (Outback) paint marks.
