Service Bulletin No. 441

MODEL	ТҮРЕ	SECTION/GROUP	DATE
J4500	Field Change Program	12-Suspension	Dec. 22, 2016
SUBJECT LEVEL SENSOR GUARD			
CONDITIONS)

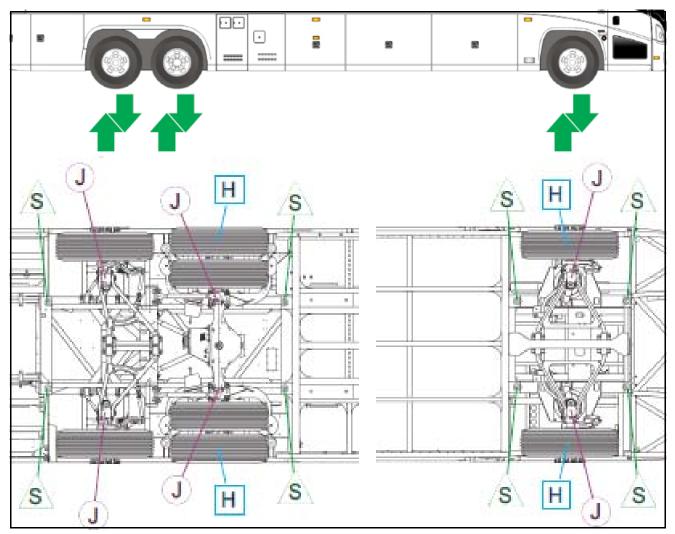
Figure 1. J4500 coach safety stands location.

3. Position safety stands underneath the coach in only the specified locations shown in Section 3F in the MCI J4500 Maintenance Manual (as shown in Figure 1).

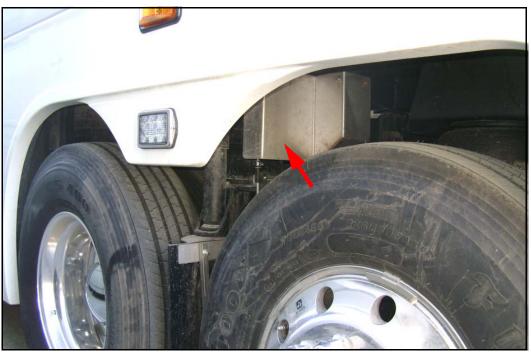
Figure 2. Location of the level sensor guard.

4. Standing rearward of the tag wheel, locate the level sensor guard shown in Figure 2.

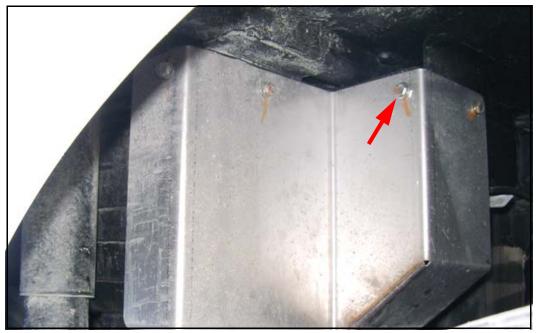
Figure 3. Mounting hardware.

5. Locate the mounting hardware securing the level sensor guard to the coach structure (refer to Figure 3). Remove and retain the four (4) capscrews, washers and lock washers, to be re-installed at a later step in this procedure. Remove and discard the existing level sensor guard.

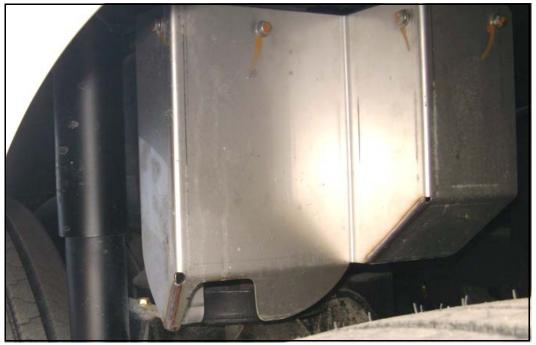
Figure 4. Completed installation of the level sensor guard

- 6. Orient the new level sensor guard, p/n 12-03-1598 or 12-03-1599, to the existing mounting holes.
- Using the existing hardware removed in Step 5, secure the level sensor guard to the structure. Torque to 8-10 ft-lbs. Apply torque seal over the face of the torqued capscrews (refer to Figure 4 for completed installation).
