074 (Rev 1, 9/13/2016)	August 2016
NUMBER	DATE
СНА	Multiple Models
GROUP	MODEL

TECHNICAL SERVICE BULLETIN

MDPS FLEXIBLE COUPLING REPLACEMENT

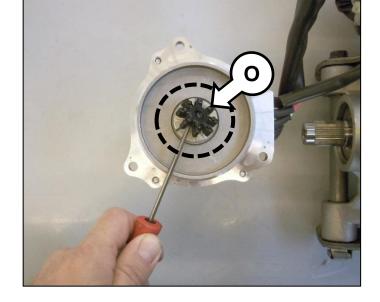
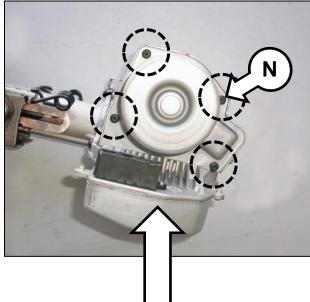
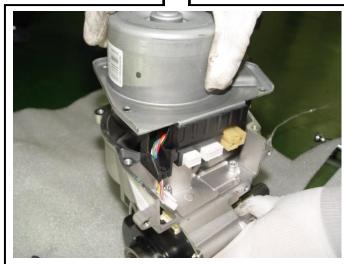
Remove the original flexible coupling (O) from the housing. In addition, use an air gun to remove any foreign matter from the motor and/or the housing.

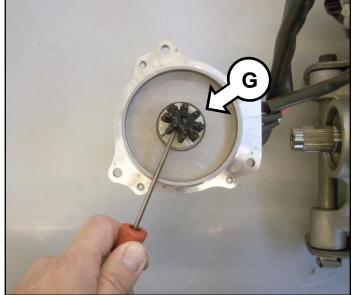
Remove the original flexible coupling (G) from the motor. In addition, use an air gun to remove any foreign matter from the motor and/or the housing.

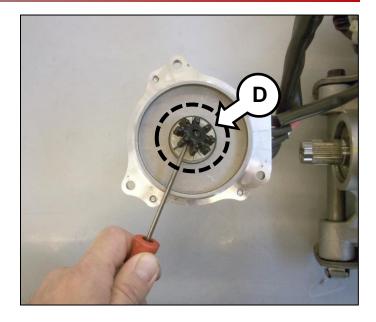
Remove the original flexible coupling (D) from the motor. In addition, use an air gun to remove any foreign matter from the motor and/or the housing.
