MODEL
2011-2014MY
Optima
(QF/TF/TFH)

NUMBER
072 (Rev 1, 9/13/2016)

TECHNICAL SERVICE BULLETIN

SUBJECT: MDPS FLEXIBLE COUPLING REPLACEMENT CUSTOMER SATISFACTION PROGRAM (CS1604)

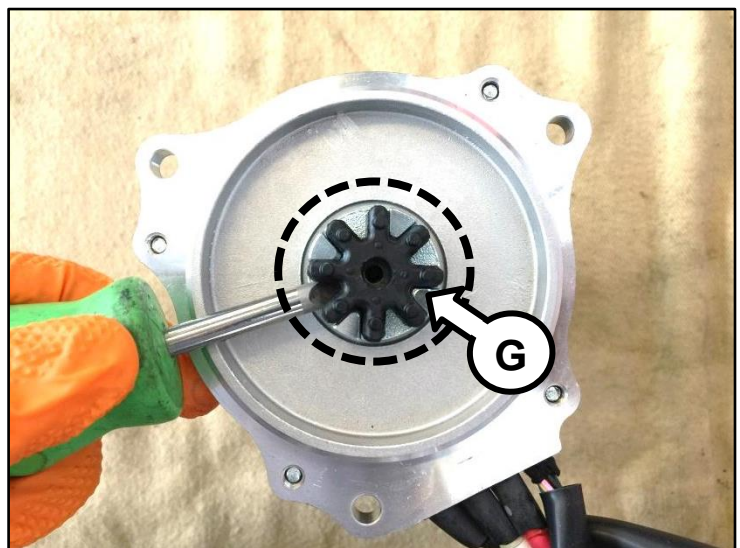
This bulletin provides information regarding the replacement of the flexible coupling in the Motor Driven Power Steering (MDPS) on some 2011-2014 MY Optima (QF/TF/TFH) vehicles, produced from August 12, 2010 to December 18, 2013. The MDPS unit may experience noise when turning the steering wheel left or right, especially while the vehicle is stopped. Kia's analysis has identified that this condition occurs mainly in extremely high humidity states adjacent to warm ocean waters due to the wear of the flexible coupling in the MDPS, after extended usage over years. The extremely high humidity states adjacent to warm ocean waters include: Alabama, Florida, Georgia, Hawaii, Louisiana, Mississippi, North Carolina, South Carolina, and Texas.

- 7. Remove the flexible coupling (G) from the housing. In addition, use an air gun to remove any foreign matter from the motor and/or the housing.
