Technical Service Bulletin

19 Coolant pipe seepage on turbocharger

19 16 76 2036167/5 December 6, 2016. Supersedes Technical Service Bulletin Group 19 number 16-75 dated October 19, 2016 for reasons listed below.

Model(s)	Year	VIN Range	Vehicle-Specific Equipment
A8, S6, S7, S8, RS 7	2013 - 2017	All	4.0 T

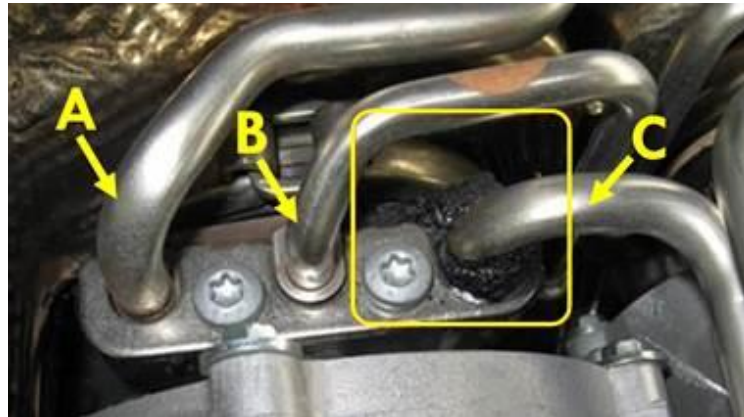
There may be slow coolant loss from the connections at the coolant feed pipe and the coolant return pipe. High temperatures cause the coolant to become encrusted on the connection flange of the turbocharger (Figure 1).

Figure 1. Black, encrusted coolant residue (outlined area), coolant feed pipe (A), oil feed pipe (B), and coolant return pipe (C).

The resulting heat after switching off the engine can, under special operating conditions, lead to very high temperatures on the coolant seals of the turbocharger. This can damage the O-ring.

Optimized temperature-resistant O-rings on the coolant connection of the turbocharger together with an extended operating period of the auxiliary cooling pump after switching off the engine.

Replace the respective O-rings on the coolant supply and return pipes according to the table listed below:

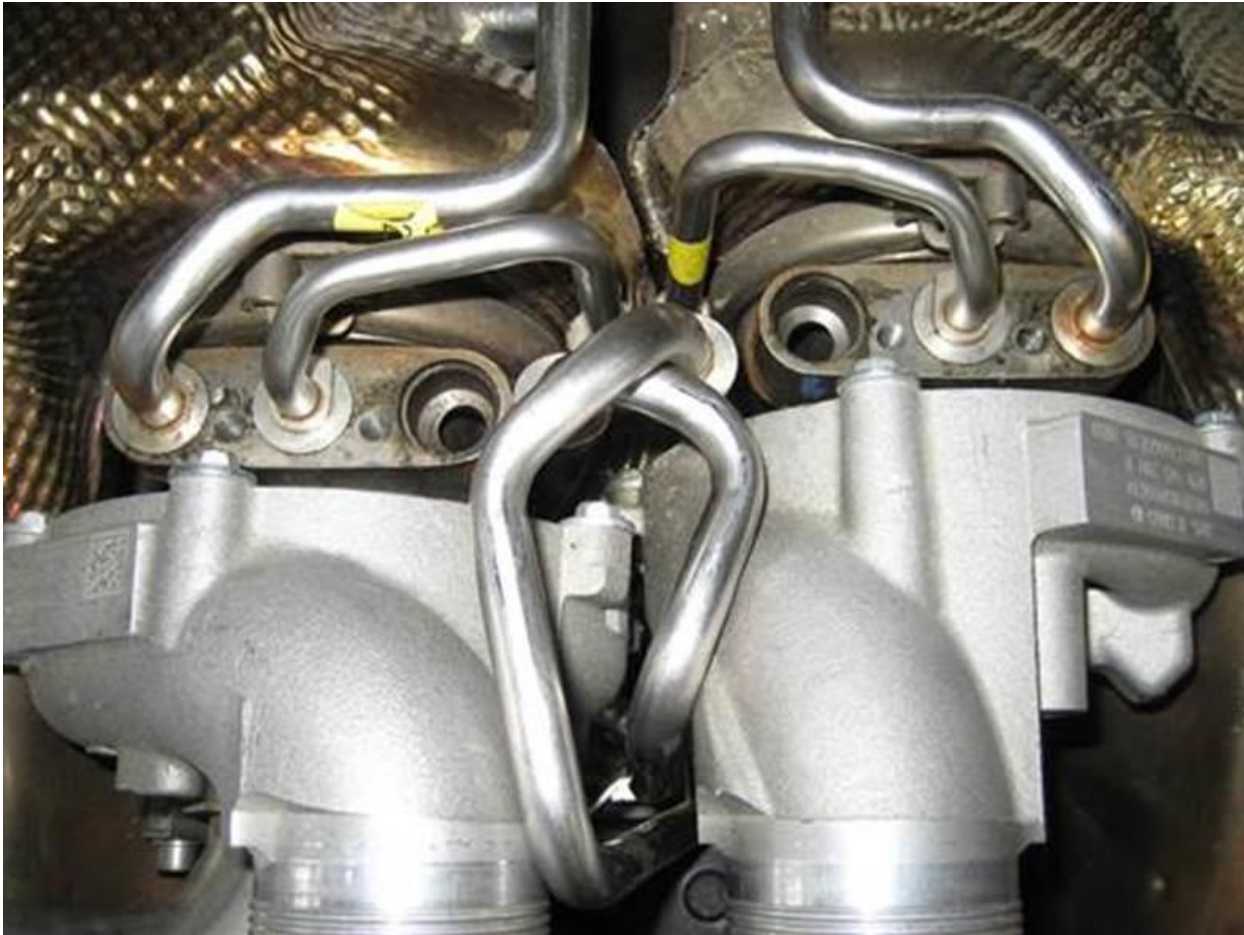
Figure 2. Recommended pipe position.

For the replacement of the two O-rings for the coolant supply pipes we recommend the following pipe position to allow access to remove and replace the O-rings (Figure 2).

1. Clean the intake ports for the coolant pipes on the top of the turbochargers, the ports should be clean and dry before installing the coolant pipes with the O-rings. The new O-rings are coated with a lubricating agent and should be installed dry.
2. Replace the oil feed pipe O-rings. Coat lightly with clean engine oil, do not allow engine oil to touch the coolant O-rings.
3. Install the pipe retaining plate and secure loosely, attach pipe retainer brackets and torque retaining plate bolts to 9 nm and reassemble intake pipes and hoses.
4. Fill the new coolant additive in the cooling system according to manufacturer guidelines. Observe the mixture ratio and filling-up procedure.
5. Only mix distilled water with coolant additives. Distilled water provides optimum corrosion protection.
