Technical Service Bulletin

SUBJECT: CLICKING NOISE FROM STEERING WHEEL WHEN TURNING EITHER DIRECTION		No: TSB-16-37-001
		DATE: May, 2016
		MODEL: 2014-15 Outlander Sport/RVR
CIRCULATE TO:	<input type="checkbox"/> GENERAL MANAGER	<input checked="" type="checkbox"/> PARTS MANAGER
<input checked="" type="checkbox"/> SERVICE ADVISOR	<input checked="" type="checkbox"/> SERVICE MANAGER	<input checked="" type="checkbox"/> TECHNICIAN
	<input checked="" type="checkbox"/> WARRANTY PROCESSOR	<input type="checkbox"/> SALES MANAGER

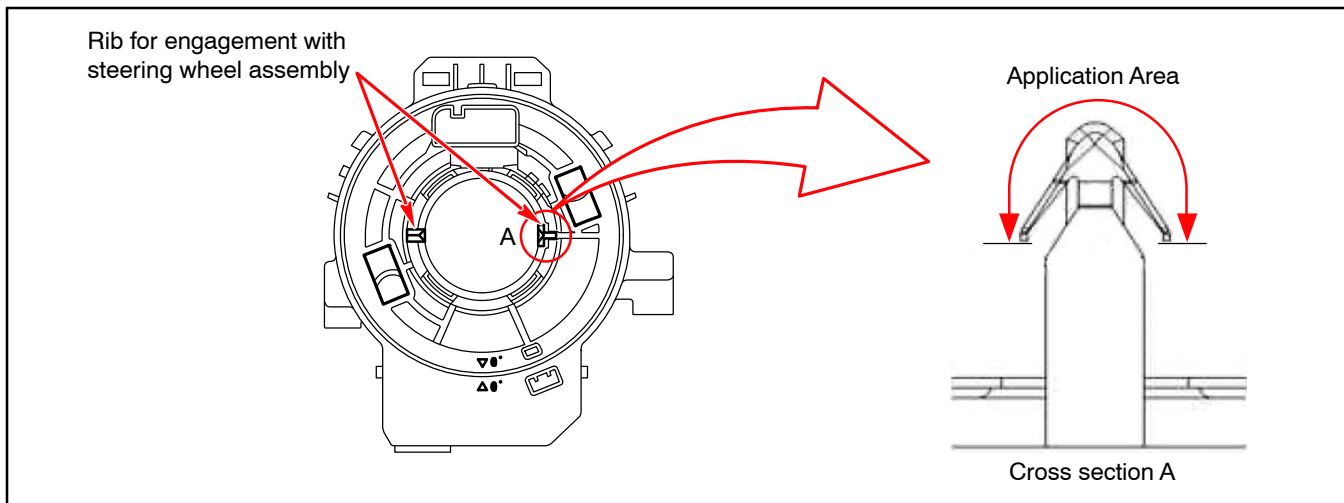
Customers may complain of a noise from the steering wheel area when turning the steering wheel in either direction. It may be described as a clicking, creaking, or rubbing noise. This may be caused by the steering wheel assembly rubbing against the ribs of the clock spring. Application of the specified grease on the ribs has been shown to eliminate the noise.

2. Apply a thin layer of Multemp SL-V grease (p/n 4405A179) to the 2 tabs as shown.

NOTE: Apply between 5 – 15 mg of grease to the tabs. Do NOT apply excessive grease.

CAUTION: Be careful not to strike the brush against the rib or damage the rib in any way.
