Technical Service Bulletin

01 MIL on (DTC P0011 and/or P0021 - camshaft position)

01 16 71 2041097/2 July 27, 2016. Supersedes Technical Service Bulletin Group 01 number 15-29 dated July 1, 2015 for reasons listed below.

Model(s)	Year	VIN Range	Vehicle-Specific Equipment
S6, S7, RS 7, A8, S8	2013 - 2014	All	4.0 TFSI

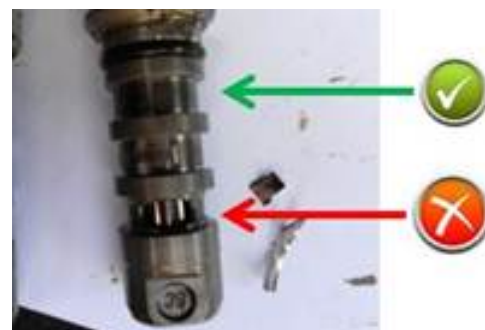
- On the camshaft adjustment valve, the filter element can loosen (Figure 1).
- There is no consequential damage from loosened particles in the oil circuit. They are gathered by the oil filter.

Figure 1. Two top filters are okay, bottom filter is missing.

1. The camshaft adjustment valve is fitted in four different positions. Check the affected camshaft adjustment control valve (see DTC entry). The following list shows which component is affected, based on event entry:
 - N205 – cylinder bank 1, inlet side
 - N318 – cylinder bank 1, exhaust side
 - N208 – cylinder bank 2, inlet side
 - N319 – cylinder bank 2, exhaust side
2. Remove connector (Figure 2) from control valve with DTC.
3. Remove bolt (Figure 2) from control valve with DTC, then remove valve.
4. Install O-ring on new control valve. Replace hex collar bolt and tighten new bolt to 5 Nm.

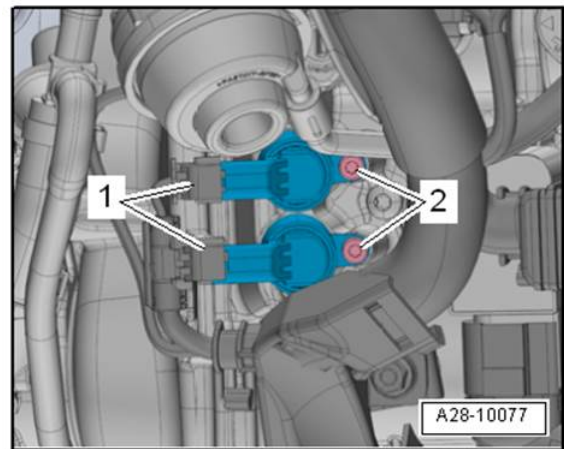
Figure 2. Connector (1) and bolt (2) to be removed from affected control valve.
