AT16-009

August 25, 2016

## 2015-2016 QX60; ENHANCED DIAGNOSTIC LOGIC FOR CVT

**APPLIED VEHICLE:** 2015-2016 QX60 (L50) with V6 engine only

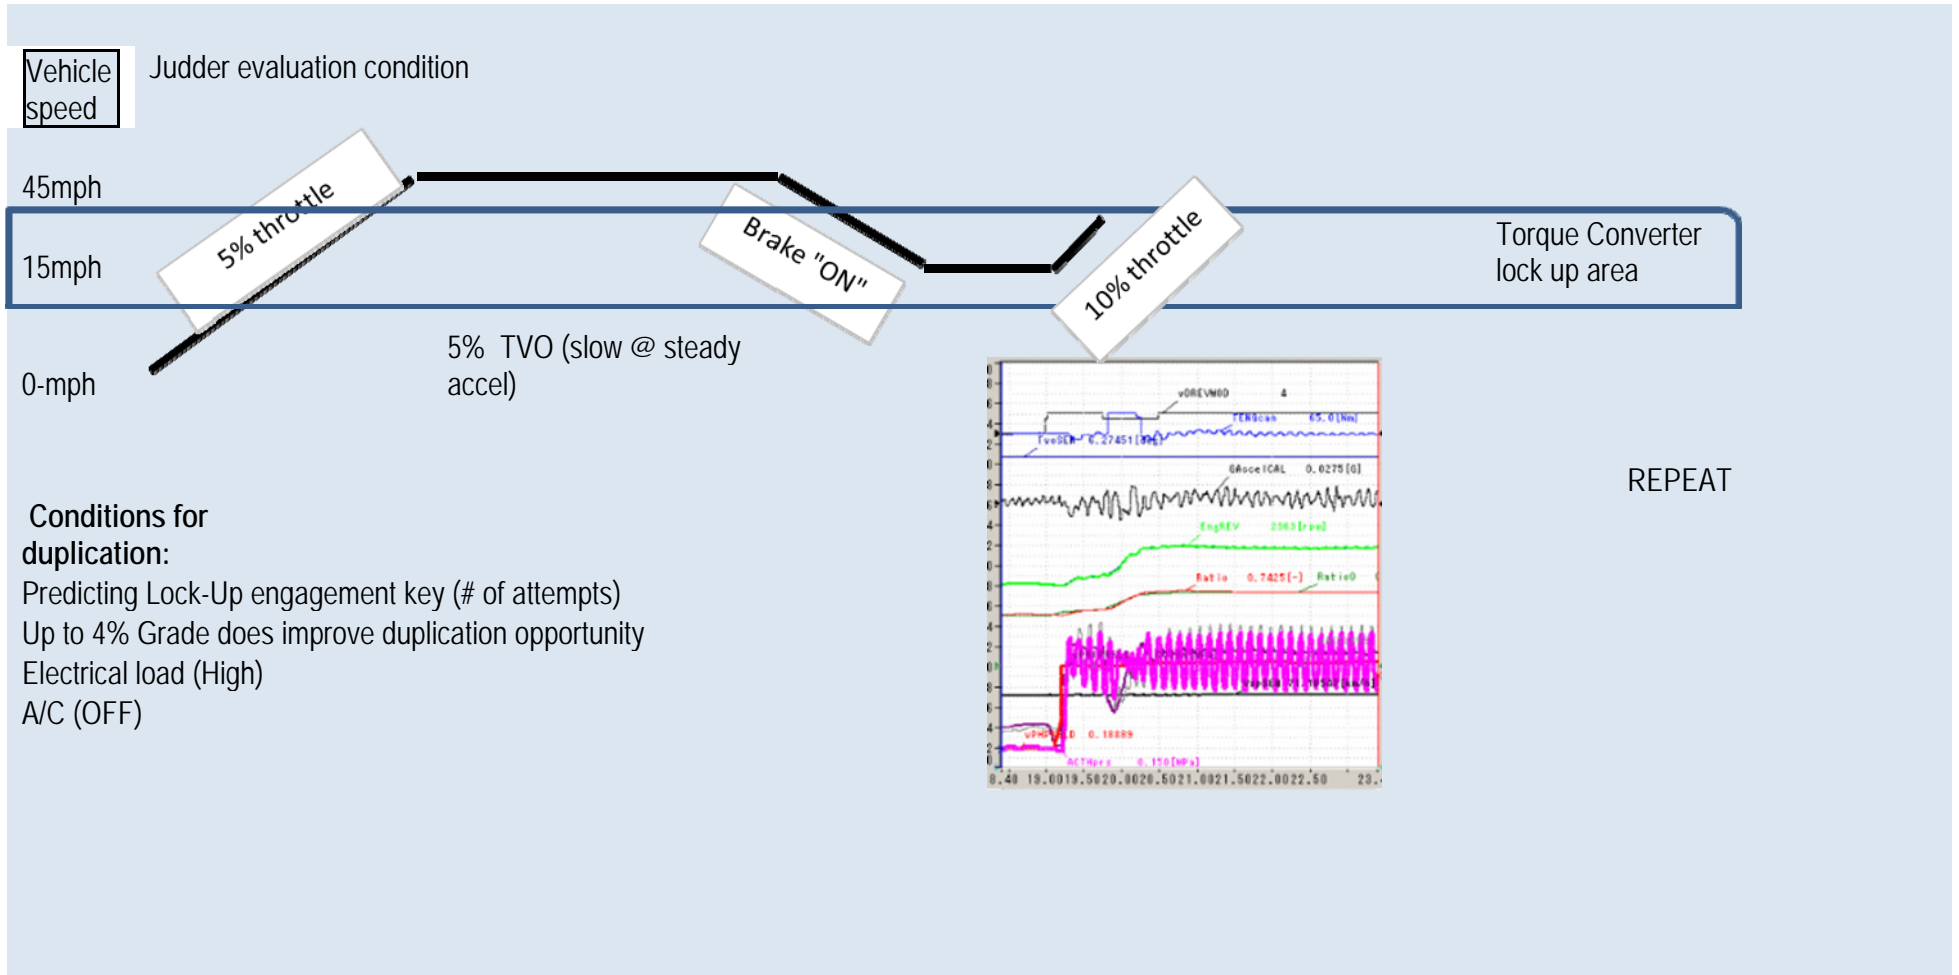
- This new diagnostic logic will monitor conditions in the CVT while the customer is operating their vehicle in their usual daily drive patterns.
  - Figure 8, on the next page, illustrates conditions under which judder can be reproduced.
  - Specific drive conditions that can be used to test for judder (shake, shudder, single or multiple bumps or vibration) are:
1. Slowly accelerate from a stop (zero mph), applying only slight accelerator pedal (**0% - 10% throttle opening**) until 40 mph is reached.
    - During acceleration, torque converter engagement (full lock up) can occur between 20-35 mph.
  2. Prior to torque converter lock up, slowly modulate the accelerator pedal:
    - A. Decrease accelerator pedal pressure slowly, approaching a closed throttle position.
    - B. Smoothly and slowly reapply accelerator pedal pressure back to approximately 10% throttle opening.

- Figure 8 below illustrates conditions under which judder can be reproduced.

- Slight grade (climbing hill) may aid in performing the above drive conditions.
- DTC detection logic will require three events before storing a DTC.
- If DTC P17F1 or P17F0 is stored, refer to ITB15-012 for repair information.
