EL12-061b

ITB12-054b

September 28, 2016

## NO AUDIO DURING PHONE CALL WITH APPLE iOS 10, NAVIGATION SYSTEM REBOOTS, AND/OR AUDIO CONTROLS WILL NOT RESPOND

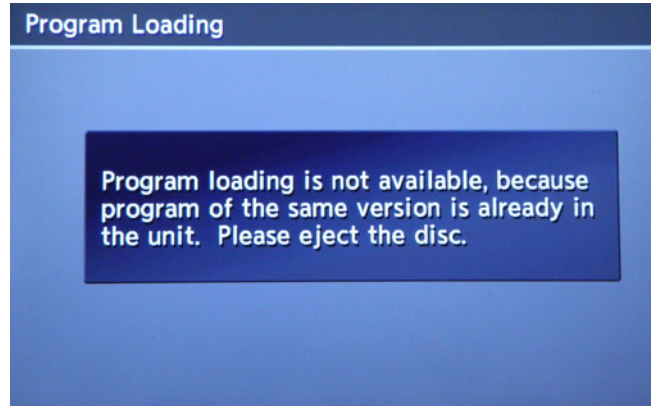
Figure1

- If the screen in Figure 1 is displayed, this update has already been performed and this bulletin does not apply.
  - Turn the Bluetooth back ON and remove the DVD from the CD slot.

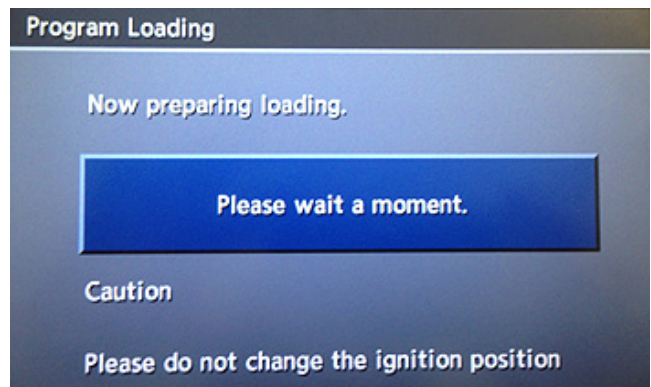
- If "Now preparing loading" shown in Figure 2 is displayed, follow the on screen Caution while the Navigation is updated.

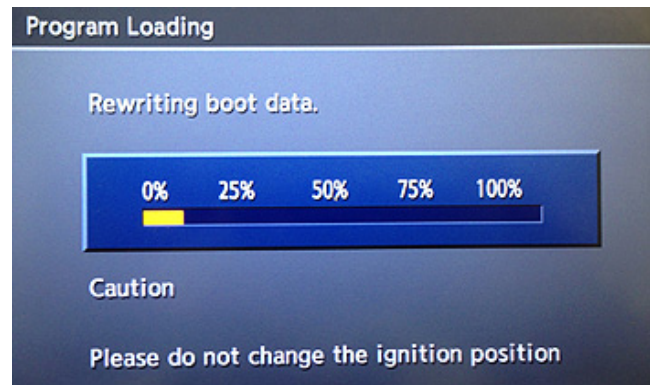
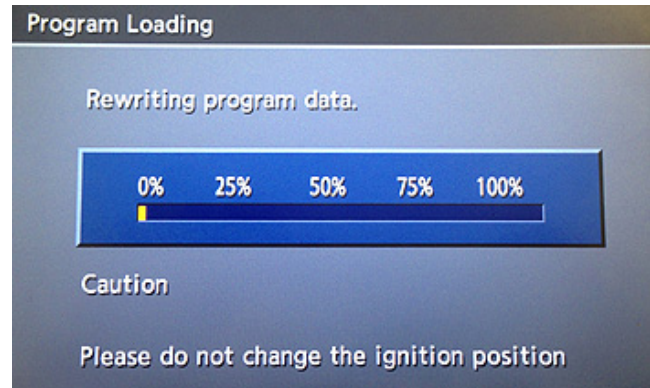
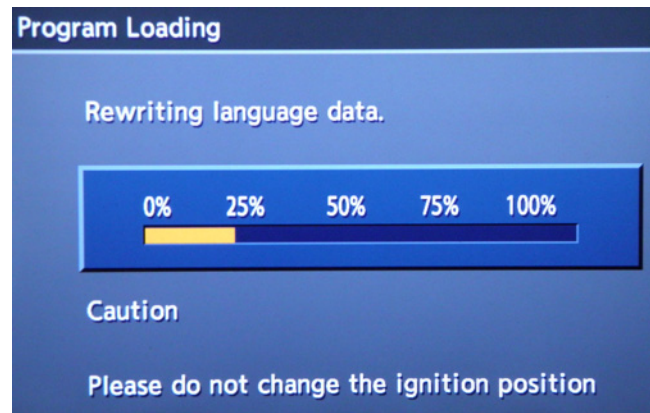
7. During the first part of the update process 3 more screens will be displayed along with a percentage of completion (progress) bars:
  - Rewriting boot data (Figure 3)
  - Rewriting program data (Figure 4)
  - Rewriting language data (Figure 5)

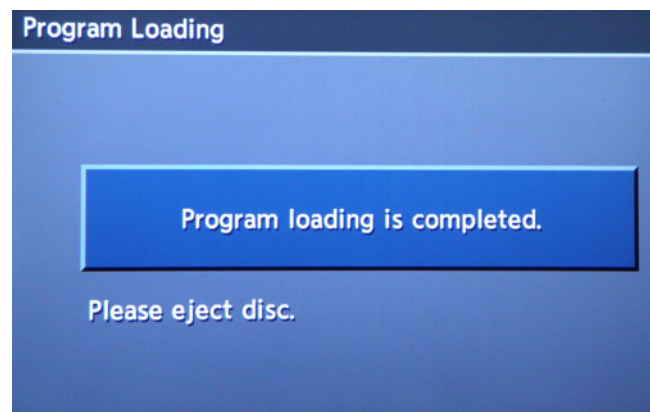
Figure 6

8. When the first part of the program has finished loading:
  - "Program loading is completed" will be display (Figure 6).
  - The Re-programming Software DVD will automatically eject.
9. Remove the DVD and continue to the second part of the update in step 10.

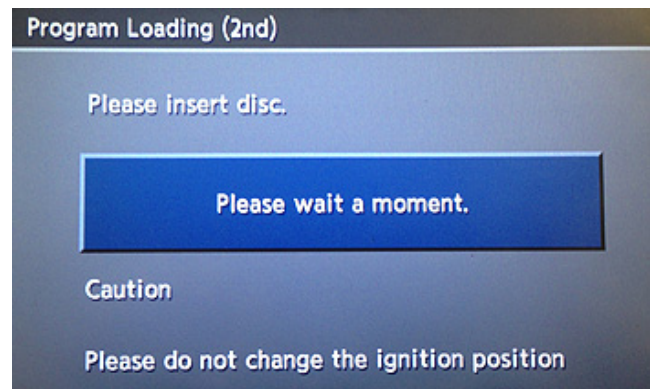
10. After the DVD is removed, the screen in Figure 7 "Please insert disc" may ask to reinstall the **same** Re-programming Software DVD for a second time.

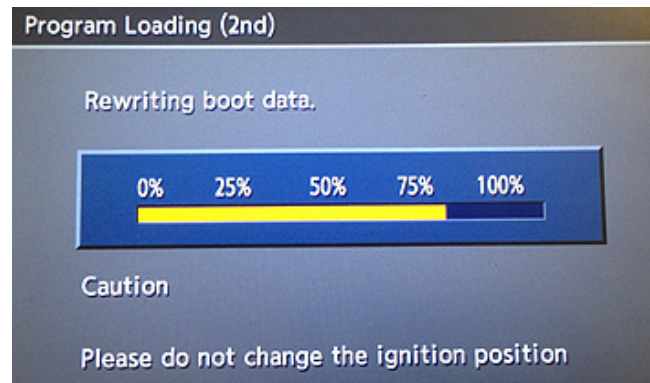
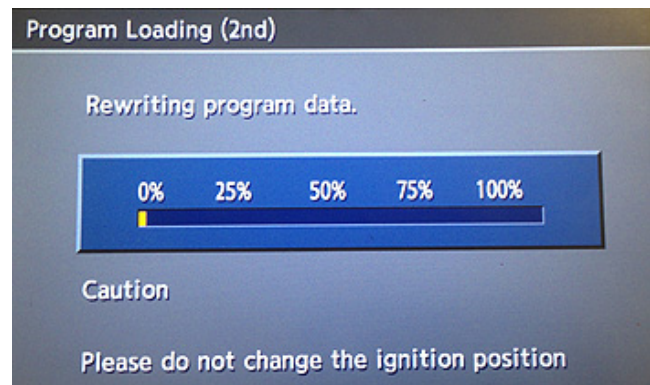
11. "Rewriting boot data" and "Rewriting program data" will be displayed once the DVD is reinstalled.

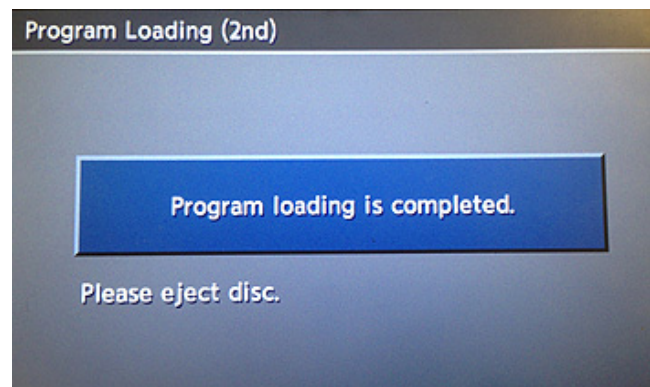
Figure 10

- "Program loading is completed" will be display (Figure 10).
- The Re-programming Software DVD will automatically eject.
- The Navigation system will restart.
- Proceed to step 13.
