SERVICE BULLETIN

Classification: EL12-060b	Reference: NTB12-070b	Date: September 28, 2016
------------------------------	--------------------------	-----------------------------

NO AUDIO DURING PHONE CALL WITH APPLE iOS 10, NAVIGATION SYSTEM REBOOTS, AND/OR AUDIO CONTROLS WILL NOT RESPOND

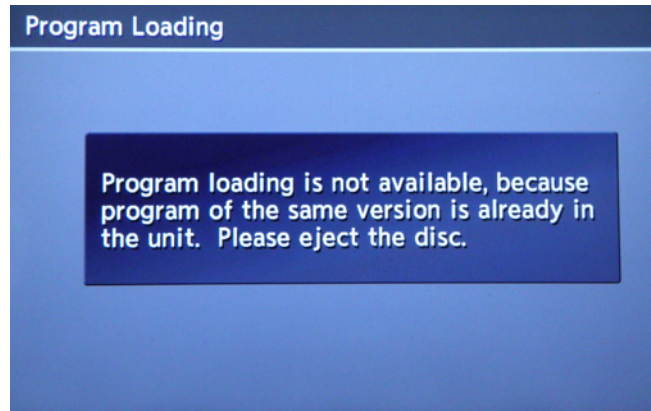
Figure1

- If the screen in Figure 1 is displayed, this update has already been performed and this bulletin does not apply.
 - Turn the Bluetooth back ON and remove the DVD from the CD slot.

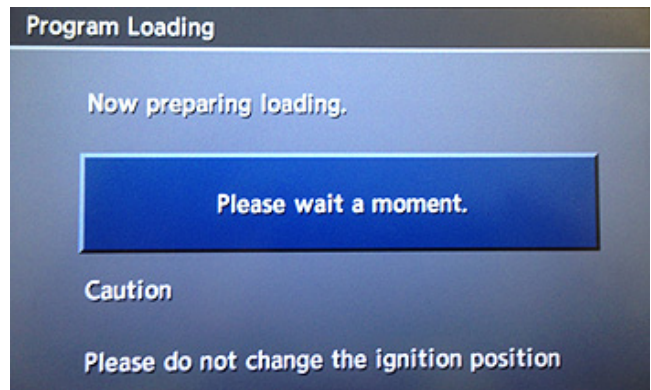
- If “Now preparing loading” shown in Figure 2 is displayed, follow the on screen Caution while the Navigation is updated.

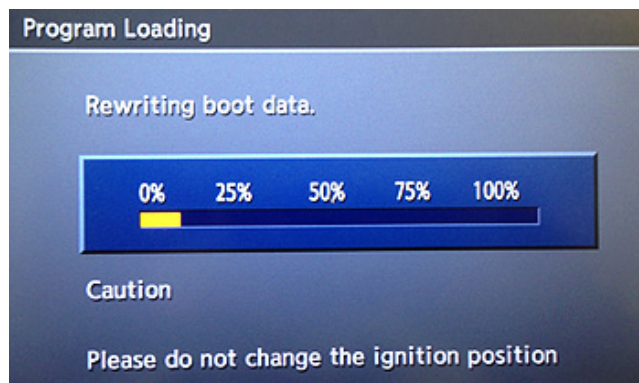
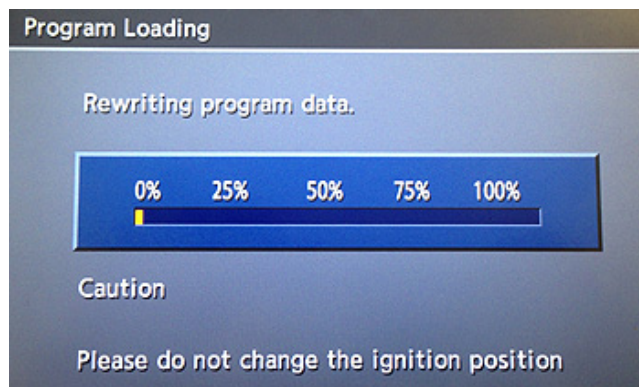
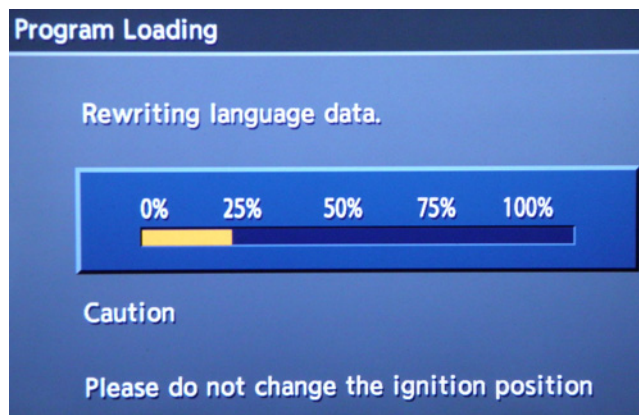
7. During the first part of the update process 3 more screens will be displayed along with a percentage of completion (progress) bars:
 - Rewriting boot data. (Figure 3)
 - Rewriting program data (Figure 4)
 - Rewriting language data (Figure 5)

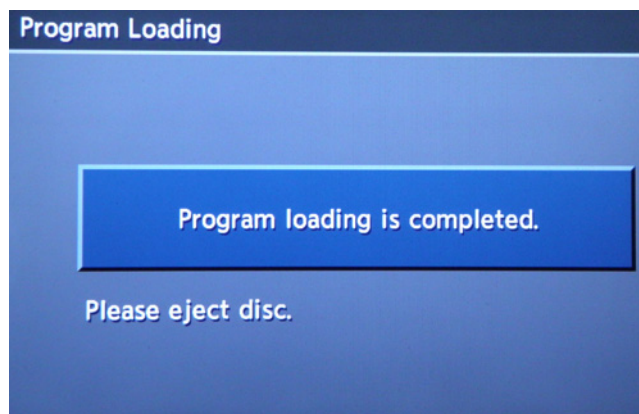
Figure 6

8. When the first part of the program has finished loading:
 - “Program loading is completed” will be display (Figure 6).
 - The Re-programming Software DVD will automatically eject.
9. Remove the DVD and continue to the second part of the update in step 10.

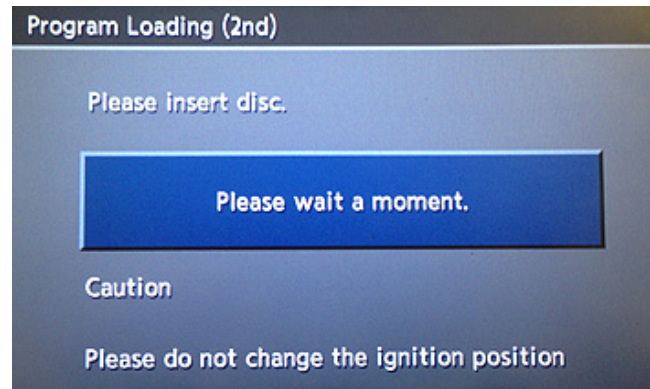
10. After the DVD is removed, the screen in Figure 7 “Please insert disc” may ask to reinstall the **same** Re-programming Software DVD for a second time.

- If not, the re-programming is complete. Proceed to step 13.
- If so, re-insert DVD disc.
 - At the top of the screen “Program Loading (2nd)” will be displayed.

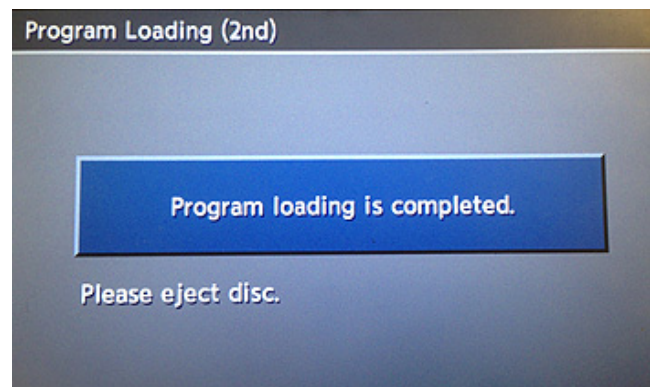
Figure 10

- “Program loading is completed” will be display (Figure 10).
- The Re-programming Software DVD will automatically eject.
- The Navigation system will restart.
- Proceed to step 13.
