| | GROUP<br><b>BOD</b> | MODEL<br><b>2014~2015MY<br/>Forte (YD) 4DR</b> |
| | NUMBER<br><b>132</b> | DATE<br><b>March 2016</b> |
| <b>TECHNICAL SERVICE BULLETIN</b> | | |
| <b>SUBJECT: WATER LEAK/CONDENSATION IN REAR COMBINATION<br/>TAIL LAMP(S)</b> | | |

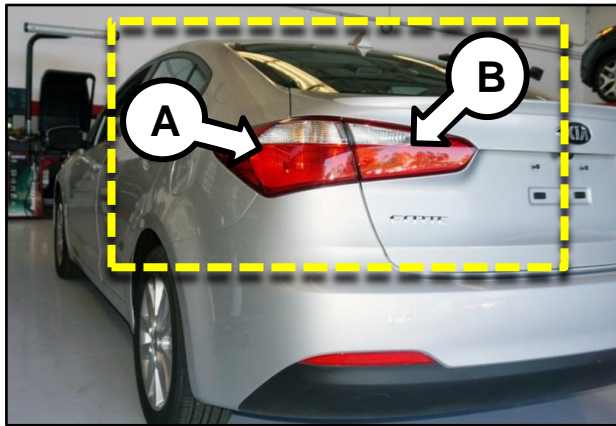
On some 2014~2015MY Forte (YD) vehicles, customers may complain about water droplets forming inside the rear tail lamp lenses following a rainstorm or after washing their vehicle. These water droplets are more visible at night and the quantity of water present is more than just a thin film of condensation which may not easily evaporate. This concern is caused by a gap between the tail lamp housing gasket and vehicle body which allows water to infiltrate into the tail lamp. To resolve this concern, order new foam gaskets and install them between the left and right tail lamps as required and the body of the vehicle, as outlined below. See off-set production dates below for the proper gaskets needed:

| Production Date | Affected Component | Figure |
|---|---|---|
| Job #1 through May 21, 2014 | Outside Rear Combination Lamp | <b>A</b> |
| Job #1 through June 20, 2014 | Inside Rear Combination Lamp | <b>B</b> |
