91 MMI volume button is missing or loose

91 16 60 2044851/1 July 20, 2016.

Model(s)	Year	VIN Range	Vehicle-Specific Equipment
A3	2015 - 2018	All	Not Applicable

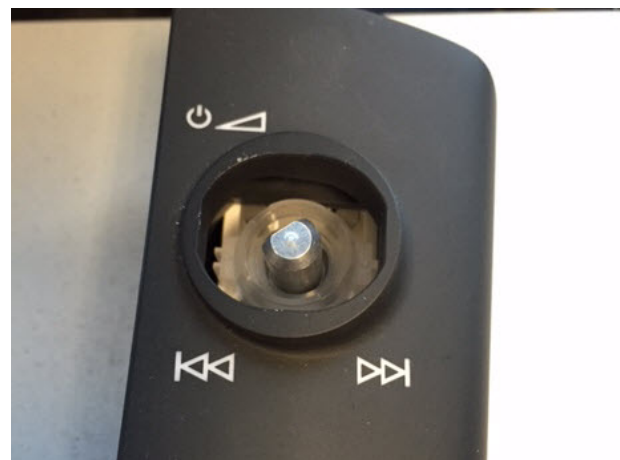
The volume knob on the MMI control panel is loose or missing because it was separated after being inadvertently caught on a bag or purse strap (Figure 1).

Figure 1. Volume knob missing from control panel.

Before proceeding, look for the knob in the vehicle. Check under the seats and floor mats. If the knob cannot be found, order the repair kit knob from ETKA. Do not order the control panel assembly.

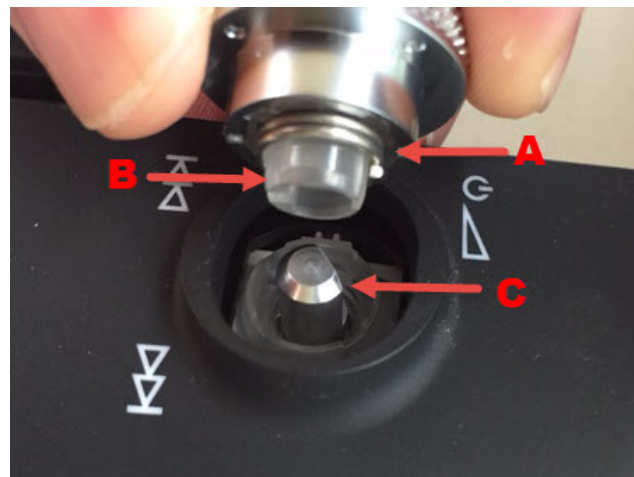
Due to tolerance differences between the knob spring, knob plastics, and metal control shaft of the control panel (Figure 2), the retention force of the knob can be lessened, particularly in varying vehicle interior temperatures. In worst-case conditions, the knob can be removed with very little effort.

Figure 2. A = Spring; B = Knob Plastics; C = Metal control shaft.

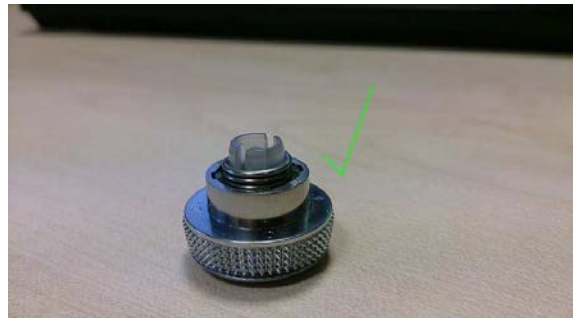
Figure 3. Spring is in correct position.

1. Before placing the knob back on to the MMI control panel, ensure that the spring is still present and is positioned up into the plastic control knob (Figure 3 and Figure 4)

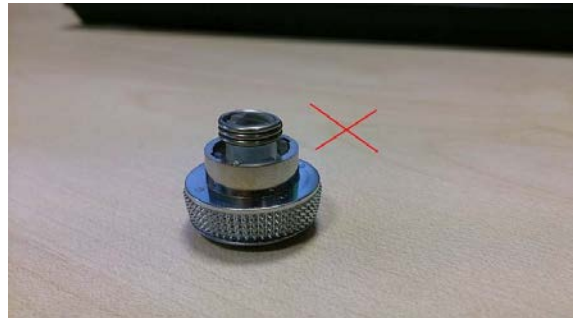
Figure 4. Incorrect position for spring.

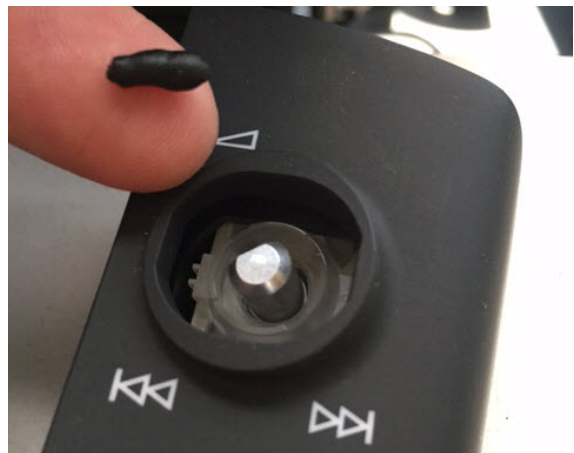
Figure 5. 1/2cm of butyl tape.

2. Place a small amount (1/2 cm) of butyl tape on the metal control shaft of the MMI control panel, over the end of the shaft (Figure 5 and Figure 6).

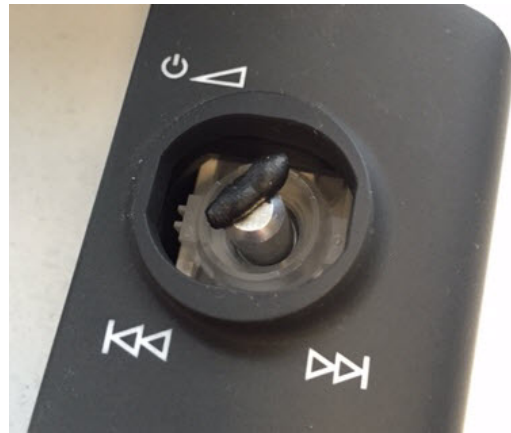
Figure 6. Butyl tape placed over flat edge.

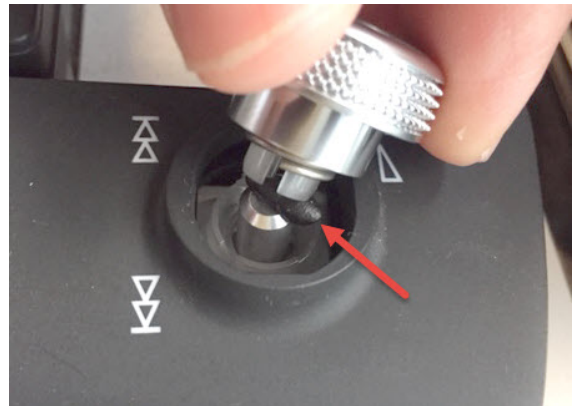
Figure 7. Press knob over butyl back onto metal shaft.

3. Press the plastic control knob back onto the metal shaft until it is fully seated on the metal shaft (Figure 7).

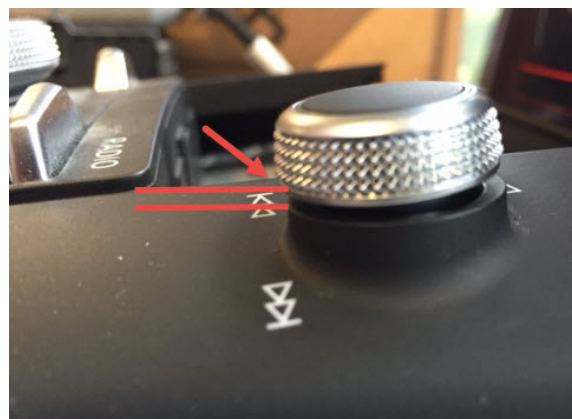
Figure 8. Gap for power function.

4. Ensure a sufficient gap is maintained between the bottom edge of the knob and the MMI control panel surface (Figure 8). This gap is required to allow the volume knob to be actuated down to enable the MMI power function. If the knob does not actuate enough, gently pull back up on the knob to provide a larger gap.

After adjusting the knob, if it can still be removed easily, reposition the butyl and install the knob again.
