**SERVICE BULLETIN**

**APPLICABILITY:** 2014-15MY XV Crosstrek Hybrid Electric Vehicle (HEV)    **NUMBER:** 16-94-15  
**SUBJECT:** Diagnosis and Repair of DTCs P172A and P0B0B                      **DATE:** 07/30/15

**INTRODUCTION**

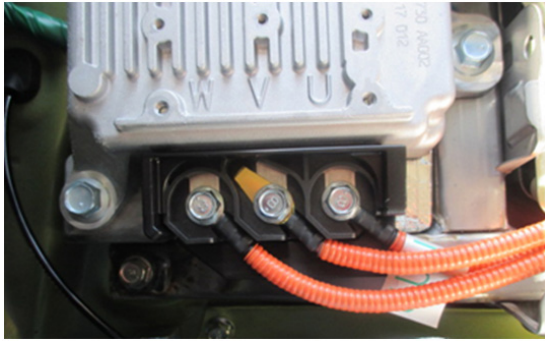
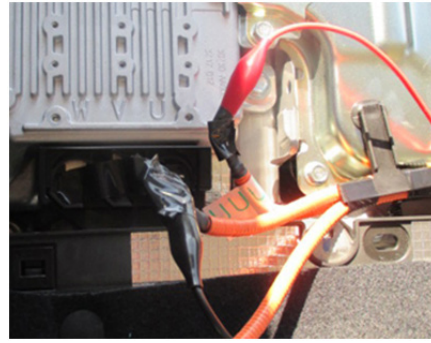
- Remove the rear cargo area floor mat and the sub-trunk (storage tray).
- Remove the orange HEV Service Disconnect plug and put it in your pocket.
- Remove the TORX screws and necessary trim clips securing the aluminum battery cover.
- **ONE AT A TIME**, remove the 3 bolts securing the orange “W”, “V”, and “U” cables to the electric oil pump inverter. As each cable is removed, cover each terminal end with one piece of electrical tape to insulate it. Connect the RED (+) test lead from the DVOM to the “U” cable end and BLACK (-) lead to the “V” cable end as shown. Confirm the “W” cable end is wrapped with insulating tape.

**IF THE DVOM SHOWS 0.5V OR MORE:** the o-ring and drive motor are damaged. The drive motor / case assembly must be replaced. Remove the CVT assembly following the procedure in the applicable Service Manual.

**IF THE DVOM SHOWS LESS THAN 0.5V:** the root cause of the DTC is elsewhere. Continue with the DTC diagnostic procedure in the applicable Service Manual.
