Technical Service Bulletin

91 Drive select, ACC, cruise control, navigation, Bluetooth, smartphone interface, or voice recognition not available

91 16 64 2042506/3 July 26, 2016. Supersedes Technical Service Bulletin Group 91 number 16-37 dated April 14, 2016 for reasons listed below.

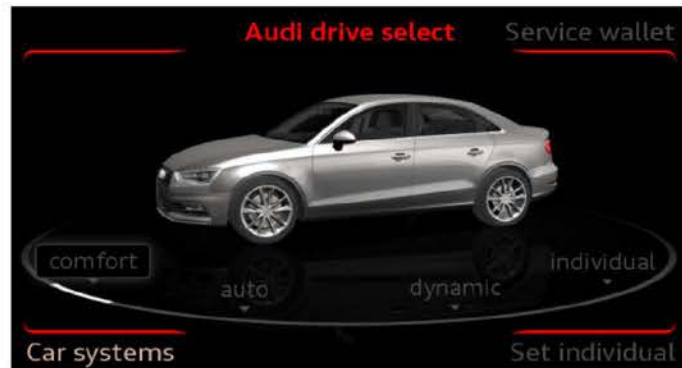
- Audi drive select functions cannot be selected (Figure 1).
- Cruise control does not work (in A3, TT, R8, B9, or Q7 only) and **DTC P161200** (ECM incorrect coding) is stored in one or more of the control units on the Powertrain CAN bus (address word 03 (ABS), address word 01 (ECM), etc.).
- Navigation is not activated (Figure 2 and Figure 3).
- Bluetooth is unavailable.
- Audi smartphone interface, including CarPlay or Android Auto, is not available.
- Voice recognition is unavailable (in all cars except A3 cabriolet. For A3 cabriolet, see TSB 2038136).

Figure 1. Audi drive select functions unavailable and greyed-out.

1. In ODIS, run the SVM Activations test plan at *FLASH >> START FLASH >> SVM Activations >> PERFORM TEST >> -2- Obtain existing activations from server for replacement control module?* (Figure 5). This test plan will recover all activation codes for the MMI and Gateway functions.

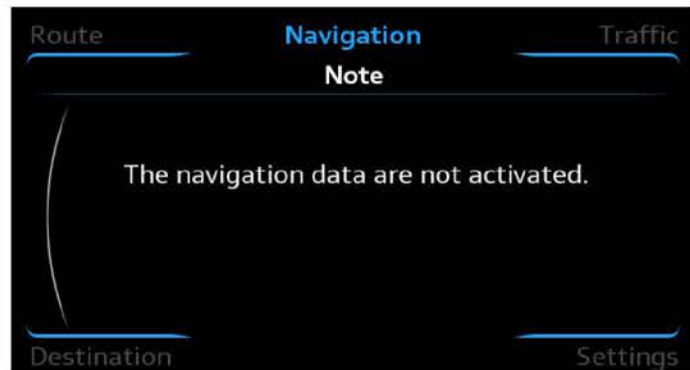
Figure 2. Navigation not activated message (Original MIB HMI)

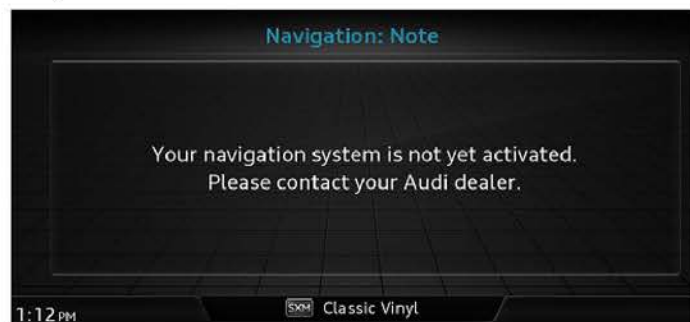
Figure 3. Navigation not activated message (New MIB2 HMI)

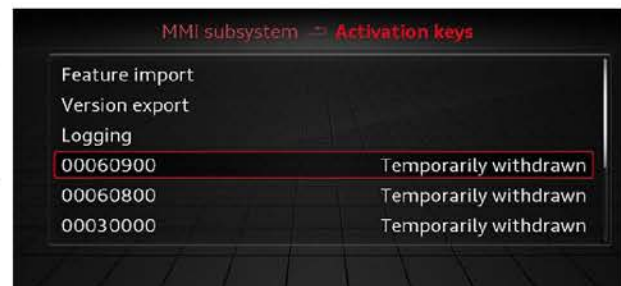
Temporarily withdrawn or Temp illegal = This indicates that the SVM activation test plan was not completed (Figure 4). This status is normal for all parts that have been swapped from a different vehicle. Perform the SVM Activations test plan as indicated below, under *Repair Procedure*.

Figure 4. Activation keys showing “Temporarily withdrawn”
