Subject: WRINKLES ON LEATHER SEAT SURFACE OF NEW VEHICLE	Bulletin No: 09-016/16
	Last Issued: 06/22/2016

2015-2017 Mazda3	2015-2017 Mazda6	2015-2016 Mazda CX-5	2015-2016 Mazda MX-5
2015-2016 Mazda5	2016 Mazda CX-3	2015-2016 Mazda CX-9

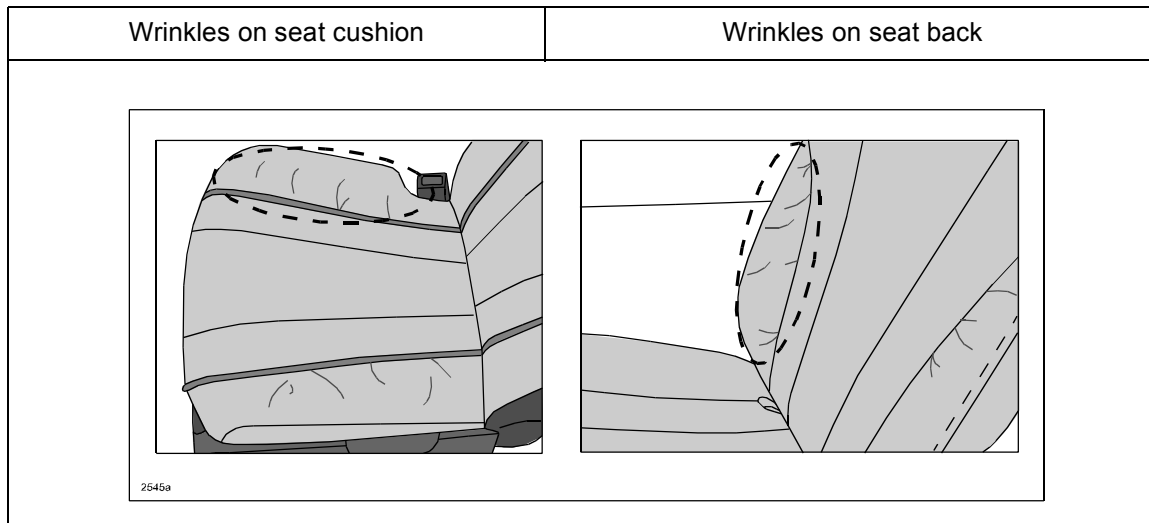
At PDI or when new vehicle is delivered, some customers may complain about wrinkles on the leather seat cushion and/or seat back surface.

Customers having this concern should have their vehicle repaired by a qualified upholstery repair specialist using the following repair procedure.

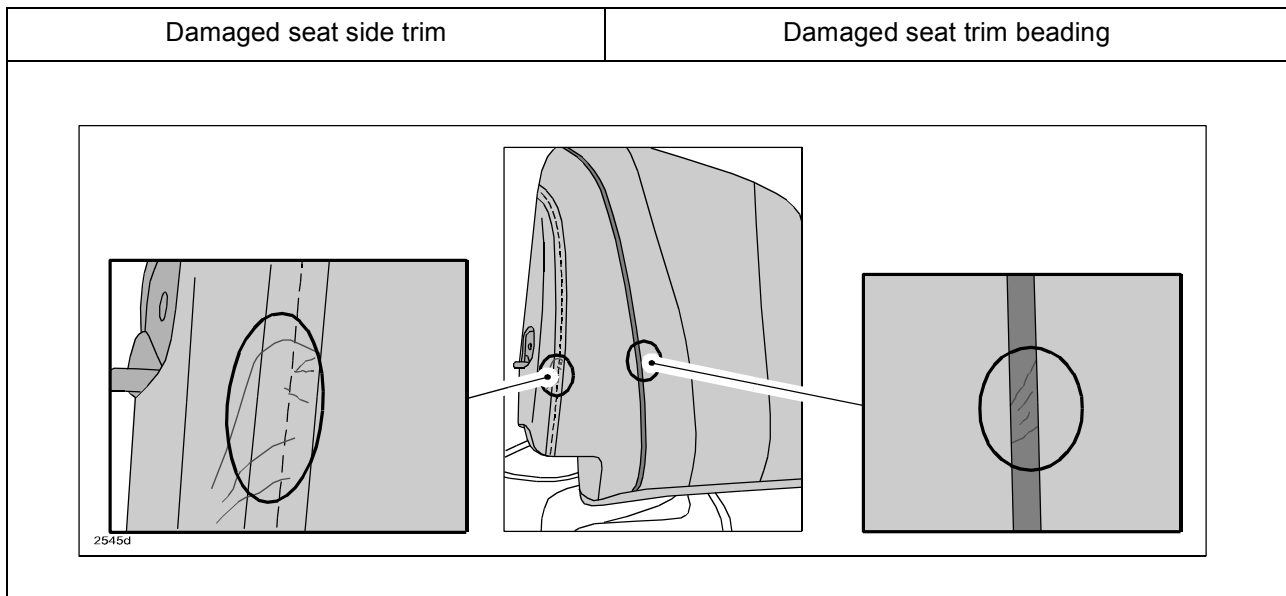
- Do NOT keep the steamer head at the same place for a long time.
- Do NOT run the steamer head without a water-soaked cloth especially over seat trim beading and seat side trim area.
- Seat damage may occur if the caution points above are not followed as shown below.
