<b>Reference</b>	SSM72581
<b>Models</b>	XJ / X351
<b>Title</b>	X351 XJ Centre Console Cup Holder Cover Split
<b>Category</b>	Body
<b>Last modified</b>	07-Jul-2016 00:00:00
<b>Symptom</b>	107000 Interior Trim
<b>Attachments</b>	1Cup Holder Cover.jpg (1Cup Holder Cover.jpg)

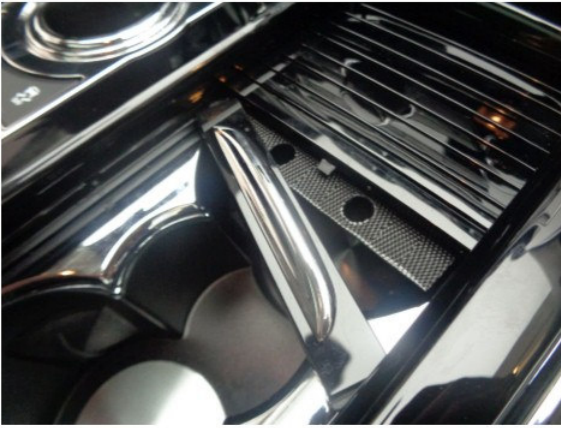
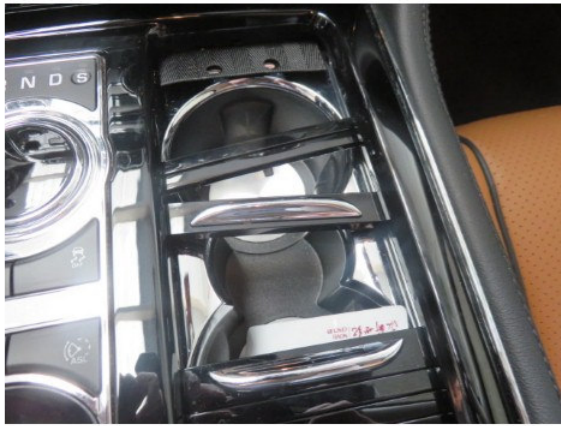
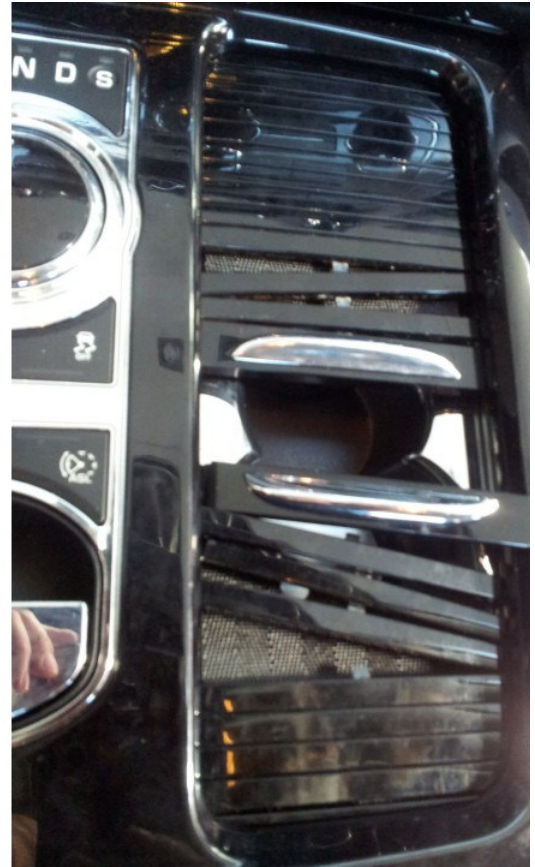
Centre Console Cup Holder Cover Split (See attachment)

Insufficient retention between cup holder cover bars and substrate material. Mechanical fixings (plugs) to the leading handle bar and substrate have been added to improve the bond from VIN No.V93401.

Ensure that there are no other factors that have caused the cup holder to fail, for example spilled drinks that have contaminated the sliding mechanism causing it to stick. The only repair option is to replace the cup holder.
