Technical Service Bulletin

61 Water leak at front corners of convertible top

61 16 25 2024108/5 August 12, 2016. Supersedes Technical Service Bulletin Group 61 number 16-24 dated June 8, 2016 for reasons listed below.

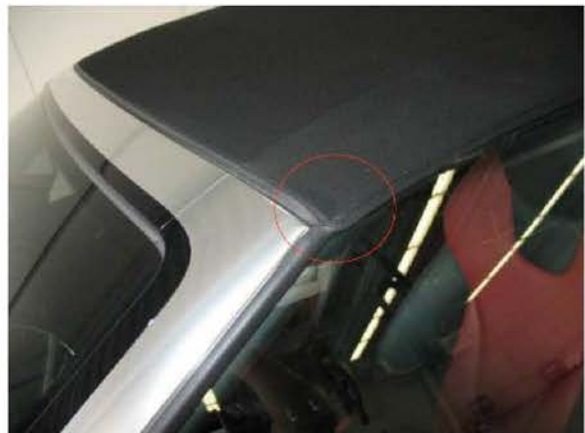
After heavy rain, water can migrate beyond the front convertible top header seal in the area where the convertible top header meets the windshield. The leak may not be immediately noticeable, but after a period of time following strong rainfall, the leaks can become evident in the front corners (Figure 1 and Figure 2).

Figure 1. Location where a leak may occur.

A section of butyl cord is installed in the roof frame seal (header) to close the path of water migration.

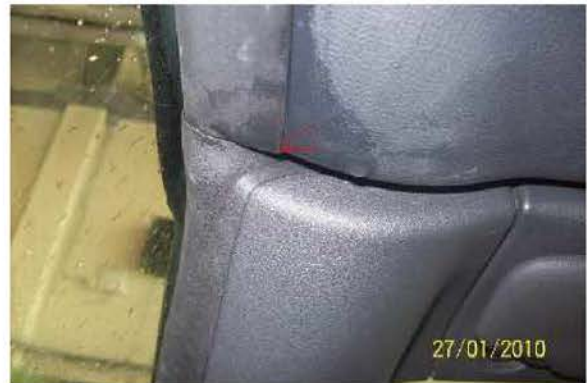
Figure 2. Evidence of a leak.
