Subject: FRONT SEAT RECLINER LEVER KNOB DIFFICULT TO USE	Bulletin No: 09-032/16
	Last Issued: 05/13/2016

2016 CX-3 vehicles with VINs lower than JM1 DK ***** 136420 (produced before March 01, 2016)

2016 Mazda2

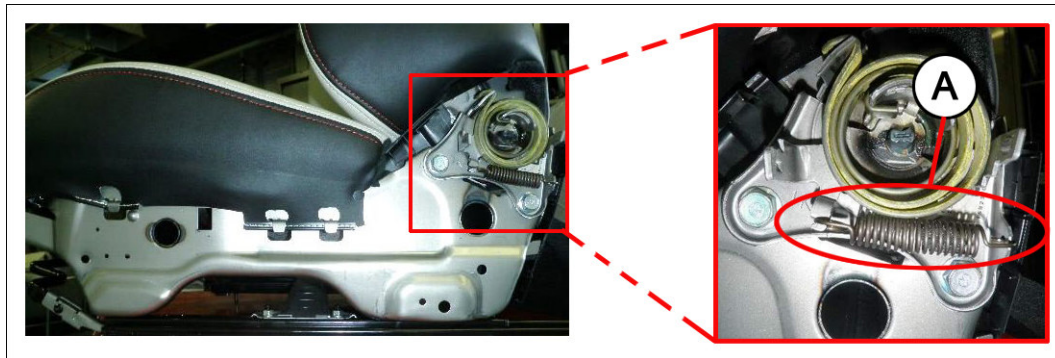
Front seat (Driver side)

Some customers may complain about a front seat recliner lever knob difficult to move. This makes it difficult to change the seat back reclining position.

This may be caused by a return recliner lever knob spring (A) that is too strong.

Customers having this concern should have their vehicle repaired using the following repair procedure.
