SERVICE BULLETIN

APPLICABILITY: 2014MY Forester

NUMBER: 12-158-13

SUBJECT: Uneven Gap between “A” Pillar Trim and Speaker Grille

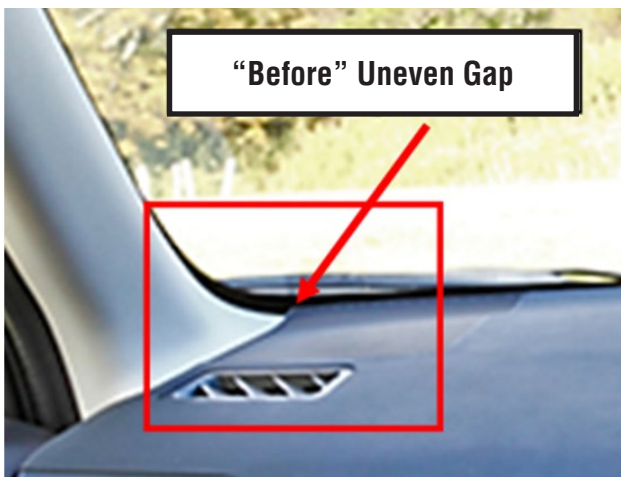
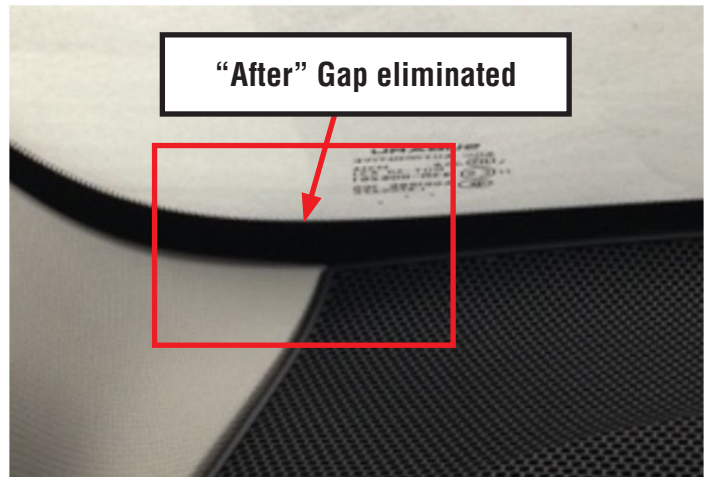
This bulletin provides a procedure to eliminate an uneven gap between the base of the “A” pillar trim and the tweeter speaker grille as shown in the “Before” and “After” photos below.
