Technical Service Bulletin

19 Coolant temperature control implausible signal

19 16 70 2043770/2 April 11, 2016. Supersedes Technical Service Bulletin Group 19 number 16-69 dated March 31, 2016 for reasons listed below.

Model(s)	Year	VIN Range	Vehicle-Specific Equipment
R8	2007 - 2015	All	Not Applicable

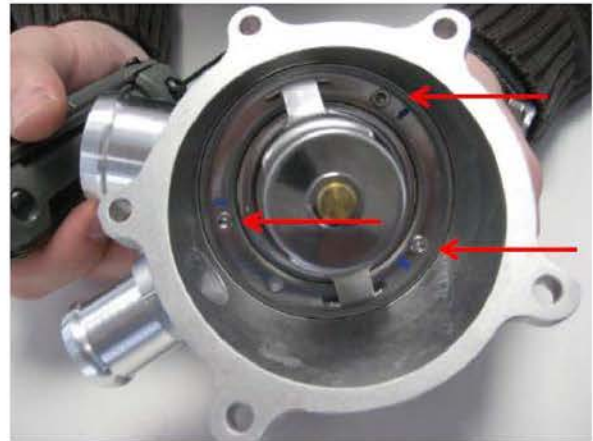
Figure 1. Remove the three Allen screws (red arrows) to remove the thermostat.

1. Remove the coolant thermostat housing according to the instructions in Elsa.
2. Note the position of the thermostat element within the housing. Remove the thermostat element by removing the three Allen screws (Figure 1).

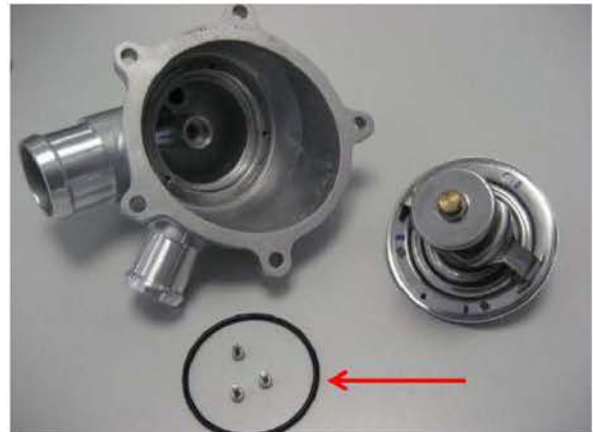
Figure 2. Thermostat housing seal (red arrow).

3. Take the seal out of the thermostat housing and replace it with the new seal (Figure 2).

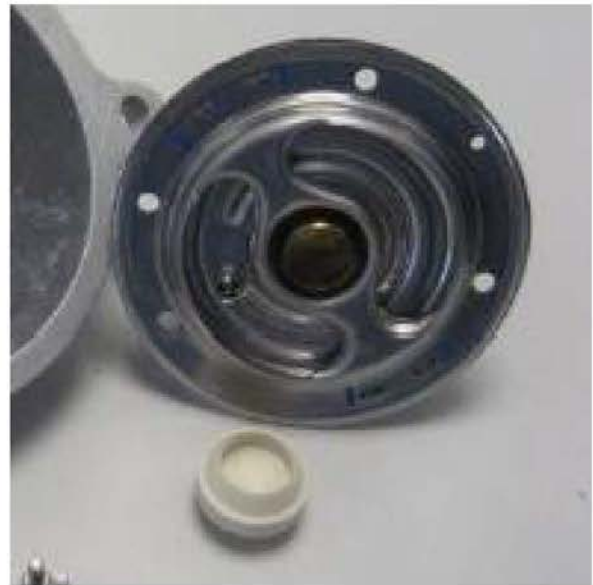
Figure 3. Insulation sleeve.

4. Ensure that the insulation sleeve is fitted on the underside of the thermostat element (Figure 3). Before fitting the insulation sleeve and O-ring, lightly coat them with coolant.

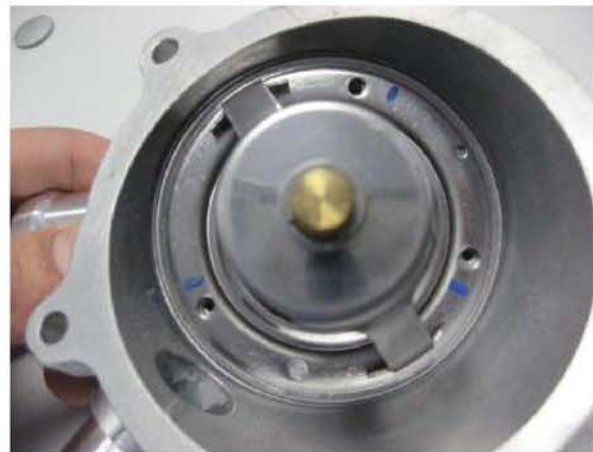
Figure 4. New thermostat installed.

5. Insert the new thermostat element (including insulation sleeve) into the housing (Figure 4).

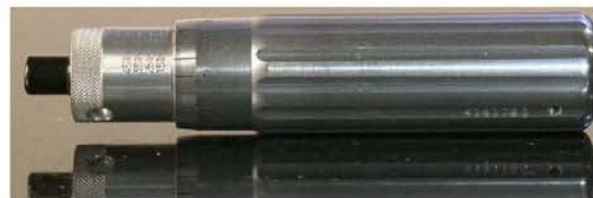
Figure 5. Torque wrench.

6. Secure the thermostat element with the three new Allen screws. Use special tool V.A.G 1624 or VAS6494, or equivalent torque wrench (Figure 5). Tighten to 2 Nm (+1 / -0 Nm).
