## SERVICE BULLETIN

**APPLICABILITY:** 2015-16MY Legacy and Outback Models      **NUMBER:** 12-176-14R  
**SUBJECT:** Service Procedure to Address a Wind Rushing Sound from the Front Door Sash Area      **DATE:** 12/05/14  
**REVISED:** 10/16/15

### INTRODUCTION

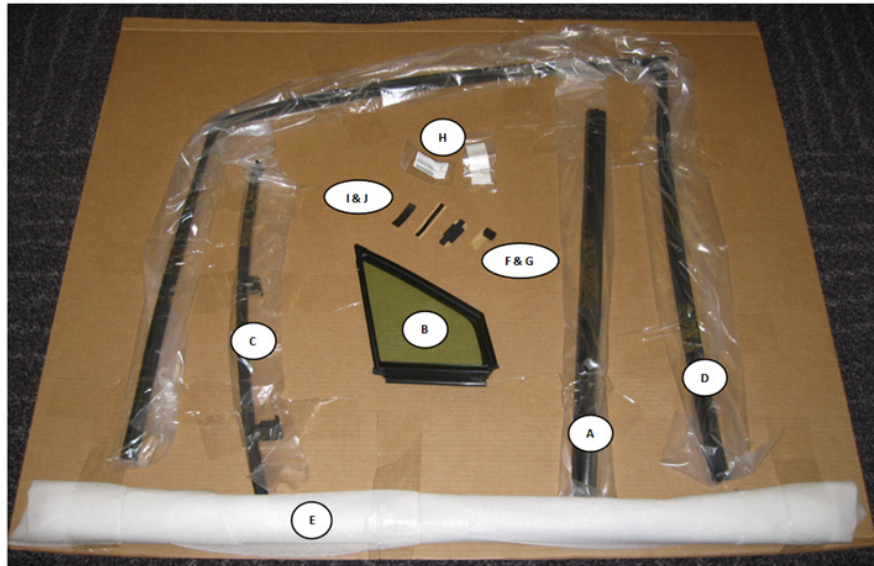
**NOTE:** If you have in stock or receive a repair kit with an 80mm section of butyl tape included (item “J” in the photo below), a much longer, **(320mm)** section, p.n. **SOA635138** must be ordered to properly complete these repairs. All repair kits with a Pack Date after May 1st, 2015 will include the longer **320mm section** of butyl tape. The repair kit part numbers will remain unchanged.

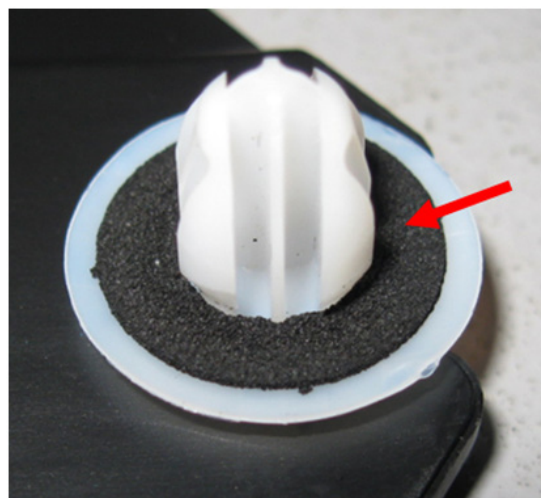
**NOTE:** Pay close attention to the small sealing gaskets used on the door trim and pad insert retaining clips. **All of these** gaskets must be in place as shown below before reassembly to properly seal their respective component **and further reduce the chance of a rattling or wind rushing sound.**

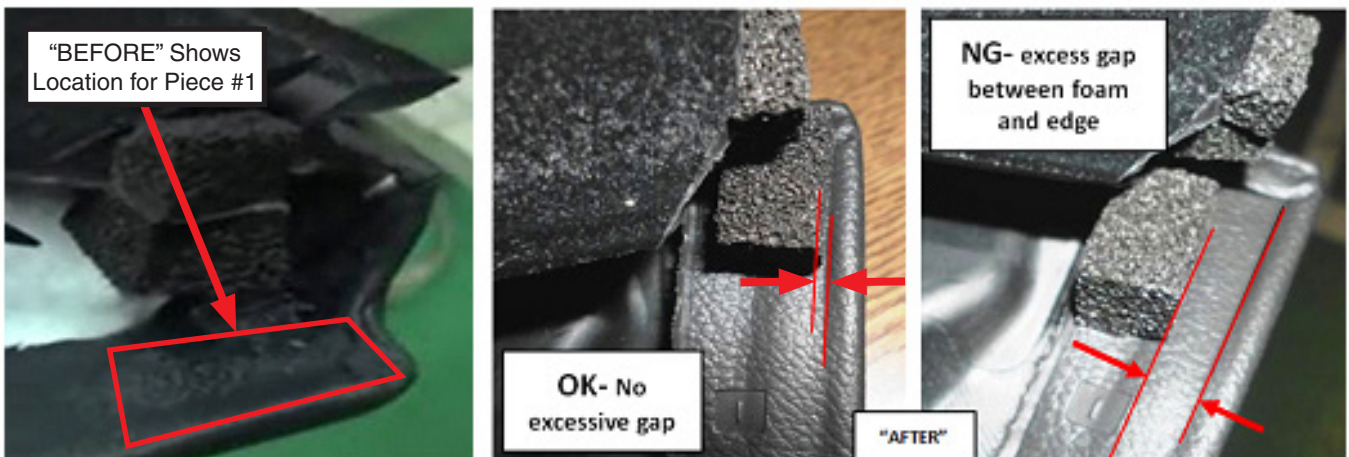
- EPT Foam Piece #1 is applied to top REAR inside corner of the door trim panel where the trim material wraps around the back edge as shown in the “Before” and both the proper and improper installation “After” photos below. The NG photo shows an excessive gap between the foam and edge of the trim panel.

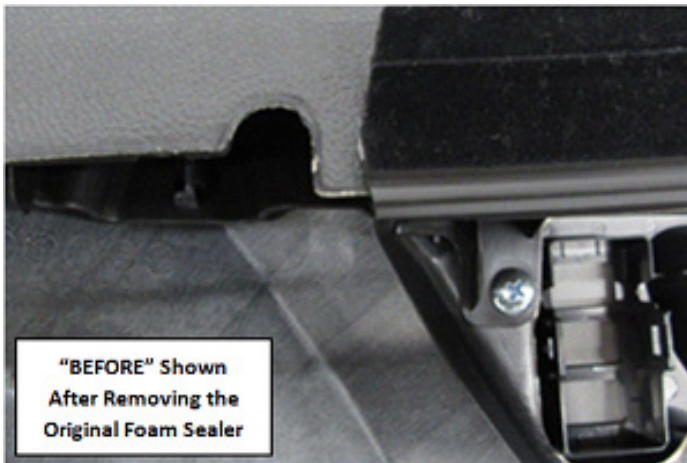
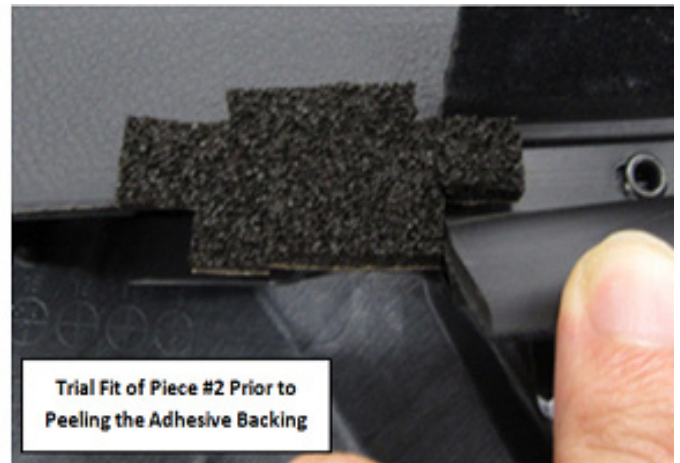
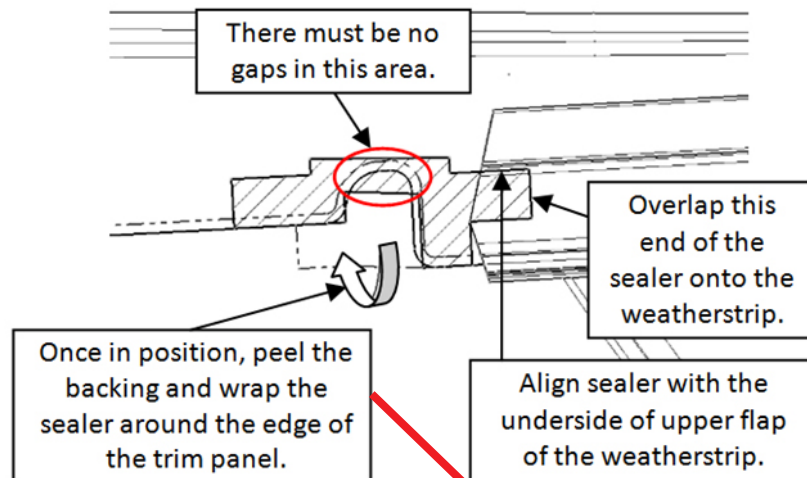
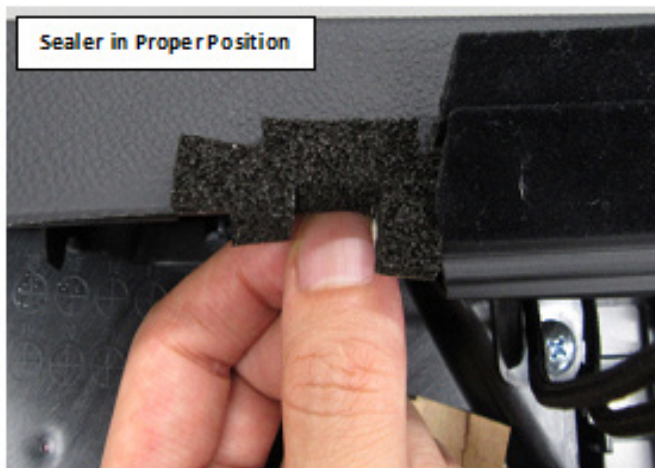
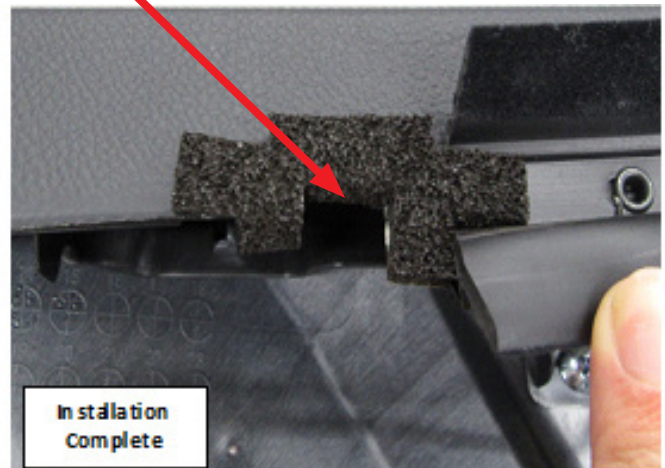
- **EPT Foam Piece #2** is applied to the top front of the door trim panel at the front edge of the inner door glass inner weatherstrip. This piece seals the inside face of the sash and has been pre-cut so it can be properly folded into position as shown in the illustration and photos below.

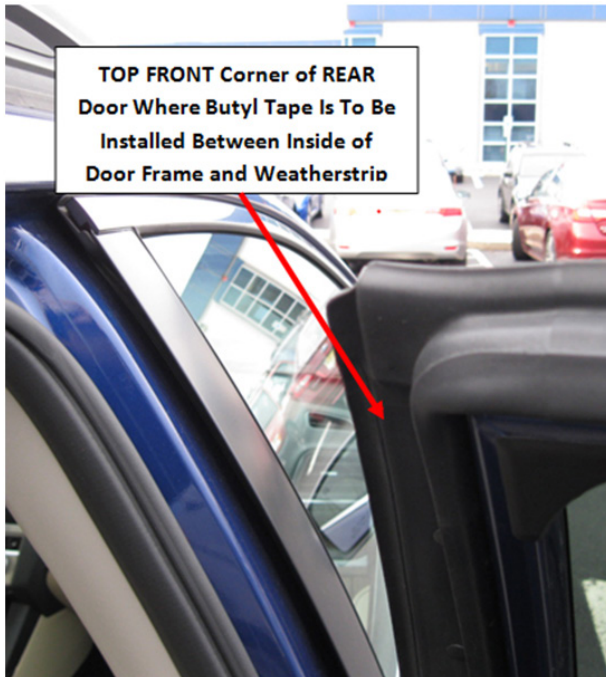
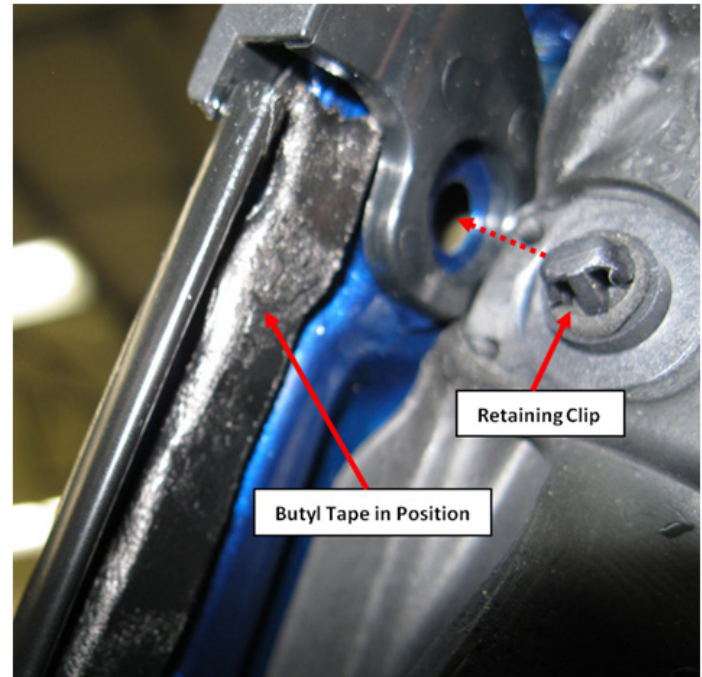
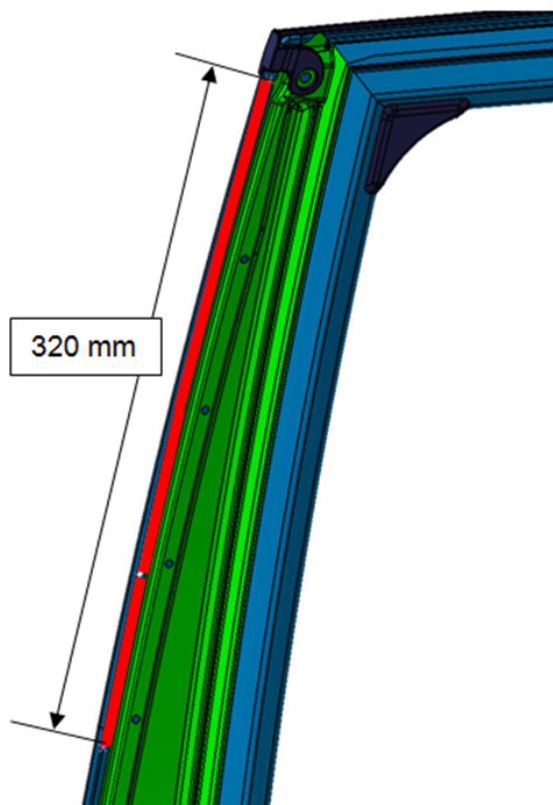
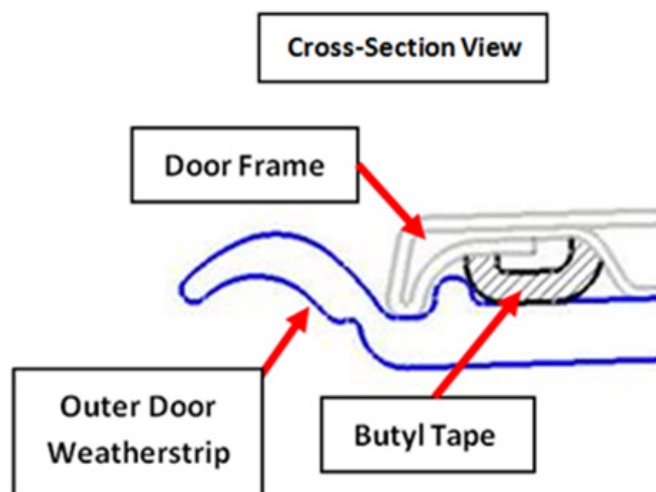
- To better secure the **upper front corner of the REAR DOOR frame weatherstrip** to the door frame, release the plastic retaining clip and pull back the weatherstripping to access the area where the **320mm section of butyl tape** will be applied. Be sure to clean the area where the butyl tape will be applied with a mild solvent on a clean shop cloth. After drying the area completely, apply the butyl tape to the door frame where indicated in the illustrations and completed installation photo below.

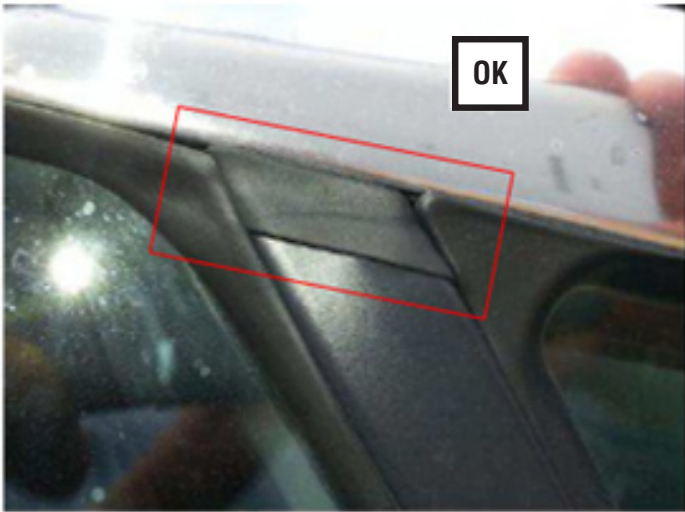
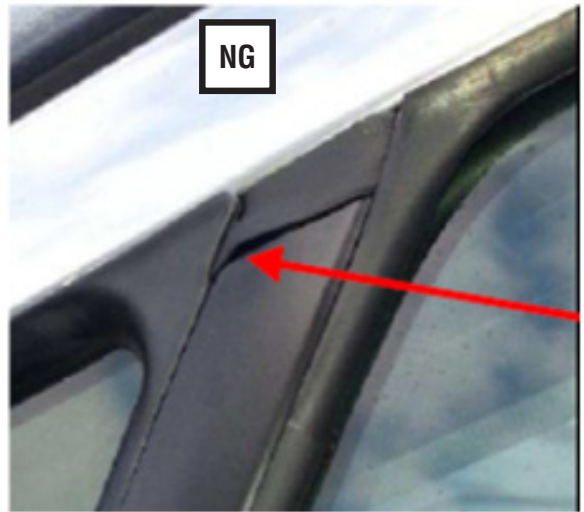
- Before torquing the sash hardware, inspect the partition glass weatherstrip / seal closely for proper fit with no gaps or bunching up of the seal outer lip. An example of a proper and an improper fit are shown below.
