SERVICE BULLETIN

APPLICABILITY: 2014-15MY XV Crosstrek Hybrid Electric Vehicle (HEV) **NUMBER:** 16-94-15R

SUBJECT: Diagnosis and Repair of DTCs P172A and P0B0B

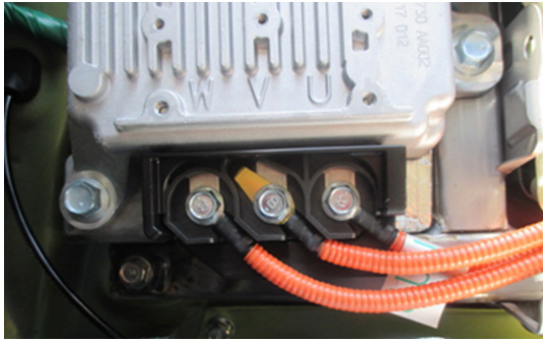
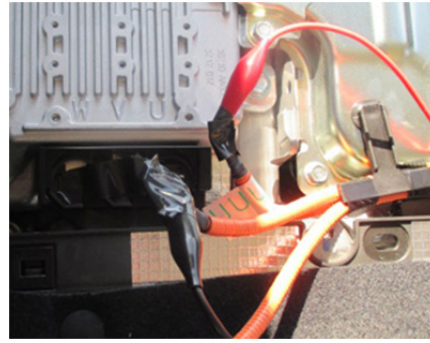
- Remove the rear cargo area floor mat and the sub-trunk (storage tray).
- Remove the orange HEV Service Disconnect plug and put it in your pocket.
- Remove the TORX screws and necessary trim clips securing the aluminum battery cover.
- **ONE AT A TIME**, remove the 3 bolts securing the orange “W”, “V”, and “U” cables to the electric oil pump inverter. As each cable is removed, cover each terminal end with one piece of electrical tape to insulate it. Connect the RED (+) test lead from the DVOM to the “U” cable end and BLACK (-) lead to the “V” cable end as shown. Confirm the “W” cable end is wrapped with insulating tape.

- Reinstall the orange HEV Service Disconnect plug.
- Turn on the DVOM and set it to measure AC Voltage.
- Start the engine and with the transmission in PARK, hold the engine at 1800 RPM.
- Read the AC voltage on the DVOM display and record your result.

IF THE DVOM SHOWS 0.5V OR MORE: the o-ring and drive motor are damaged. The drive motor / case assembly must be replaced. Remove the CVT assembly following the procedure in the applicable Service Manual.

IF THE DVOM SHOWS LESS THAN 0.5V: the root cause of the DTC is elsewhere. Continue with the DTC diagnostic procedure in the applicable Service Manual.
