SERVICE BULLETIN

APPLICABILITY: 2015-16MY Legacy and Outback Models

NUMBER: 12-192-15

SUBJECT: Windshield Cracking Concerns

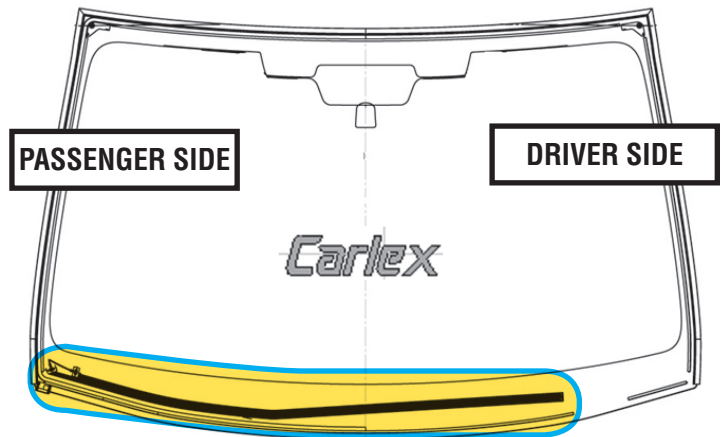
Subaru of America, Inc. (SOA) Quality Assurance has identified an increase in the number of cracked windshields on some 2015 and 2016MY Legacy and Outback models. Further investigation has determined the root cause for many of these failures to be the ceramic materials used for the black-colored printed perimeter combined with the silver-colored material used for the wiper deicer portion of the windshield glass. In response to this increase, SOA is extending the original warranty on applicable factory-installed windshields to 5 years / unlimited miles. This warranty extension will cover windshield replacement a maximum of **ONE TIME** where applicable on a vehicle with a VIN prior to those listed in the Production Change Information on page 2 and meeting the guidelines outlined in this bulletin.

IMPORTANT: The information in this bulletin is only applicable to certain windshield glass manufactured by CARLEX and equipped with the windshield wiper deicer feature (part of the All-Weather Package) on vehicles within the specified VIN ranges. The affected windshields can develop cracks when impacted in the printed black area of the highlighted wiper deicer area shown in the illustration below.

IMPORTANT NOTE: The illustration to the right shows the windshield as viewed from **OUTSIDE** the vehicle.

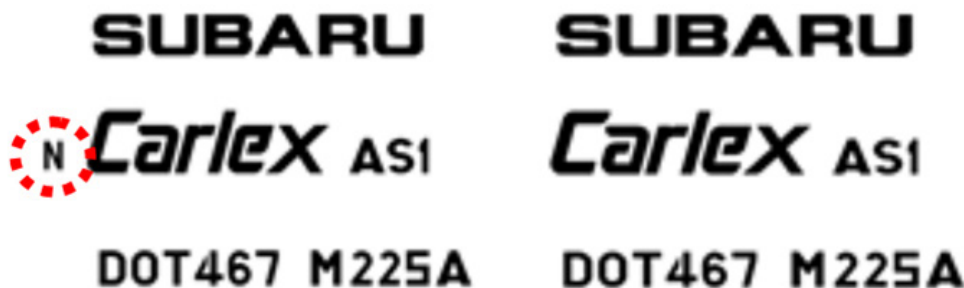
Fig. 1

The original windshields (before production change) can be easily identified by the identification markings found in the lower left, driver’s side corner shown in Figure 1 below.

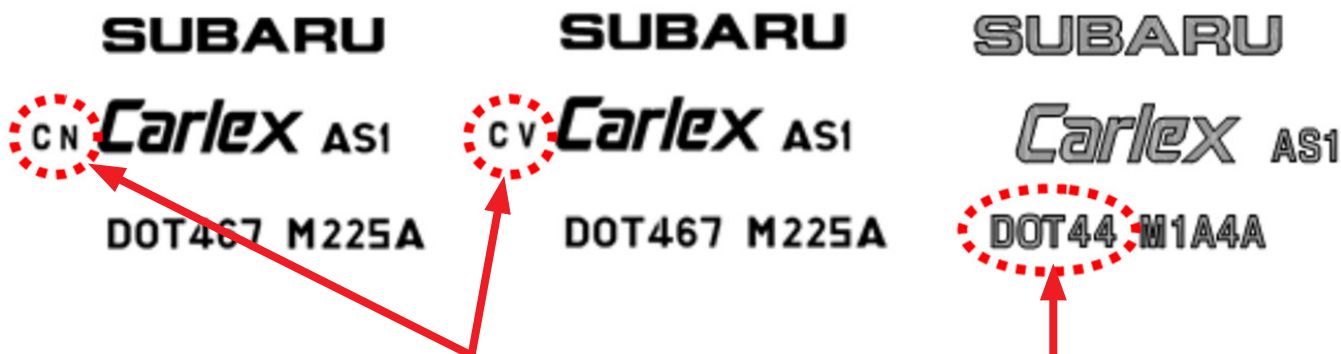
The enhanced production parts and replacement part windshields are identified by the additional identification markings (CN, CV, DOT44) as shown in Figure 2 below. Windshields with these markings are NOT eligible for replacement under the warranty extension.

Fig. 2	These 2 production markings can be found on production or replacement part windshields.	This marking is found on replacement part windshields only.
---------------	---	---

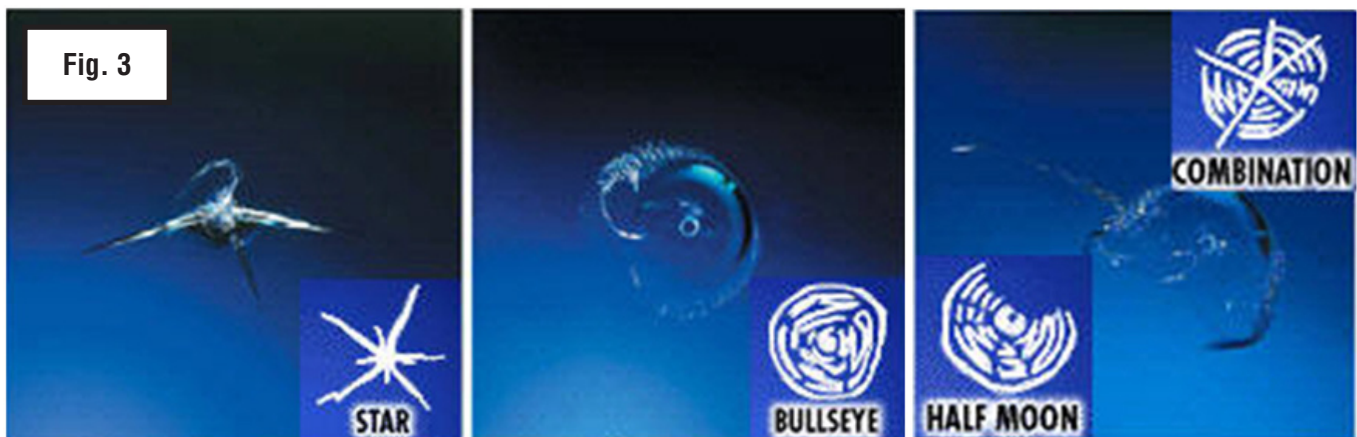
Confirm the windshield is actually cracked and the crack does not originate from a bulls eye, star, or combination impact (refer to the images in Figure 3 below). These types of damages may occur on windshields which do not have the above outlined condition and would not be covered unless the damage originates in the affected wiper deicer area.

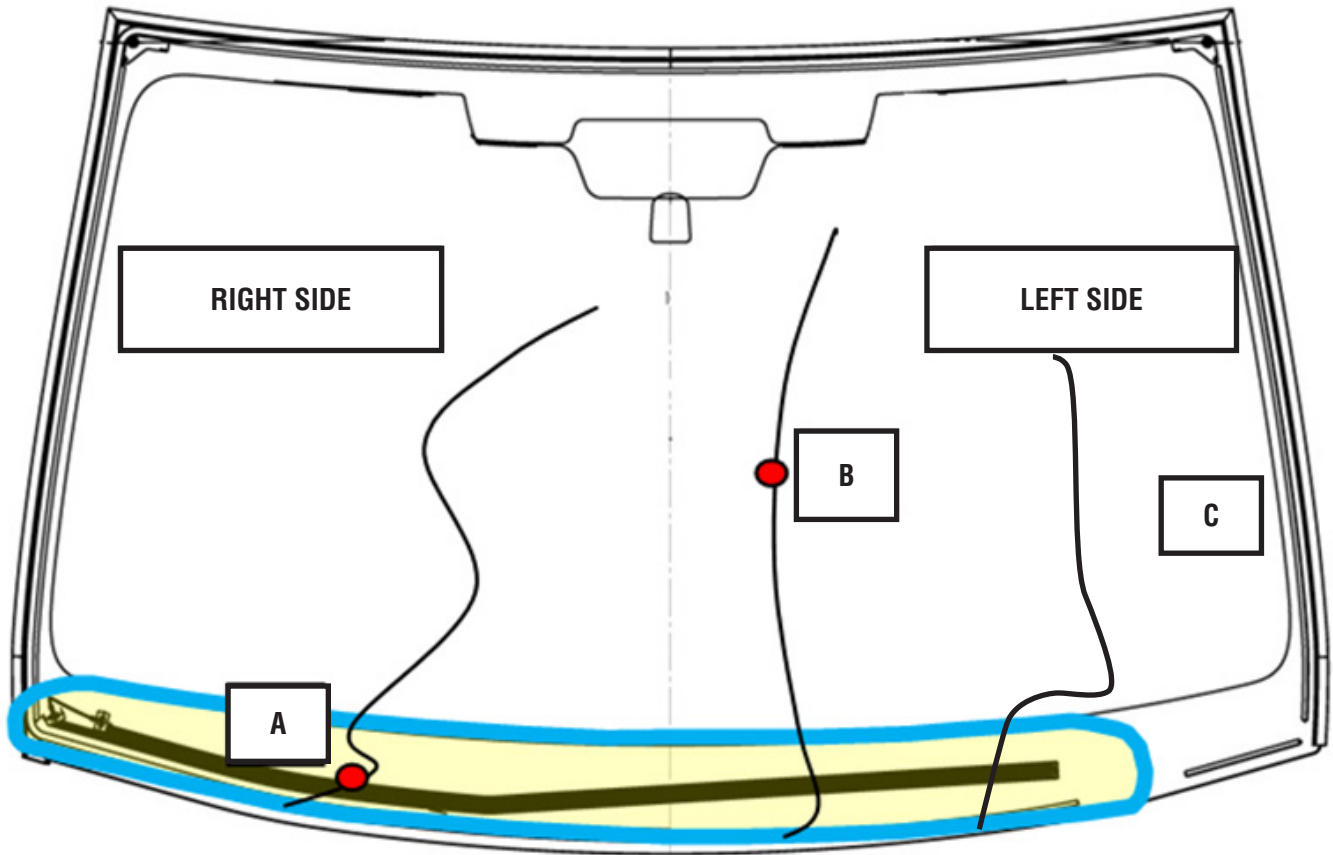
If the marking contains SUBARU and Carlex and matches the illustrations shown in Figure 1 above, proceed with the inspection as the windshield was manufactured prior to the production change. Visually inspect the crack to determine if it passes through the affected deicer area. Examine the entire length of the crack for evidence of impact. If there are no obvious signs of impact, a ballpoint pen or fingernail may be used to help locate the impact point. Move the ball of the pen (or fingernail edge) along the crack starting at one end and tracing to the other. Take note when the ball or nail catches along the crack as these are impact points.

- If an impact point is found within the affected deicer area (as shown by "A" in the illustration below), proceed with windshield replacement under the terms of this warranty extension.
- If the impact point is found outside of the affected area (as shown by "B" in the illustration below), this bulletin and warranty coverage do not apply.
- If an impact point cannot be identified and the crack passes through the affected area (as shown by "C" in the illustration at the top of the next page), proceed with windshield replacement under the terms of this warranty extension.
