SERVICE BULLETIN

APPLICABILITY: 2015-2016MY WRX and STI Models
2013-2016MY BRZ

NUMBER: 12-190-15R

SUBJECT: Elimination of Creaking Sound from Clutch Pedal Assembly

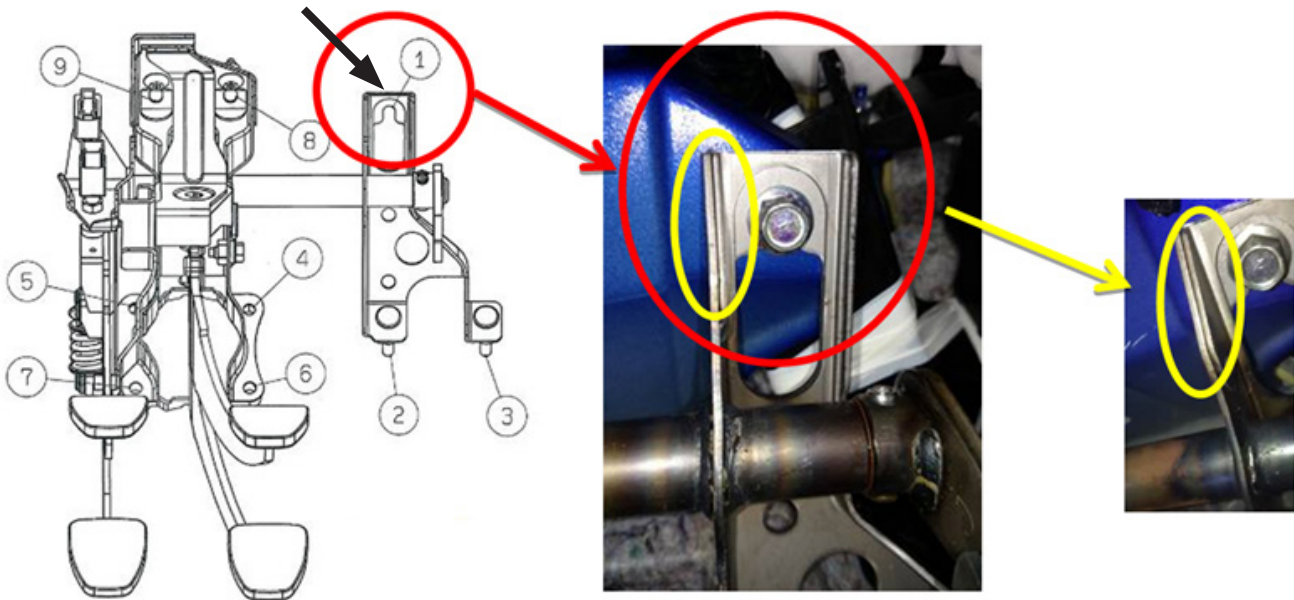
This bulletin provides a procedure to address customer concerns of a creaking sound heard when operating the clutch pedal. The cause of the sound has been identified as a very slight amount of movement between the 2 layers of metal (circled in yellow) which form the specific clutch and brake pedal assembly mounting bracket shown in the illustration and photos below.

- If the sound is unchanged with the screw driver in place, the source is likely to be located elsewhere.
- If the sound is eliminated or changed with the screw driver in place, order the applicable replacement pedal assembly from the parts table provided above.

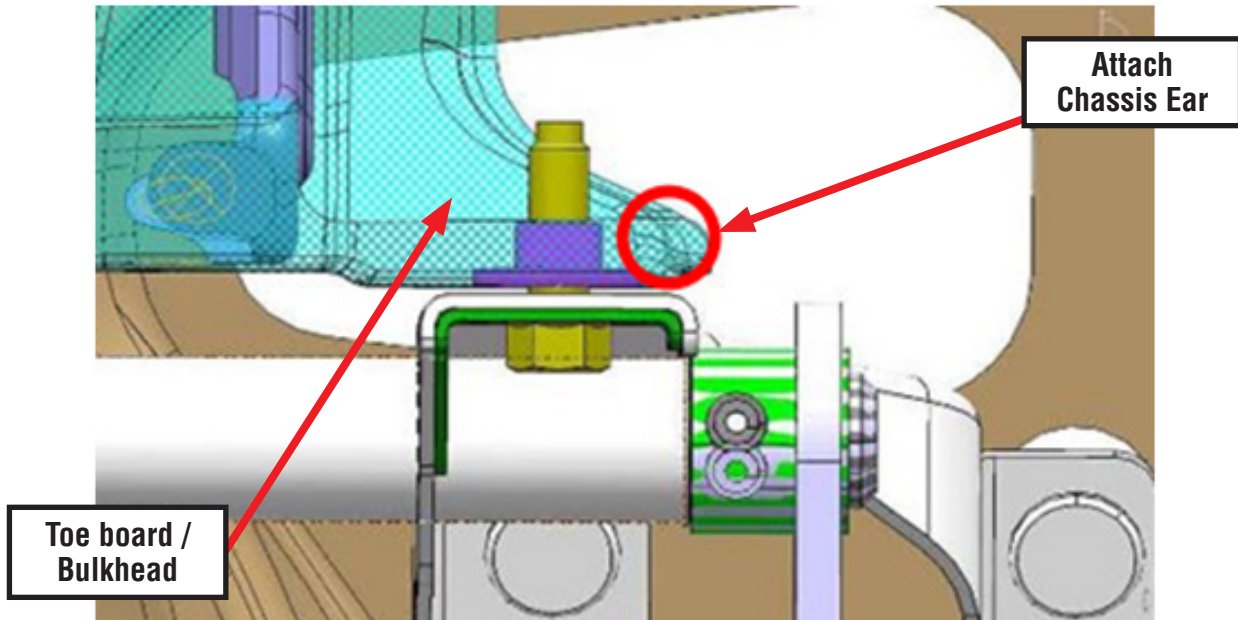
Once the sound has been verified, attach a chassis ear to the toe board / bulkhead in the location circled in the illustration below then operate the clutch pedal.

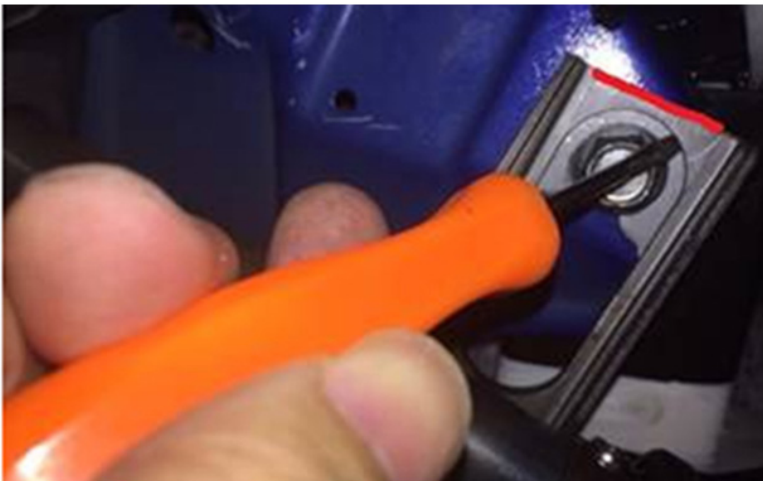
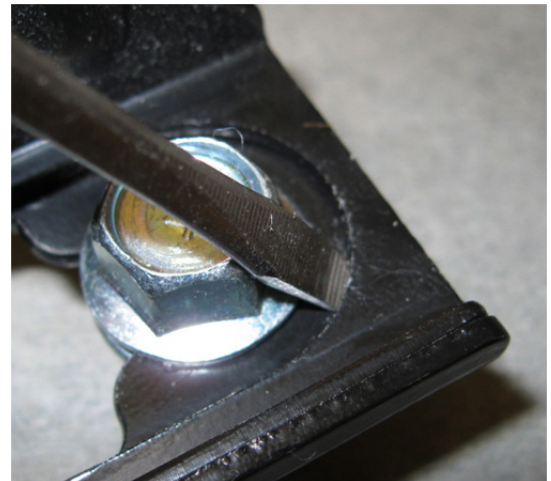
If the sound is confirmed to be originating from that location, use a small flat-blade screw driver to prevent movement of the upper layer while slightly separating it from the lower layer of the bracket as shown in the photo below. Operate the clutch pedal again and with the chassis ear in the same position as before, determine if the sound is changed or reduced while the screw driver is in place.
