SERVICE BULLETIN

APPLICABILITY: 2013-14MY Legacy and Outback Models with 2.5L FB Engines
 2011-14MY Forester Models with 2.5L FB Engines
 2015 MY Forester (Manual Transmissions Only) with 2.5L FB Engines
 2012-13 MY Impreza and XV Crosstrek Models with 2.0 FB Engines
 2014-15 MY Impreza and XV Crosstrek Models (Manual Transmissions Only) with 2.0 FB Engines

NUMBER: 02-157-14R
DATE: 08/28/14
REVISED: 11/12/15

SUBJECT: Surface Treatment Change To Oil Control Piston Rings

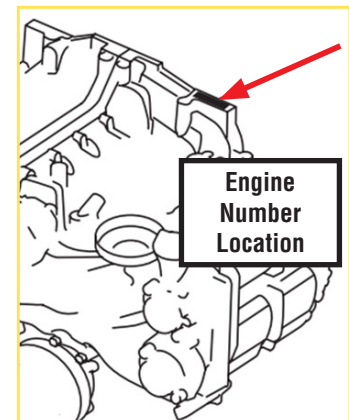
*** NOTE:** When determining the engine number, use the **LAST 8** characters of the number stamped into the boss on top of the block adjacent to the starter and shown in the illustration. The engine number range for the FA1 assembly line is 800000 to 930025 and the FB2 range is 000000 to 652640.

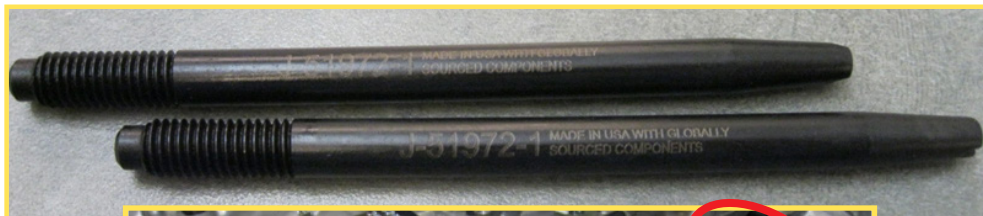
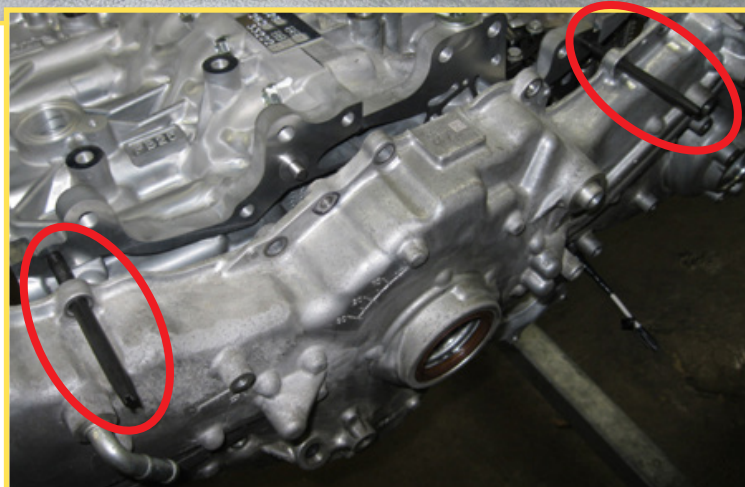
- If alignment pins are not used and the sealer gets disturbed during the cover installation, unless properly addressed, the affected area(s) will most likely be the source of an oil leak after reassembly. Don't hesitate to use a helper for the cover installation to prevent this from happening.

- **IMPORTANT:** When re-installing the front cover assembly, be very careful to not allow it to contact any of the timing sprockets. If contact does occur, it will most likely be with the exhaust sprockets and it is almost a guarantee the fresh silicone sealer beads applied to the cover will be disturbed. To minimize the possibility of this happening, alignment pins as shown in the photos below have been developed to “guide” the cover into its proper position without disturbing the fresh sealer. The Subaru Special Tool number for the alignment pin kit is J-51972. Each kit includes 2 pins.
