Technical Service Bulletin

91 Audi connect online destination search, Google Earth navigation view, or INRIX online traffic is not available

91 16 39 2042013/3 April 18, 2016. Supersedes Technical Service Bulletin Group 91 number 15-28 dated December 9, 2015 for reasons listed below.

Model(s)	Year	VIN Range	Vehicle-Specific Equipment
All	2012 - 2018	All	With Audi connect

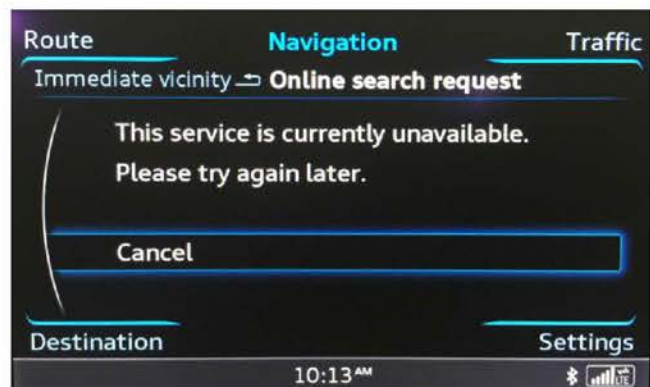
- While using Audi connect (GEN1), the customer cannot access the online destination search and/or the Google Earth navigation view.
- The following message appears in the MMI (Figure 1): "This service is currently unavailable. Please try again later."
- The customer may also see an error message in the myAudi portal indicating that one or multiple licenses are expired and must be renewed.
- Additionally, for vehicles that use INRIX online for traffic (MIB2 infotainment system), the customer may not be able to see speed and flow traffic information in the navigation map screen, and may consistently see that no traffic reports are available.

Figure 1. Message in MMI.
