Traces of oil in area around oil/water heat exchanger (inner V) on engine 642

Topic number	LI18.30-N-056338
Version	7
Design group	18.30 Oil cooling system
Date	09-01-2016
Validity	Model 639 with engine 642 Model 906 with engine 642
Reason for change	Part number added
Reason for block

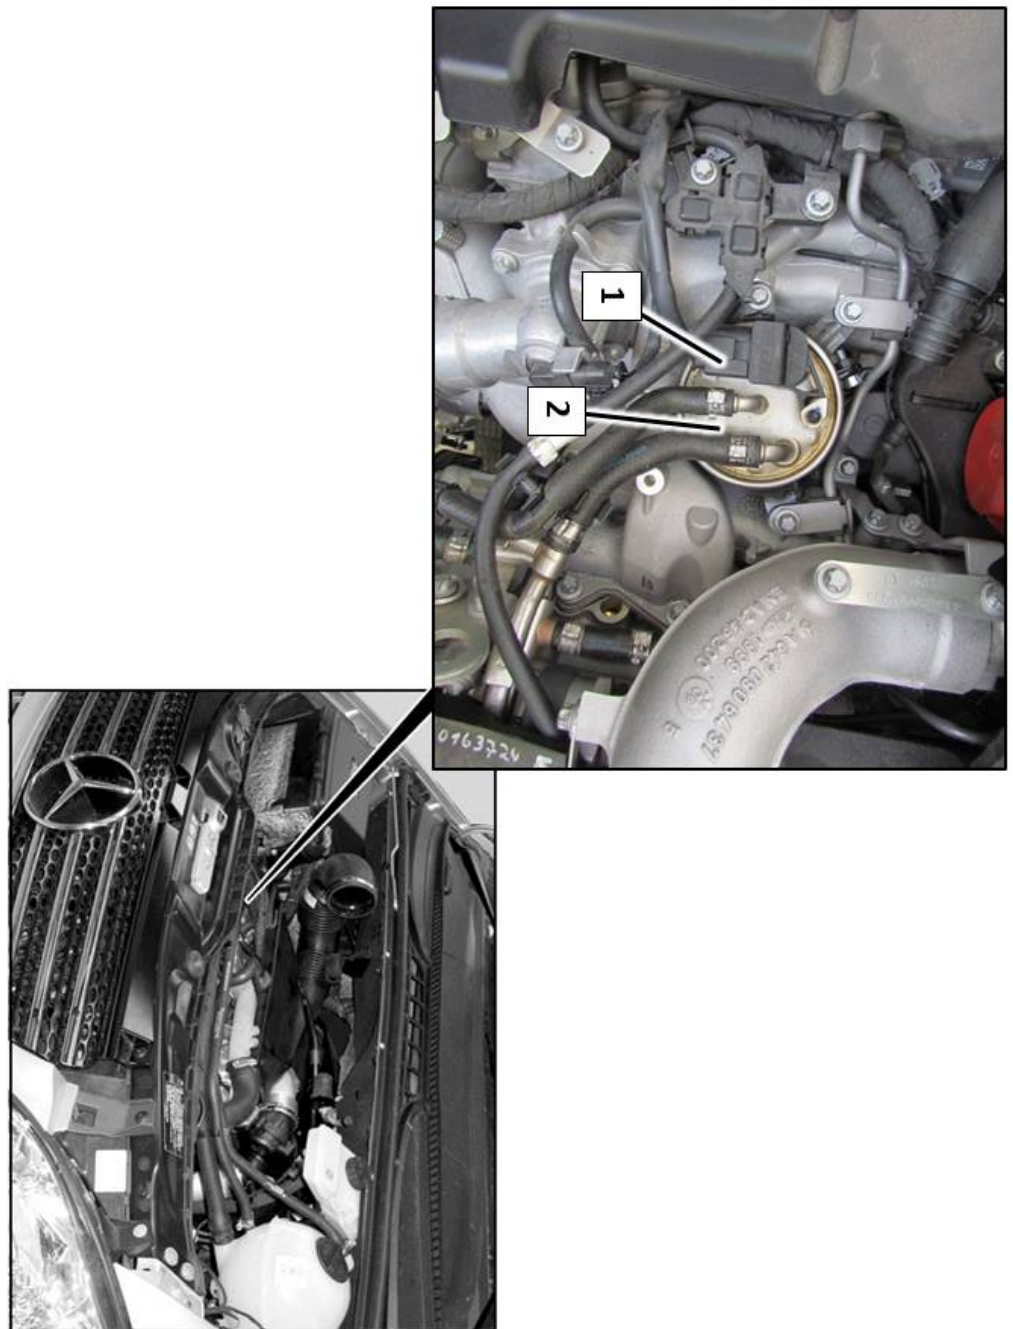
01.jpg:

Attachments	
File	Description
01.jpg	Shown on fuel filter (2) and electrical connector on engine 642.
02.jpg	Check whether the traces of oil come from the area (3) around the oil/water heat exchanger.
new_gasket2.jpg	Picture of New and Old gaskets
Oil Cooler Top.jpg	Oil Cooler Top view
Clean Away from Holes.JPG	Clean away from the holes
Engine damages due to use of abrasives_Page_1.jpg	Engine damages due to use of abrasives

- 1- Verify oil is not leaking from the Turbocharger Inlet Seal (175). (See attachment "OM 642 Turbocharger.jpg")
 - a - Reference Service Bulletin V-B-09.00/01 "Operations in Clean Air Line Area"
2. Separate the electrical connector (1) and detach the fuel filter (2) (See attachment 01.jpg) from the bracket and pull out (see AP47.20-D-0780HD for model 906, AP47.20-S-0780B for model 639 with engine 642.990 or AP47.20-S-0780C for model 639 with engine 642.890).

Note: Do not disconnect the fuel hoses from the fuel filter (2).
3. Use a borescope (000 588 01 21 00) to check whether the traces of oil come from the area (3) around the oil / water heat exchanger.

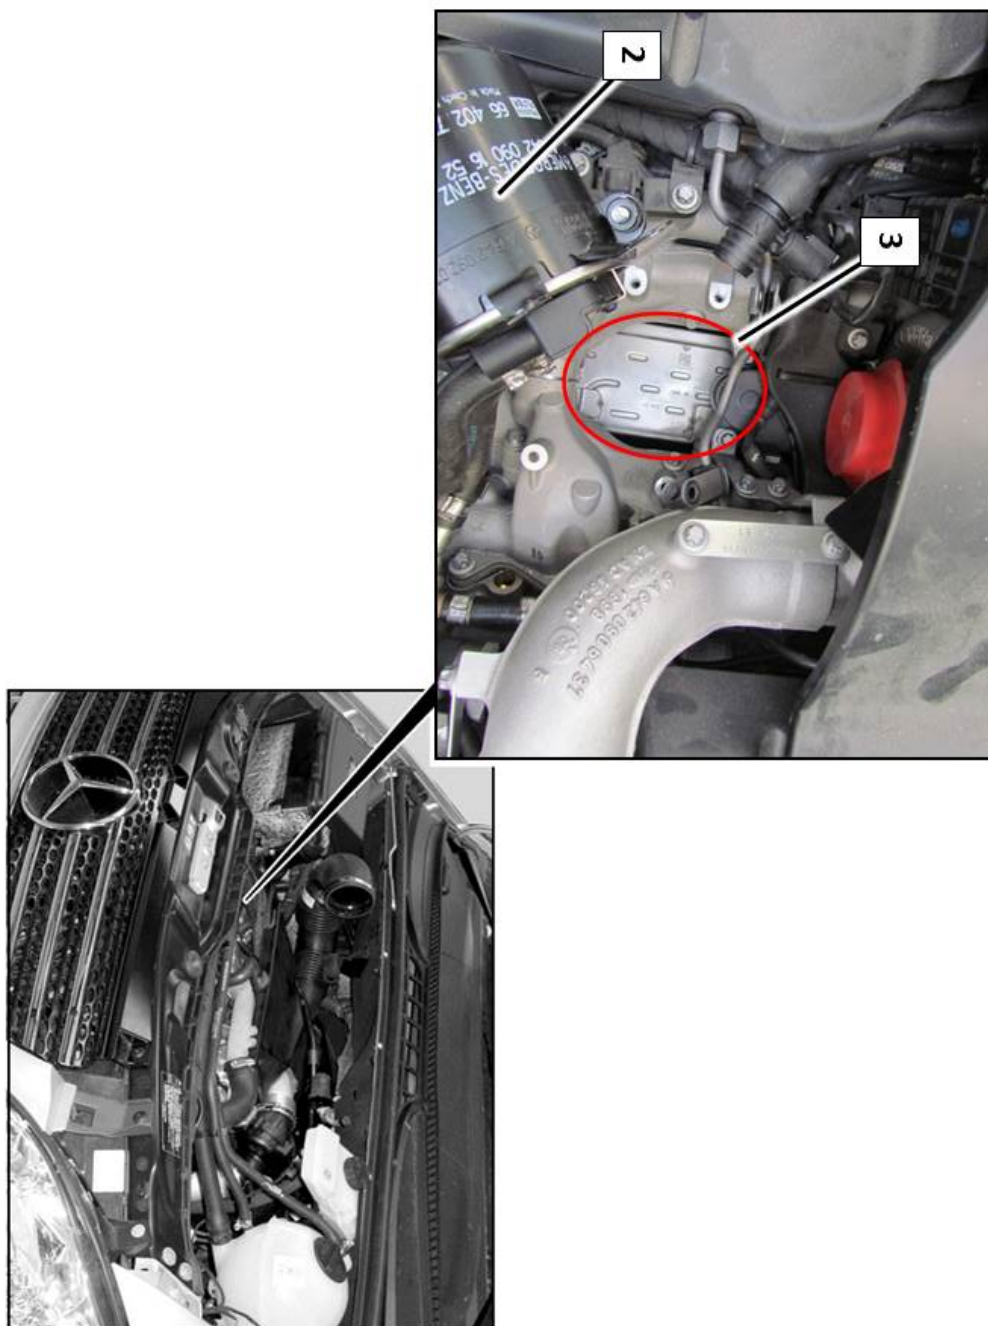
02.jpg:

- Traces of oil in area (3) around oil/water heat exchanger (inner V) on engine 642. (See attachment "02.jpg")
- Traces of oil at drain points of inner V on engine 642.

Note: If the traces of oil come from the area (3) around the oil / water heat exchanger, continue with step 4. If the traces of oil do not come from the area (3) around the oil / water heat exchanger, ascertain the exact cause of the problem and initiate appropriate measures.
4. Remove oil cooler; refer to WIS document "AR18.30-S-6840SE."

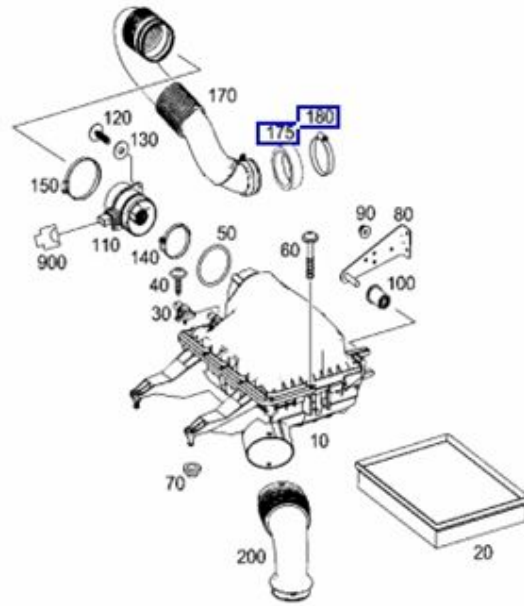
OM 642 Turbocharger.
jpg:

1. Oil leak from the Turbocharger Inlet Seal (175). (See attachment "OM 642 Turbocharger.jpg")
2. Seals between engine block and oil / water cooler may be leaking.

Attachments	
File	Description
OM 642 Turbocharger.jpg	Verify oil is not leaking from the turbocharger Inlet Seal (175)
