# Technical Service Bulletin

## 97 Rear parking assist inoperative

97 16 54 2041942/2 April 11, 2016. Supersedes Technical Service Bulletin Group 97 number 15-51 dated September 21, 2015 for reasons listed below.

Model(s)	Year	VIN Range	Vehicle-Specific Equipment
A6, A7	2015	000001 - 087920	Not Applicable

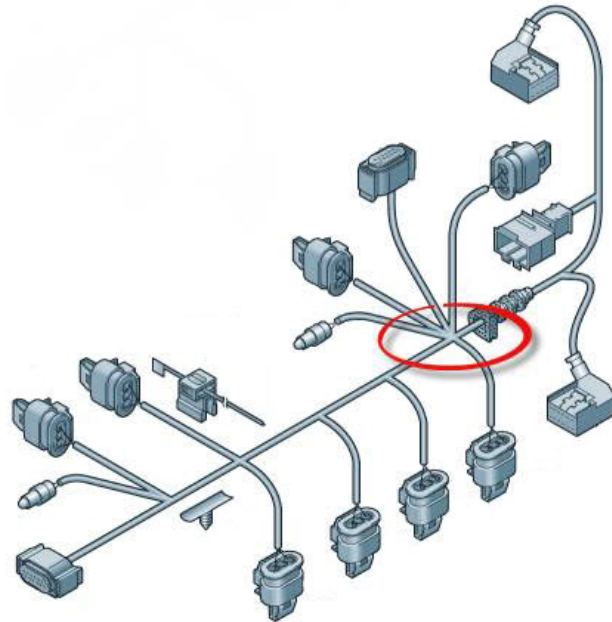
**Figure 1.** Open the protective covering of the rear bumper harness in the circled area.

1. Inspect the rear bumper wire harness for signs of damage from outside influence. If damage from outside influence is found, this bulletin does not apply.
2. Open the protective covering of the rear bumper harness just after the body grommet (Figure 1).

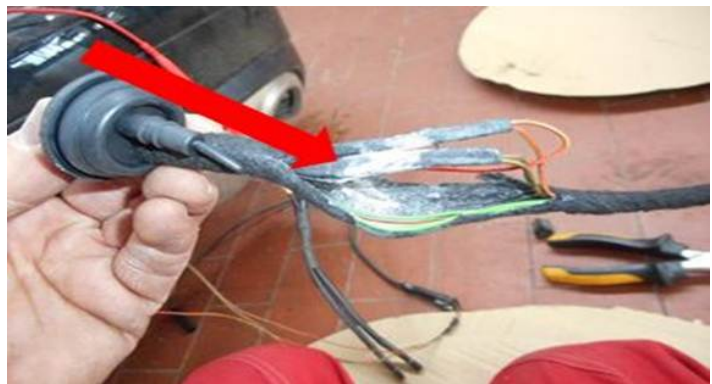
Humidity can enter into the rear wiring harness for the parking aid sensors, which can lead to corrosion of the splices.

**Figure 2.** Location of possible corrosion.

3. If one or both splices (ground splice 352 or voltage splice X68) are corroded (Figure 2 and Figure 3), replace the parking aid wiring harness. See ETKA for the improved harness part number.

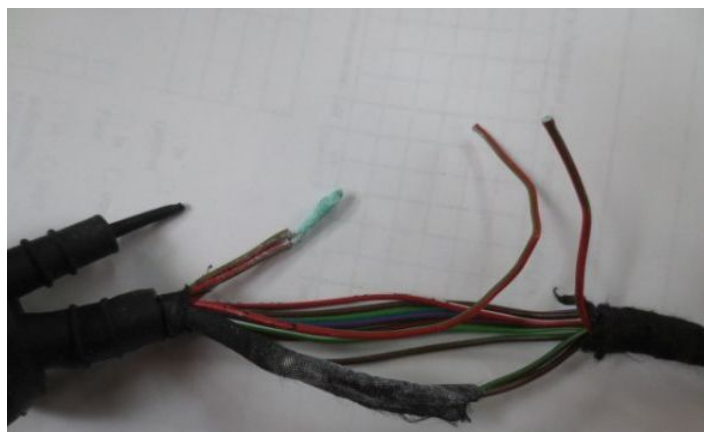
**Figure 3.** Corrosion of voltage splice X68.
