SERVICE BULLETIN

APPLICABILITY: 2013-14MY Legacy and Outback 2.5L Models

NUMBER: 11-145-14R

SUBJECT: Reprogramming File Availability for Oil Level Detection

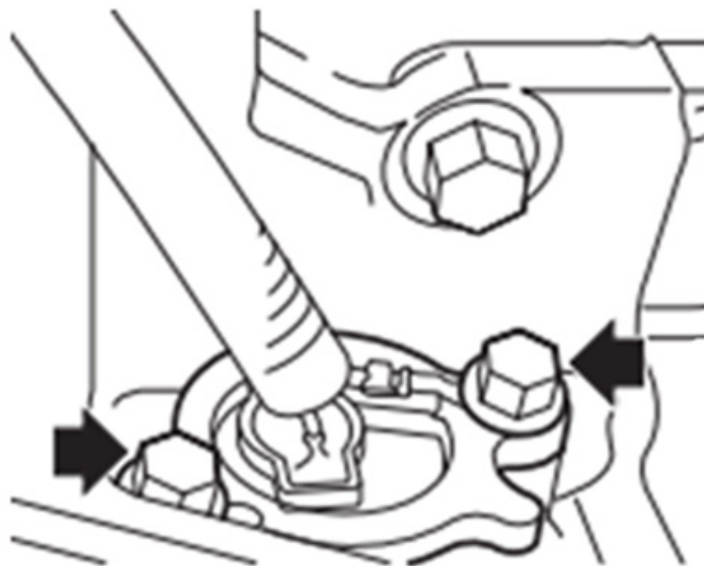
This bulletin announces the availability of reprogramming files and a revised oil level switch to optimize the ECM logic for engine oil level detection in the event of false or premature low engine oil level warning lamp illumination. Should a customer present a concern with a low engine oil warning lamp illumination and the diagnosis indicate the oil level is full or nearly full (oil level between the full and add marks/holes on the dipstick) and the customer has not added any engine oil, the ECM must be updated with this new logic and the oil level switch replaced. The new oil level switch part number supplied in this bulletin must be used. If the customer has added oil, determine how much was added. Based upon the information provided, estimate where the oil level was when the lamp illuminated in order to determine if additional action is required beyond what is described in this bulletin such as an oil consumption test. The ECM must still be updated with this new logic and the oil level switch replaced. The new oil level switch part number supplied in this bulletin must be used.

Step 3 - Once the ECM reprogramming has been completed and the oil level switch wiring has been confirmed to be OK, proceed with replacing the oil level switch assembly shown in the illustration below following the procedure outlined in the applicable Service Manual. Torque the 2 retaining bolts to 6.4 Nm (56 inch-pounds). Torque the 2 retaining bolts to 6.4 Nm (56 inch-pounds).
