# TECHNICAL BULLETIN

## K413NAS1

Service Action: Towbar Under Torqued

#### **F-PACE (X761)**

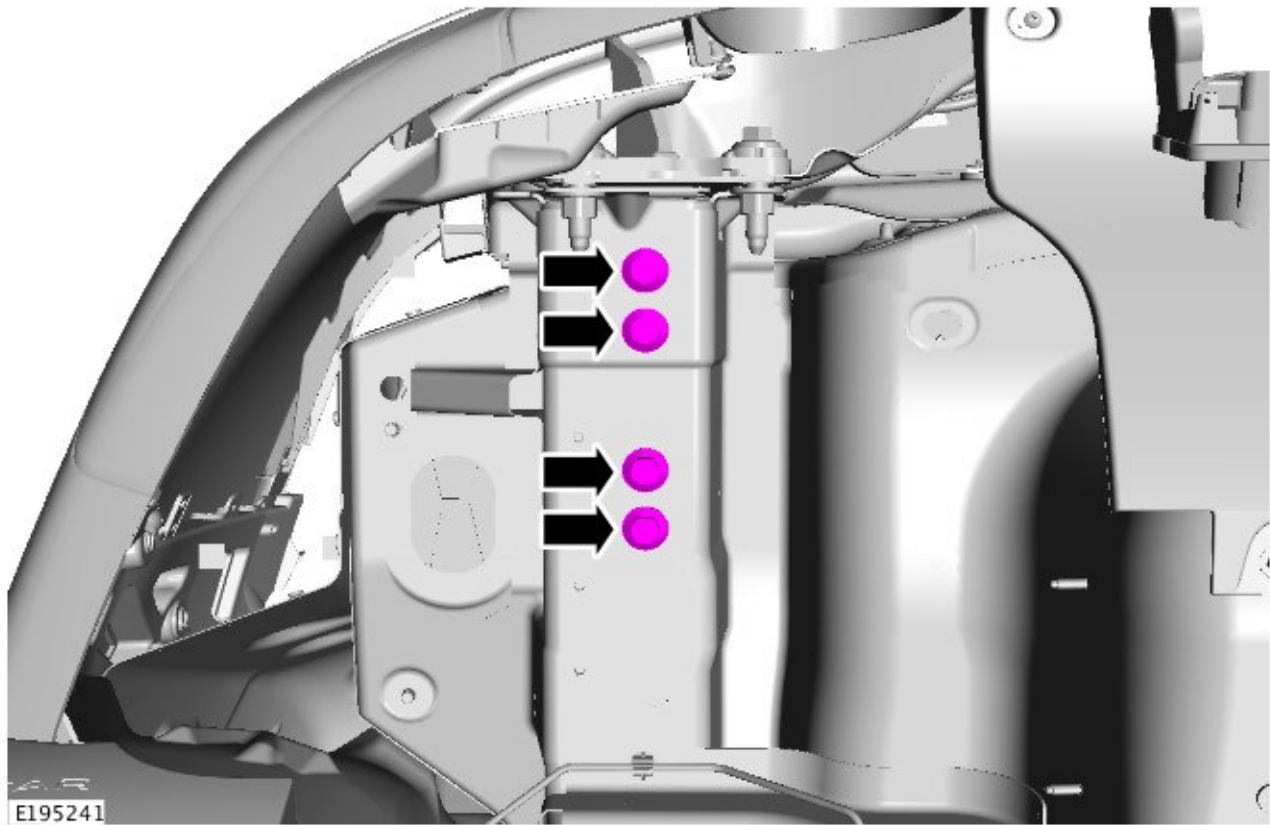
5.

Visually check the four towbar bolts for damage.

**NOTE: Torque: 100Nm +240 deg [ $\pm$  2 deg]**

- If any of the four towbar bolts are damaged, install four new towbar bolts.
- If the towbar bolts are not damaged, install the original towbar bolts.
