Service Bulletin

Subject: Wet Carpet/Floor at Driver and/or Passenger Footwell Areas

Models: 2010-2017 Chevrolet Equinox
2010-2017 GMC Terrain

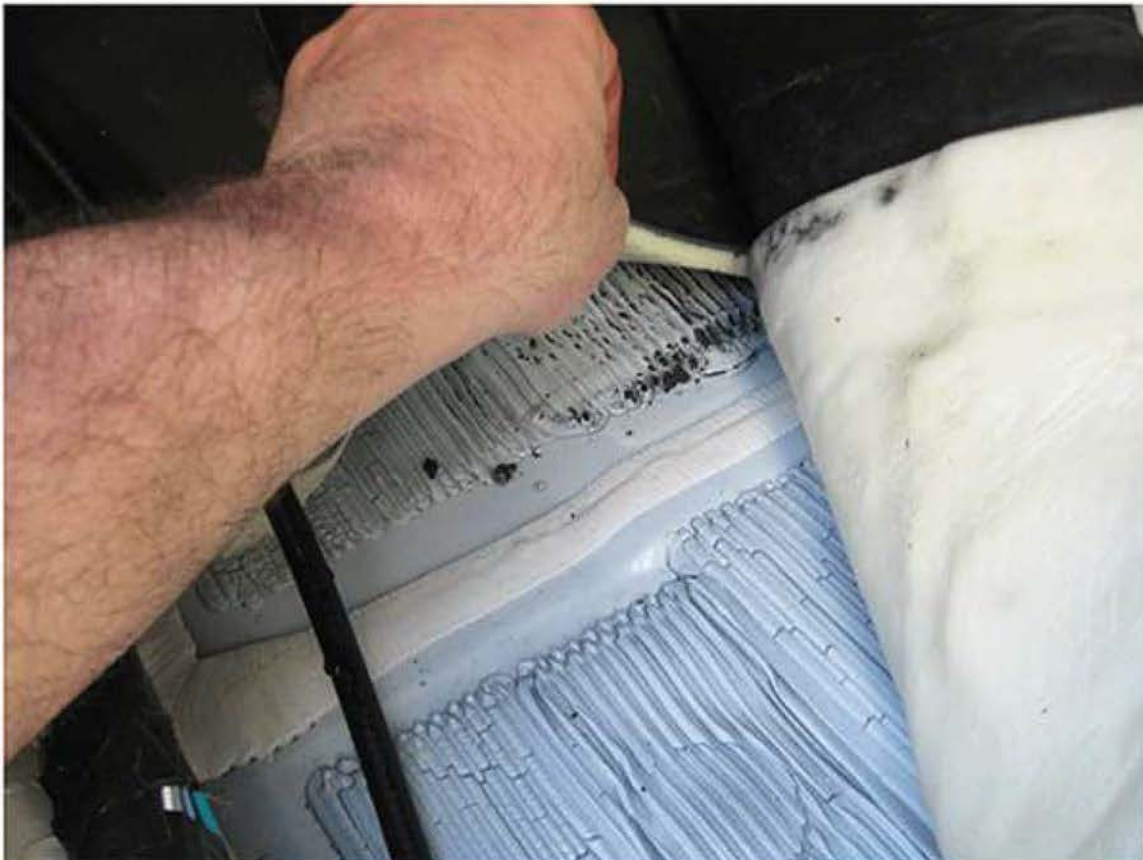
Inspect the vehicle for accumulated water or water spotting in the driver and passenger front footwell areas. Reposition the front carpet and inspect for

water/spotting between the carpet and the floorboard.

If evidence of water is found in these locations, inspect the affected side roof ditch for possible voids in the sealer. Inspect for, and correct this leak, following the repair steps below:

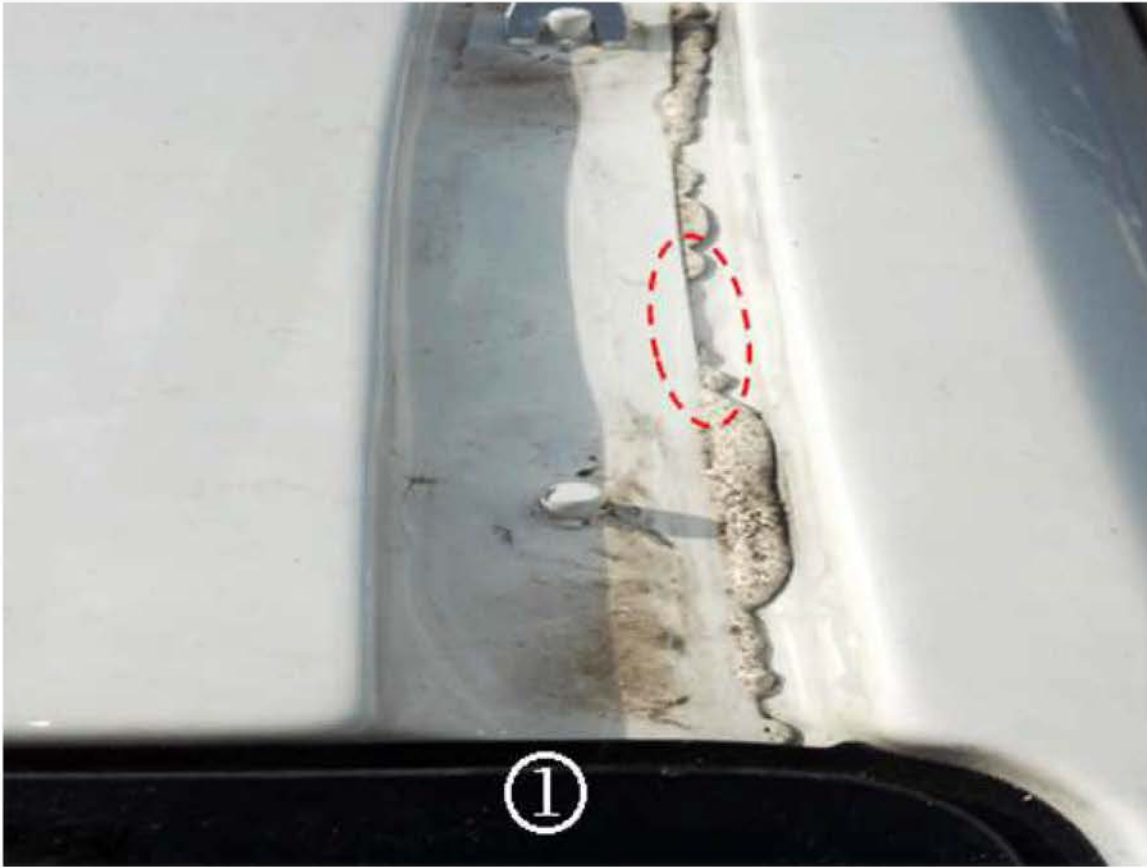
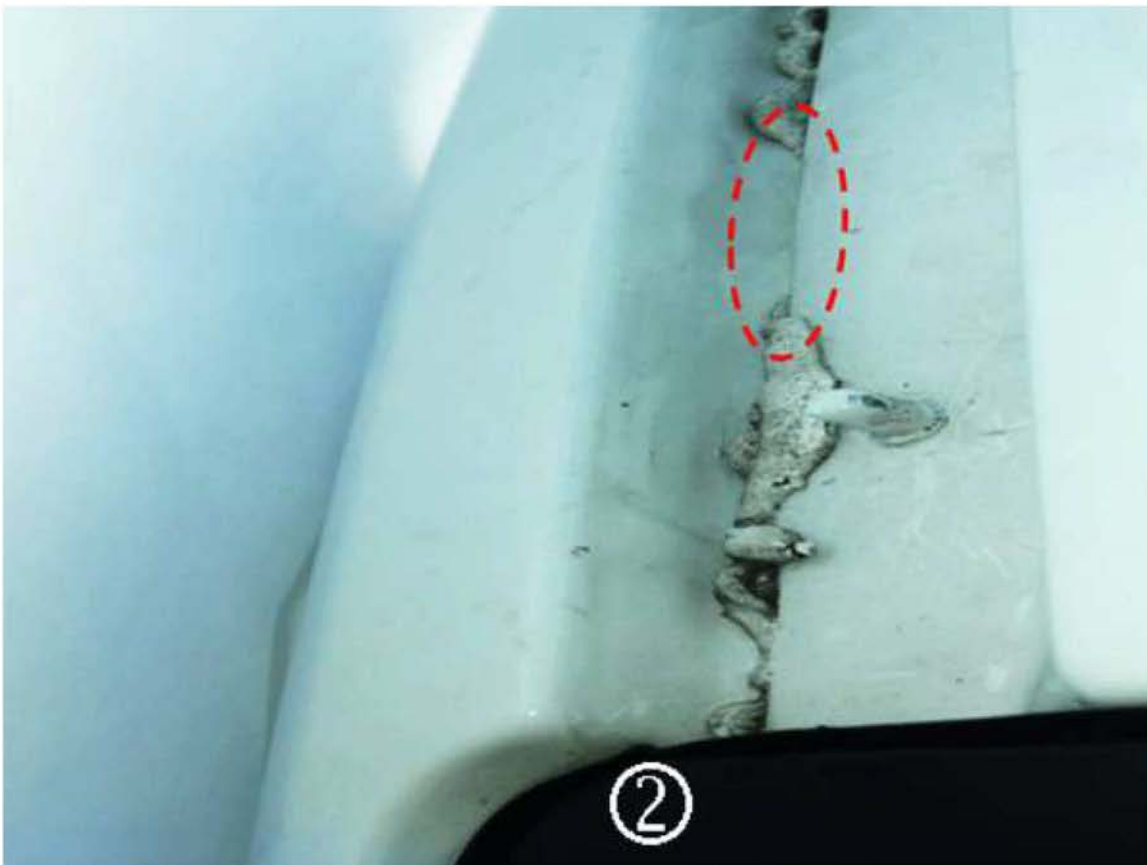
This condition may occur due to incomplete or insufficient sealing within the front roof to body side outer panel seams. The condition is most commonly found in the roof ditch within the first 30.5 cm (12 in) rearward from the windshield glass.

2. Inspect for voids/gaps in the seam sealer along the outboard edge of the roof ditch. Examples of this condition are shown in the driver side (1) and passenger side (2) graphics above.
3. Clean the affected area and seal all gaps with *Kent Automotive High-Tech™ Clear Seam Sealer, P/N 10200 (5 oz tube), or equivalent. Avoid excess sealer build up within the ditch while assuring any voids in the factory seal are filled.
4. Allow the seam sealer to adequately set-up, then water test by placing a water hose mid-roof near the ditch, allowing water to run forward to the A-pillar. Visually inspect for any water leaks along the inner roof, A-pillar and floor areas.
5. Once the repair is verified, reinstall the roof ditch molding. Refer to Roof Panel Molding Replacement in SI.
6. Dry the interior of the vehicle as needed. Refer to Floor Carpet Drying in SI.
